## ***Threemile Creek Restoration Opportunities***

### **Klawock Lake Watershed**

*October 2019*

**Klawock Sockeye Salmon Stakeholder Group**

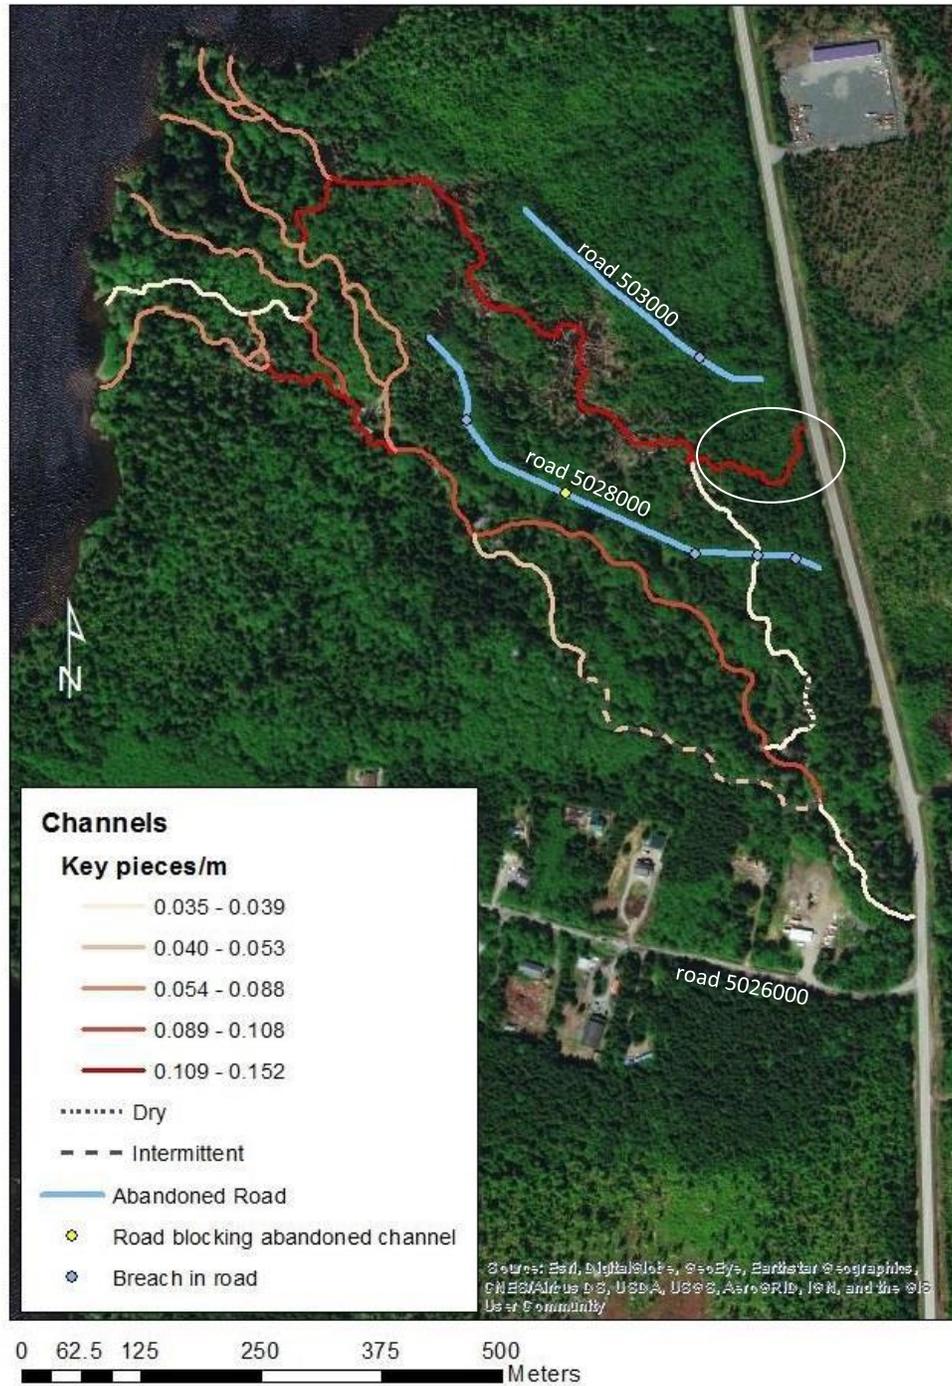
**Figure 1.** Active channels in the alluvial fan, density of key pieces of wood in different reaches, and abandoned (blue lines) and open roads. Note that the small northern tributary (in circle) flows through a culvert under the highway, but was only mapped downstream of the highway.

*Results downstream of the highway:* To better understand existing stream habitat quality and quantity, the SAWC field crew mapped the active channels in the alluvial fan and marked the locations of key pieces of wood (>0.3 m diameter, >7.6 m length) that were within the bankful width (zones 1 and 2 in Tier II) (Fig. 1). The number of key pieces of wood per meter averaged 0.09, and ranged from 0.04 to 0.15 across reaches, with the lowest value observed just downstream of the culvert where large wood is being removed from the stream, and the highest in the northern-most channel, which flowed through very dense young-growth riparian forest (Fig. 1). Because of the variability within and among alluvial

Full excavation of this road would require building temporary stream crossings and backhauling the material to a waste dump. For this reason, we suggest adding 6-8 breaches west of the active breach mentioned above. Waste material would be spread onto the remaining road bed, so backhauling would not be necessary. The excavator would lessen the grade of the existing road breaches and ford the breaches. Puncture material could be used if the ground is soft, but the construction of temporary stream crossings would not be necessary. Figure 2 (A&B) shows a photo and the design plan of a typical road breach. This breach was placed along an abandoned logging road in the Pat Creek alluvial fan near Wrangell to reconnect floodplain and allow natural channel migrations. We suggest that breach locations be chosen at the time of construction based on wetland vegetation, the presence of water or historic channels, or at regular intervals. All roadbed material would be removed at breaches to an elevation equal to or slightly below the surrounding grade. We estimate that this would be about 16-24 hours of work for a mid-sized excavator (Estimated at \$250 per hour plus mobilization costs). We estimate this action should cost around \$10,000-\$15,000. An ADF&G Fish Habitat Permit would be necessary. Aside from cost, the major negative consequence of this action is that all re-growth along the road would be removed (*See Figure 2 (c) for an example from Pat Creek*).

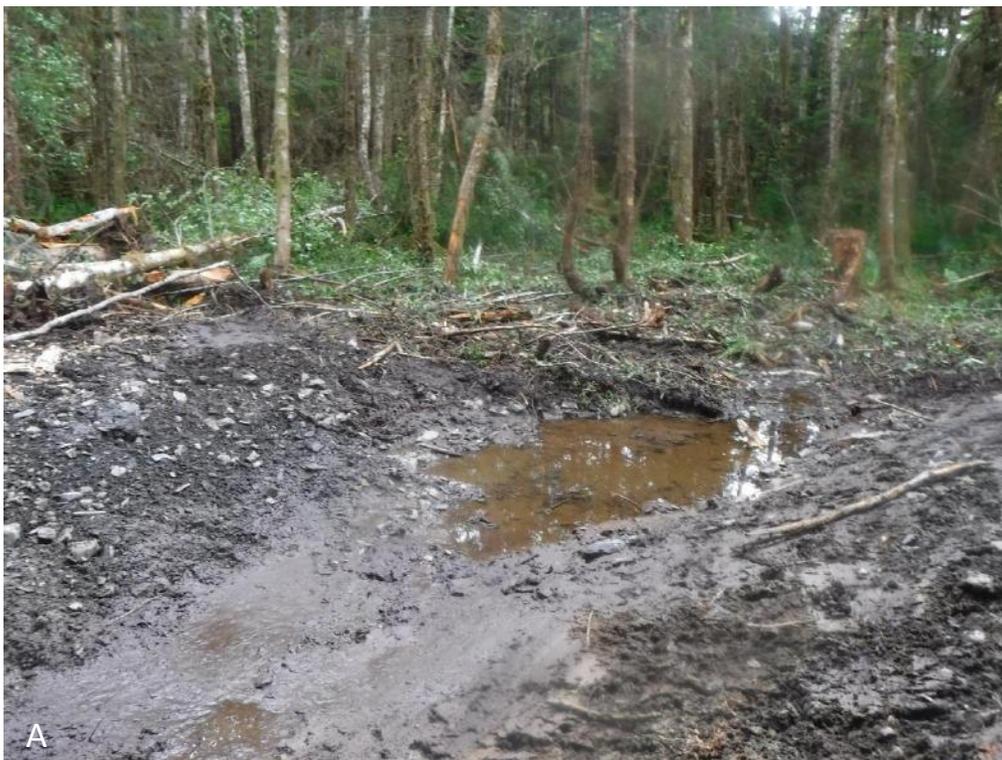
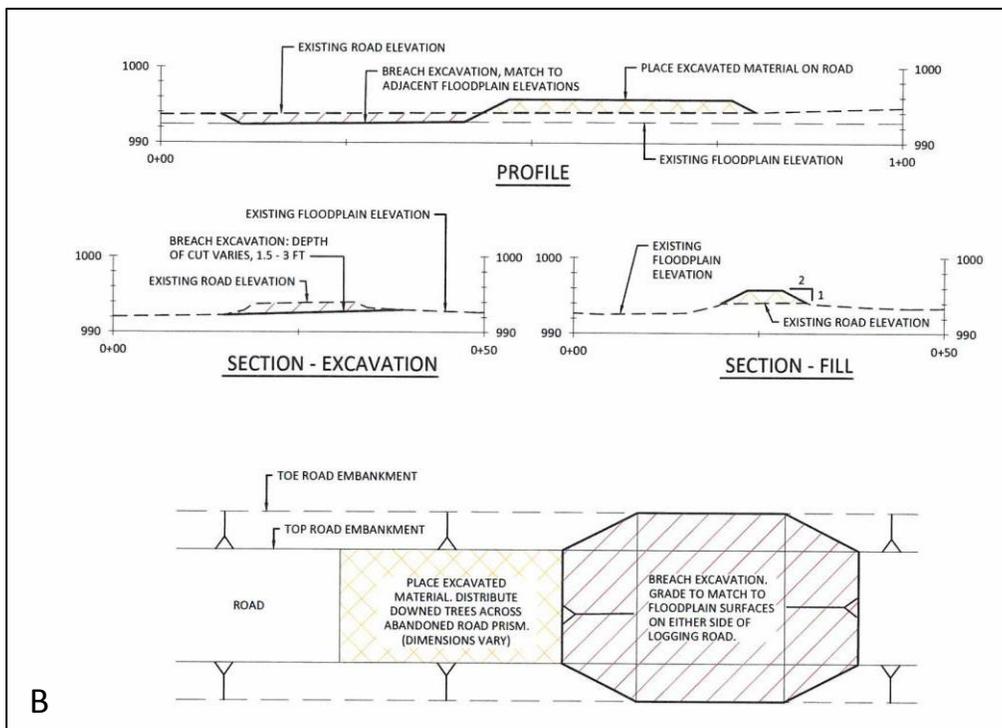
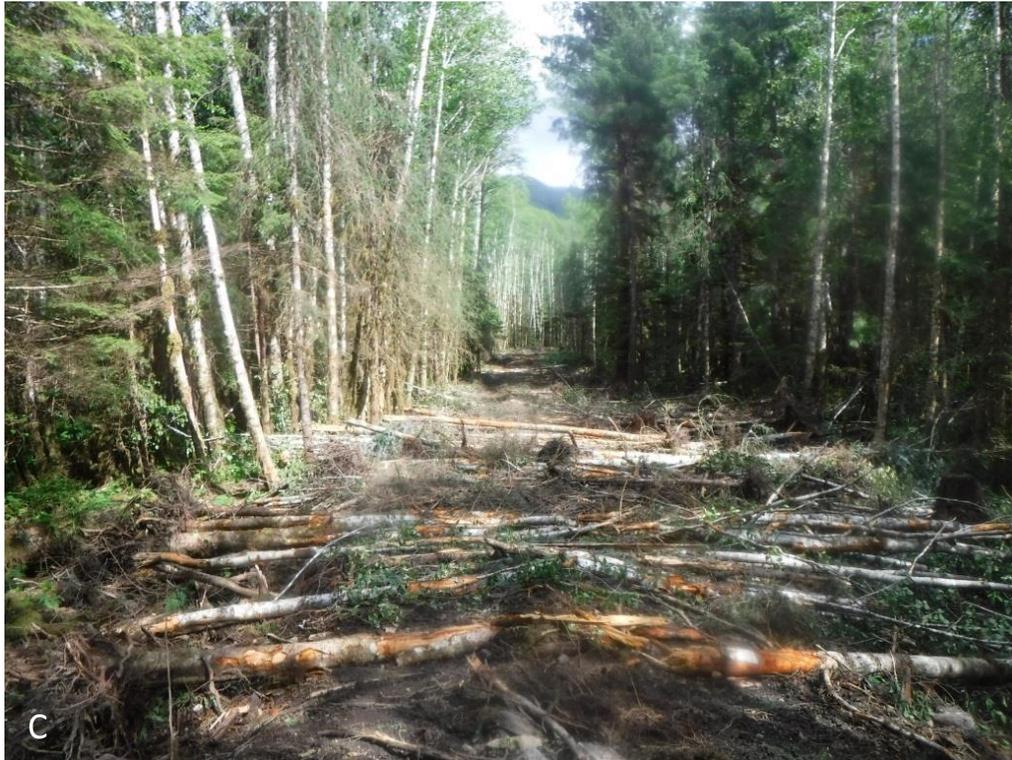
**Figure 2.** From the Pat Creek Fish Habitat Enhancement Project. (A) Example of a road breach excavated to the elevation of the surrounding grade on an alluvial fan. (B) Schematic of a typical road breach. (C) A logging road on an alluvial fan after removing alder trees to access breach sites.

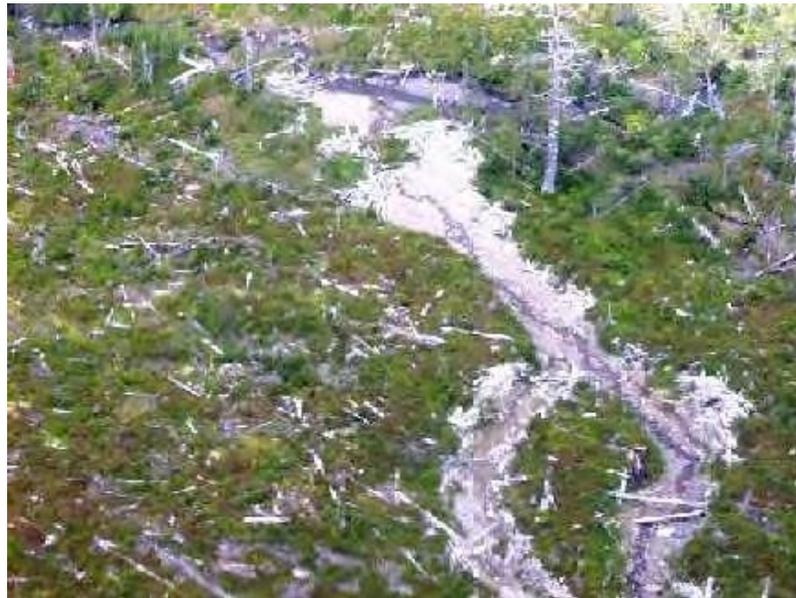
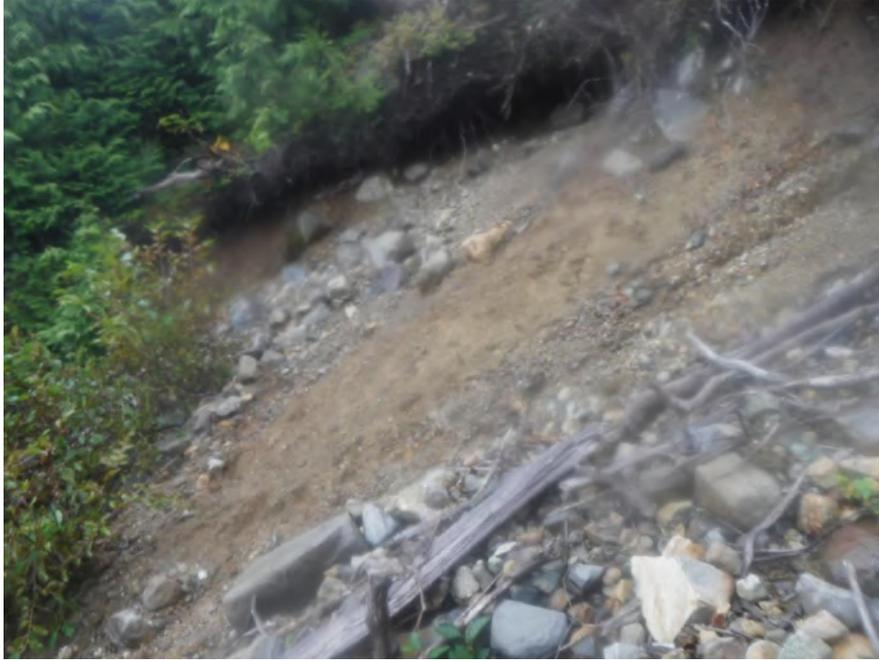
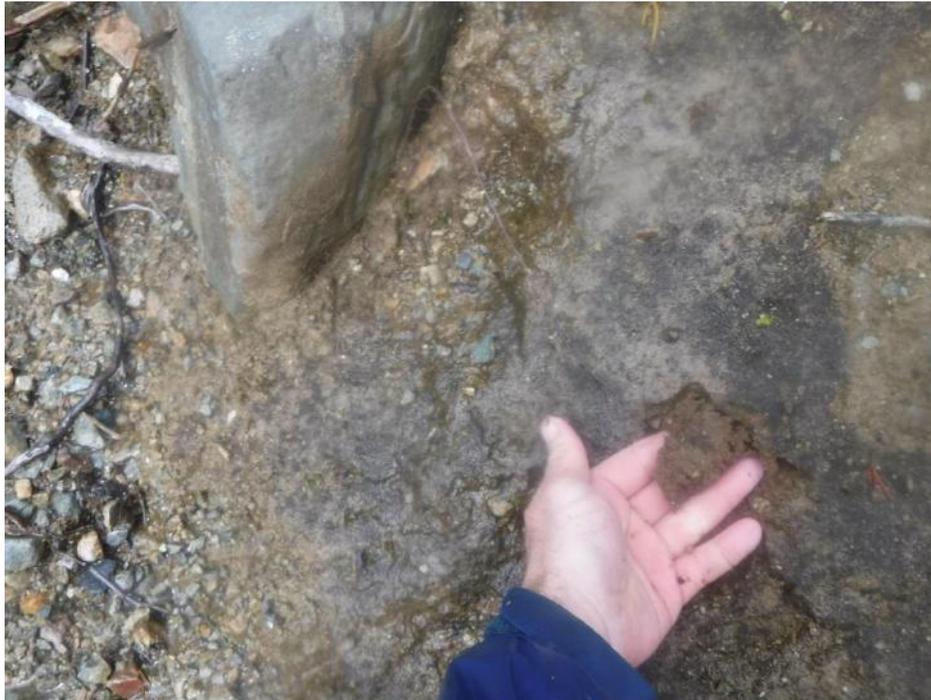
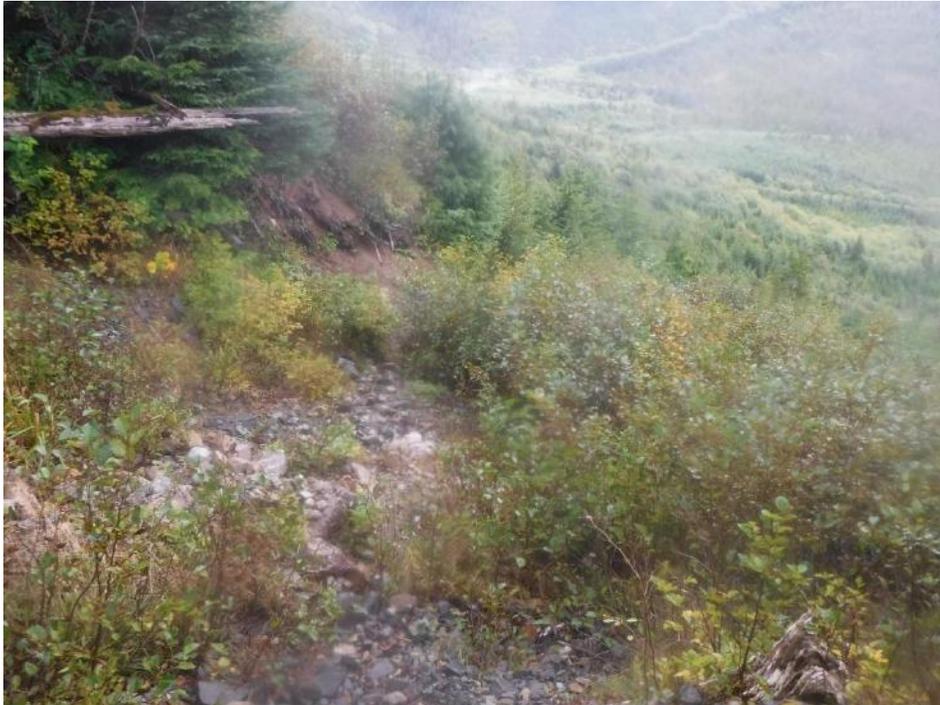
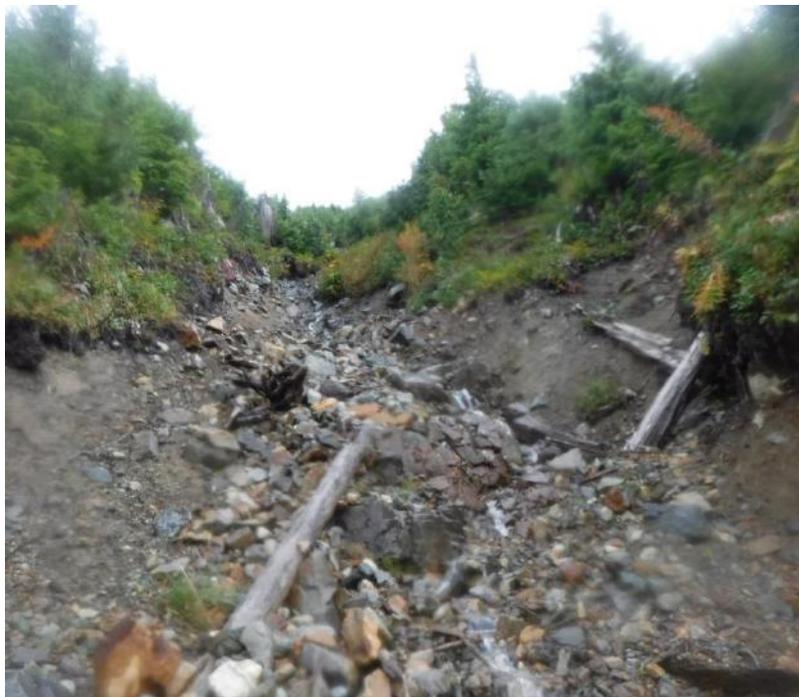
During field surveys in August of 2018 and September 2019, several old and active landslides were visible from the Klawock-Hollis Highway and other vantage points in the watershed. Landslides associated with the 5032510 and 5032500 roads were visited. We found that all culverts had been removed from these roads, waterbars had been installed, and we saw no evidence of water flowing parallel to the road bed. There were some areas that had a small amount of ponded water on the roadbed. The road appears to have been built on a steep slope on top of highly erodible sand and small gravel (Figure 3, B). Several exposed sections of clay were also visible (Figure 3, C). Satellite imagery from 2003 and 2019 show that slides initiated directly adjacent to and on the 5035210 and 5032500 roads (Figure 3 D & E). While most older slides have regrown in alder, active debris gullies are still likely contributing some material into tributaries of Threemile Creek (Figures 3, F & G). We also inspected an older slide that crossed road 5025000, and noted that it likely contributed a limited amount of material into the stream. While walking Threemile Creek above the Klawock-Hollis Highway, a large sediment slug was noted approximately 920 meters upstream that may have been from a landslide (Fig. 4).

**Figure 3.** A) Debris torrent in Threemile Creek Watershed from 1993 landslides (*taken from USFS 2002*). B) Sand and gravel underneath the 5032510 and 5032500 roads. C) Clay layer exposed in a slide along the 5032500 Road. E) 2003 satellite imagery showing slides initiating on or near 5032510 and 5032500 Roads. F) 2019 satellite imagery showing active debris gullies with some alder regrowth.

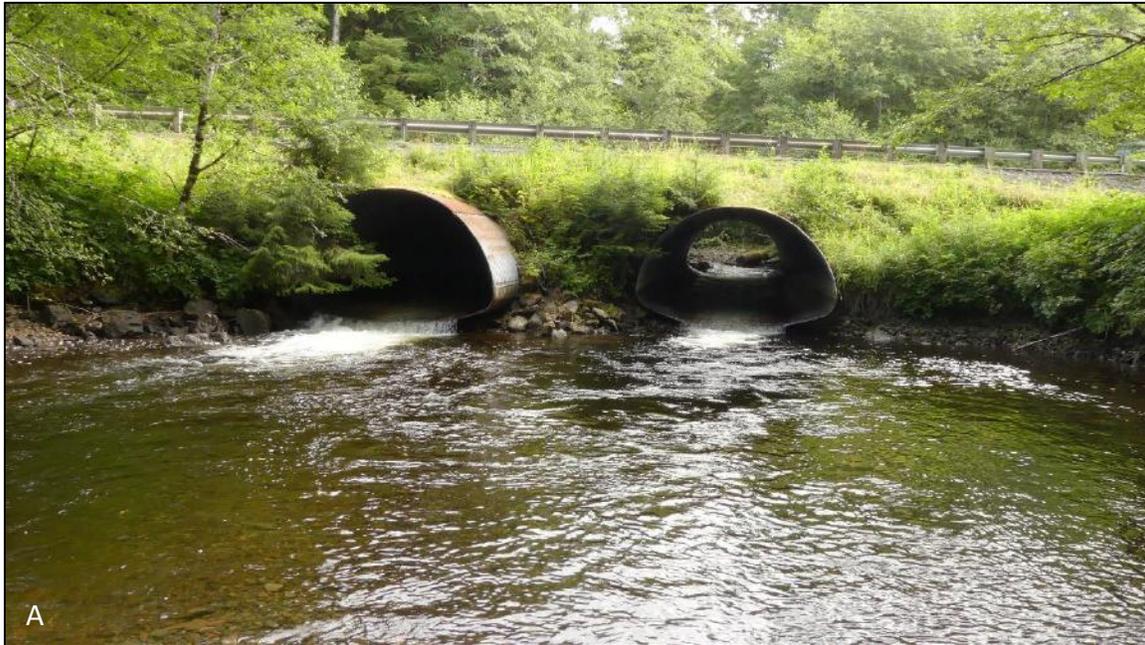
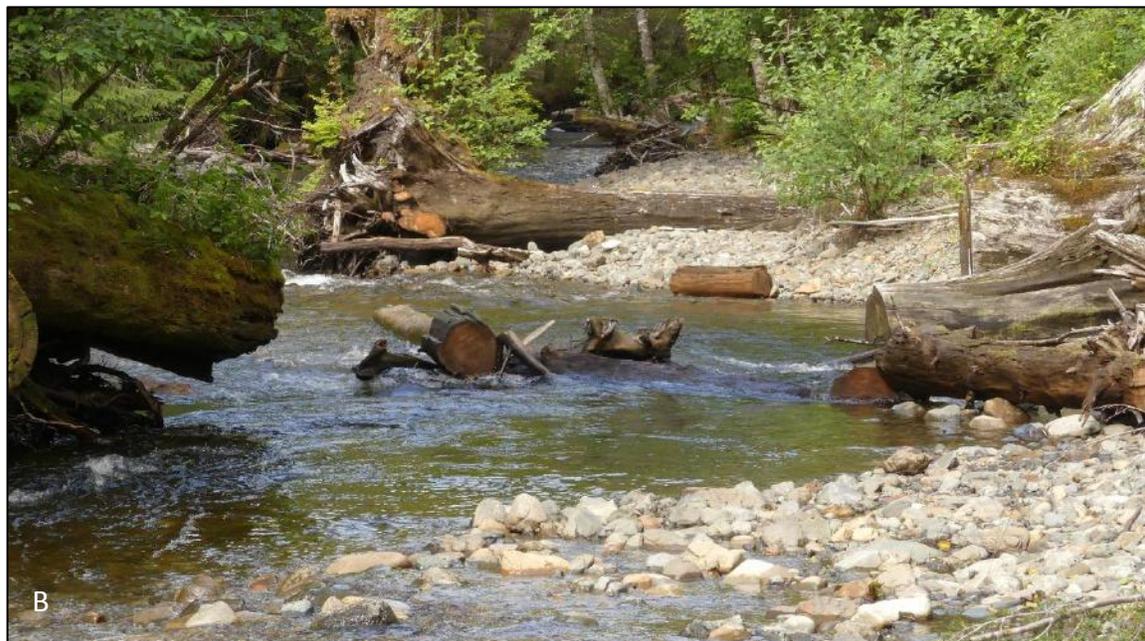
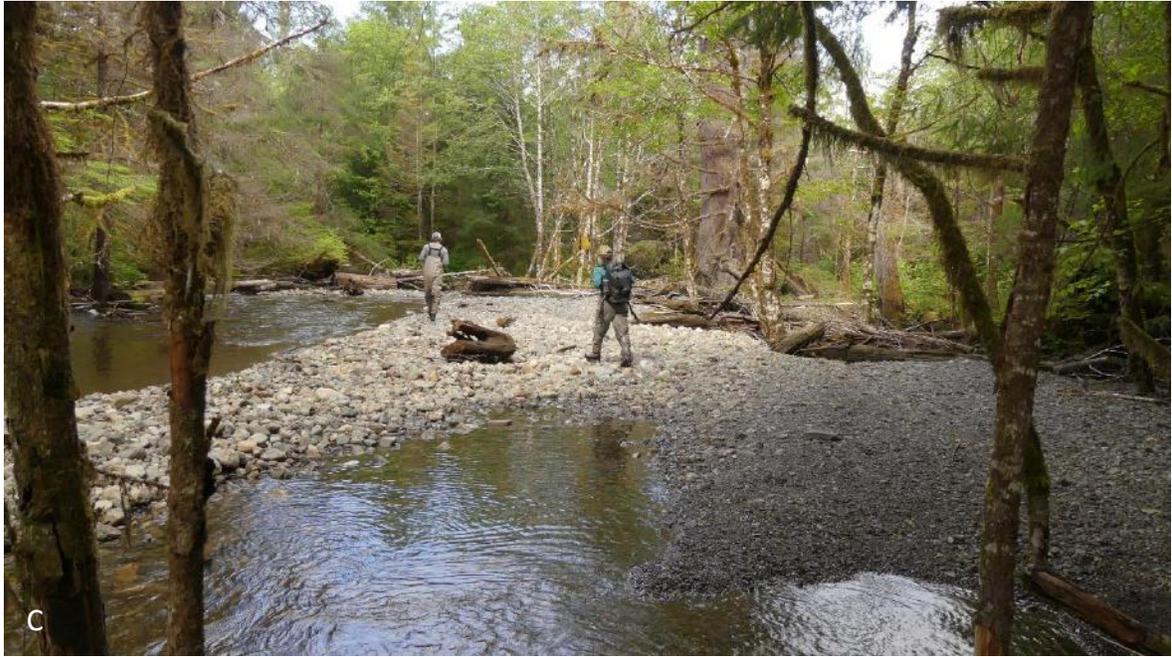
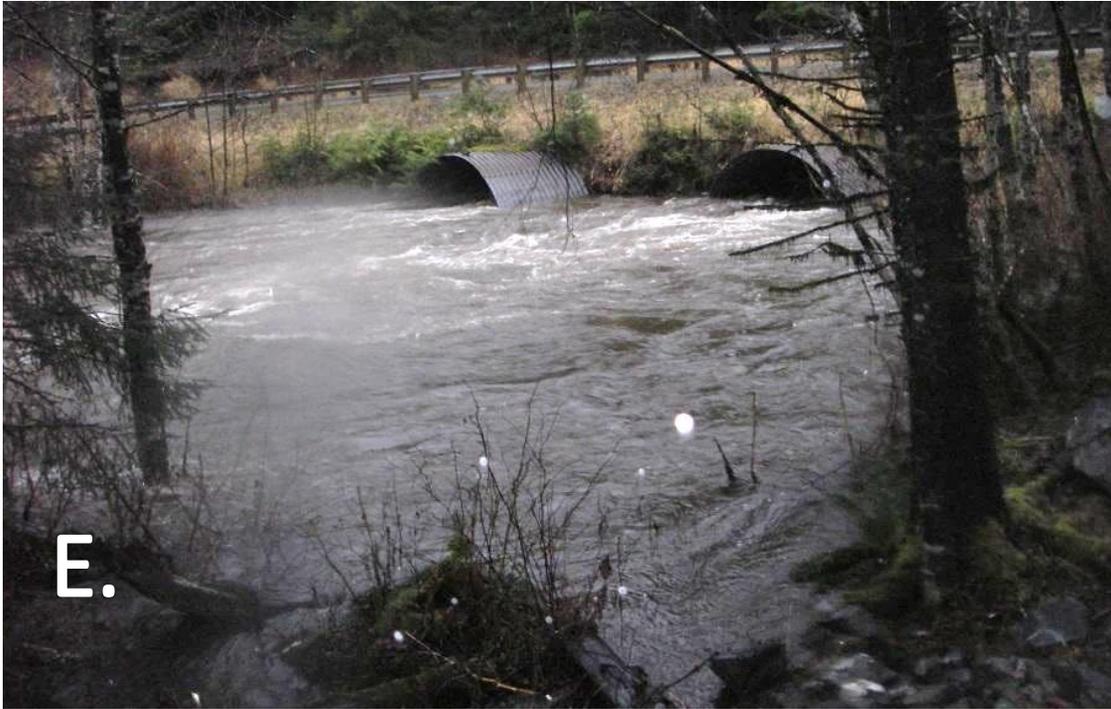
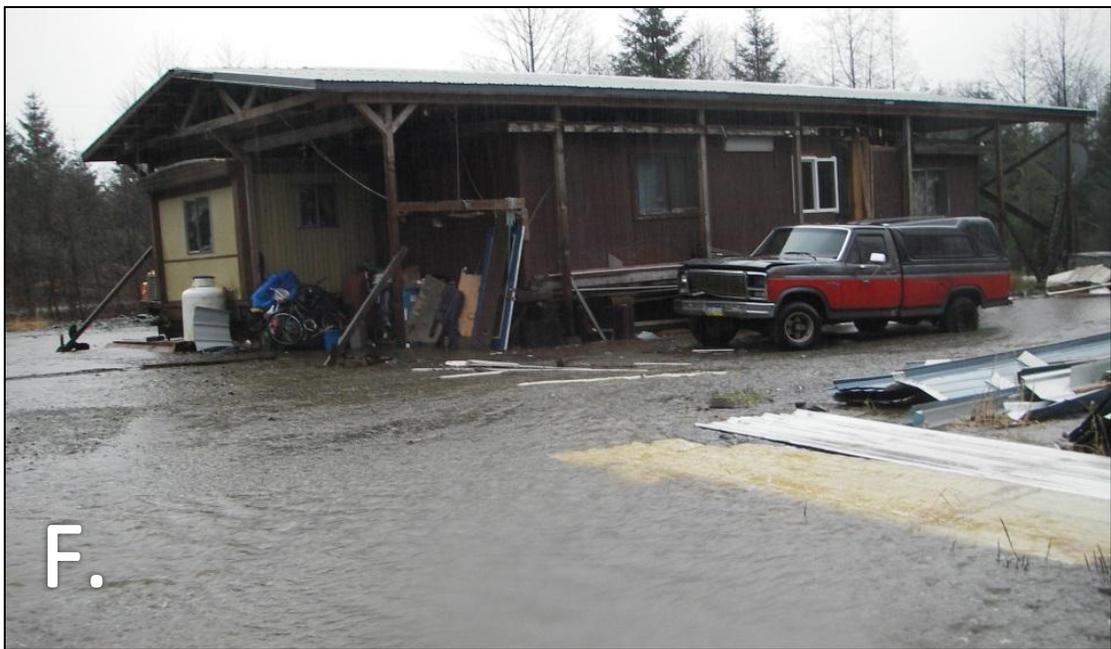
We recommend replacing the two culverts at the Klawock-Hollis Highway crossing of Threemile Creek to allow for fish passage (Fig. 5, A). Needham *et al.* (2018) surveyed this double culvert crossing and classified it as “red,” because it provides inadequate passage for juvenile fish based on criteria set by Eisenmen and O’Doherty (2014). Further, this crossing is listed as “red” by the Alaska Department of Fish and Game for outfall height and culvert gradient (ADF&G 2017).

Immediately downstream of the Klawock-Hollis Highway crossing, bank armoring on river-left and removal of large woody debris has mobilized stored sediment, causing channel incision and decreased habitat complexity (Fig. 5, B). A sediment slug immediately downstream of these operations is likely linked to upstream wood removal and channel incision, resulting in sediment aggradation and associated tree death, as well as channel avulsion on river-right. Further, a side channel on the south side of the mainstem has been blocked by a constructed dike. These activities appear tied to homeowner-initiated flood control efforts in response to the effects of the undersized culverts at the Klawock-Hollis Highway and poor site selection for the Threemile subdivision. The undersized culverts are pointed directly at a homeowner’s property, and during high water the flow in these culverts is very high and contributes to flooding risk (Fig. 5). Prior to the construction of the Klawock-Hollis Highway, the main channel of Threemile apparently flowed through this property and the Threemile Subdivision (See historic channel in Fig. 6.)

**Figure 5.** (A) Low flow through the double culvert at the Klawock-Hollis Highway crossing August, 2018. (B) Illegal cutting of large woody debris in the channel immediately downstream of the highway. (C) Downstream end of the sediment slug where sediment aggradation has caused channel avulsion and raised the water resulting in tree death.

We recommend that the design for a new stream crossing be coupled with hydrologic and geotechnical analyses to determine if flooding risk for the adjacent landowner can be reduced sufficiently to allow for in-stream habitat restoration of the stream reach immediately downstream of the culvert, including reactivation of the side channel currently diked off.

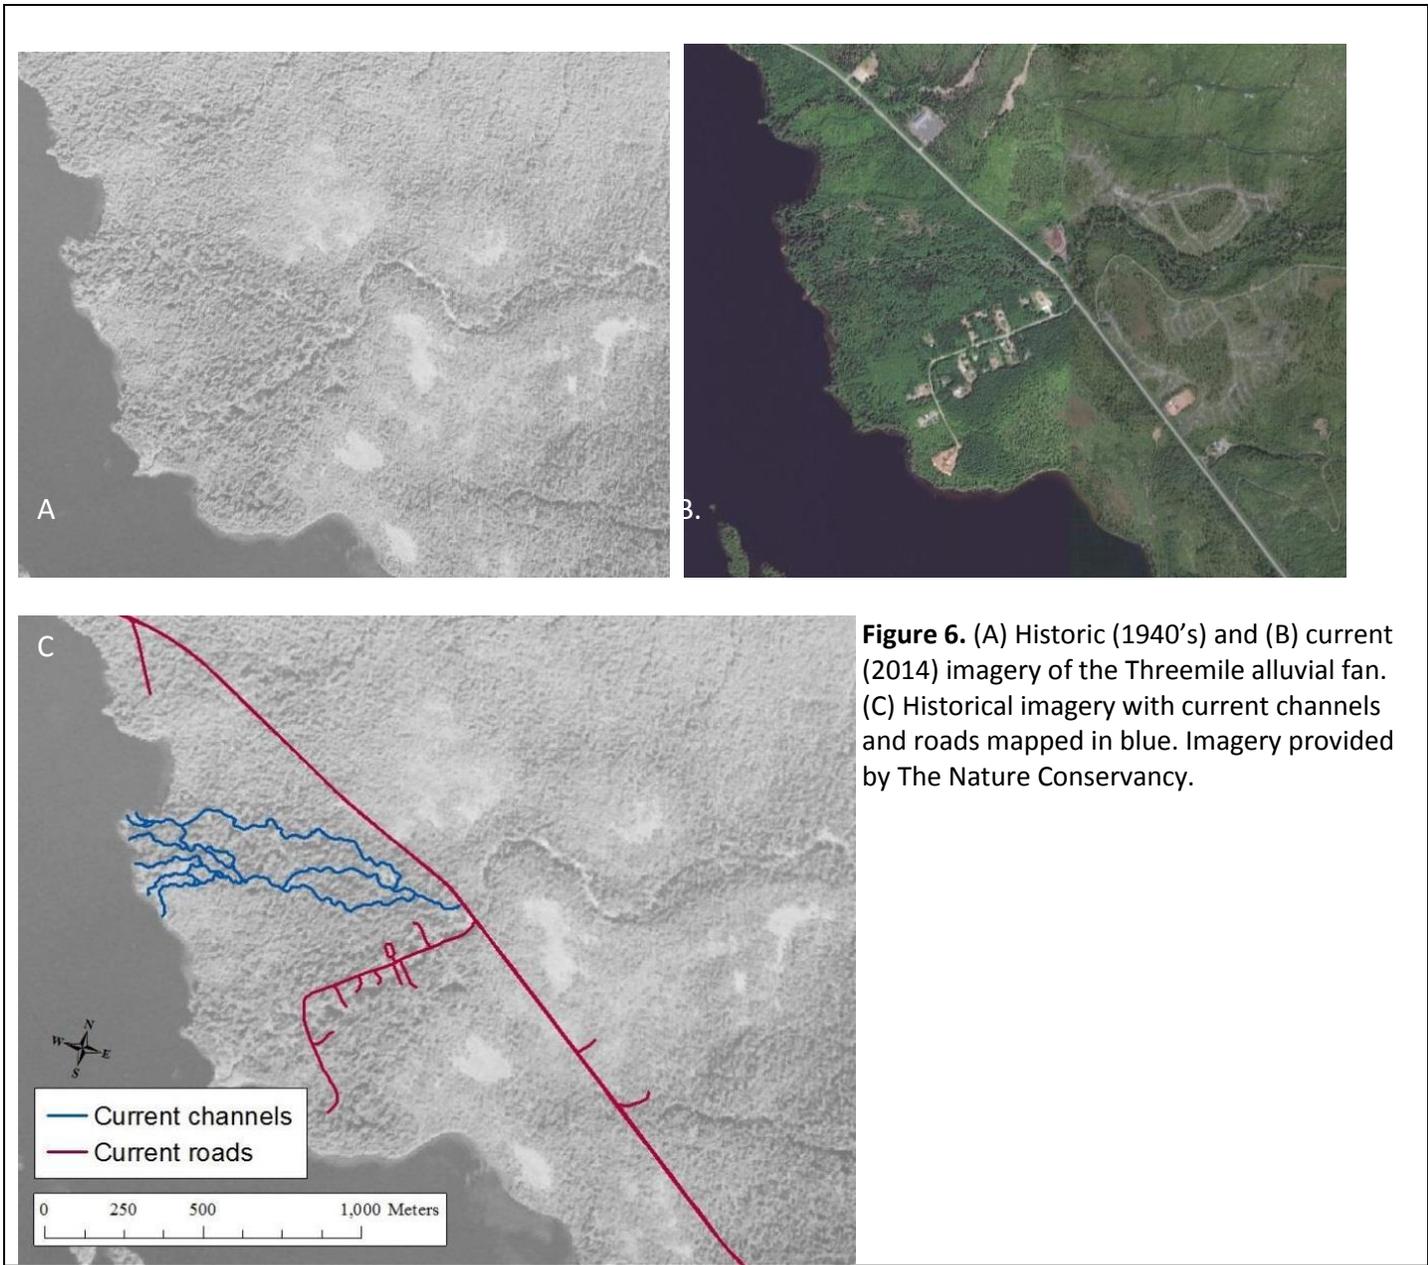
**Figure 6.** (A) Historic (1940's) and (B) current (2014) imagery of the Threemile alluvial fan. (C) Historical imagery with current channels and roads mapped in blue. Imagery provided by The Nature Conservancy.

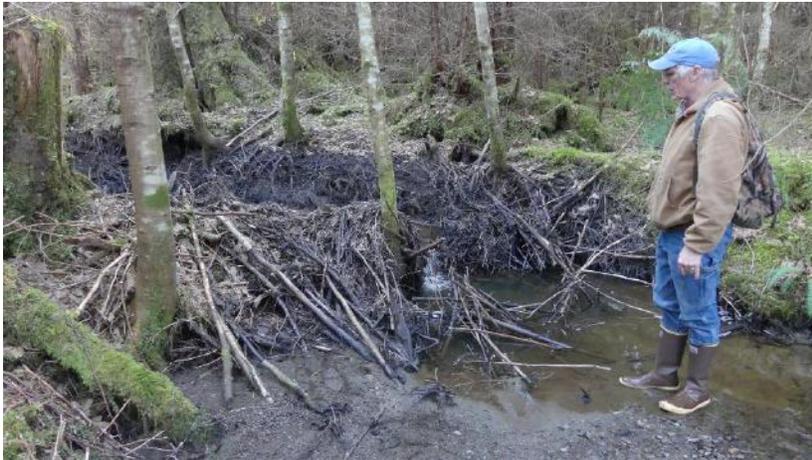
**Figure 7.** An abandoned and failing beaver dam on a tributary to Threemile Creek near the west side of the alluvial fan. Stream flow is from left to right.

The beaver dam, which is located about 200 feet downstream of the highway, is abandoned and has partially failed. Before the dam failed, sediments trapped behind the dam had completely filled the channel and portions of the floodplain. Following dam failure, the stream has begun to process and route the sediment downstream. Stream flow is alternately incising through this bedload in some areas and depositing sediment in other areas. Aggrading areas have become over-widened and often

Instream and riparian restoration are recommended for this stream, both downstream and, if warranted, upstream of the highway. The goal of a restoration project would be to improve fish habitat quality and quantity and enhance plant species and structural diversity in the riparian zone, including promoting conifer growth. Large pieces of wood sourced from riparian spruce trees can be placed in the channel using hand tools (i.e. shovels, picks, winches). The large-wood structures will be located at specific sites to route excess sediment accumulations through the reach, restore natural channel dimensions, and create riffles and pools for fish habitat. Riparian trees could be thinned or pruned to

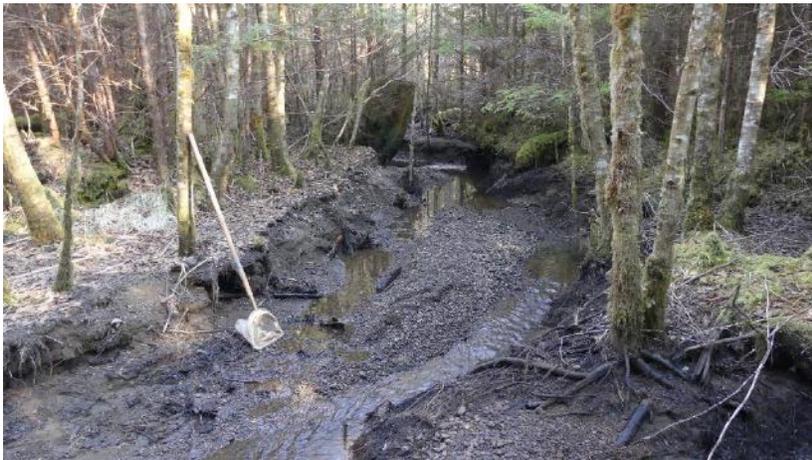
**Figure 8.** A section of formerly ponded channel about 70 feet downstream of the highway. View looking upstream.

contain mid-channel bars; frequent lateral channel shifts in aggrading reaches are eroding stream banks and exposing tree roots (Fig. 8). The abundance of large woody debris in the active channel appears to be low for a channel of this size. Downstream of the dam the channel generally has a normal appearance.

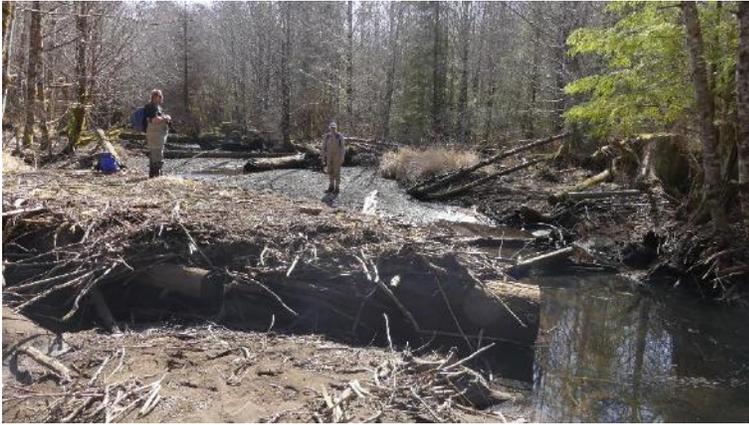
*The remains of an abandoned beaver dam on Hatchery Creek that was partially removed to expose potential spawning habitat. View looking upstream.*

Within the Klawock watershed, beavers are legally trapped and one inactive beaver dam has been removed from Hatchery Creek. The intent of the dam removal project was to restore easier access to over a mile of high-quality sockeye spawning habitat above the dam. In this case, beavers had built a dam on a channel spanning log that had been felled by humans. This dam
