PAT CREEK WATERSHED RECONNAISANCE

SOUTHEAST ALASKA WATERSHED COALITION Connect - Inform - Participate

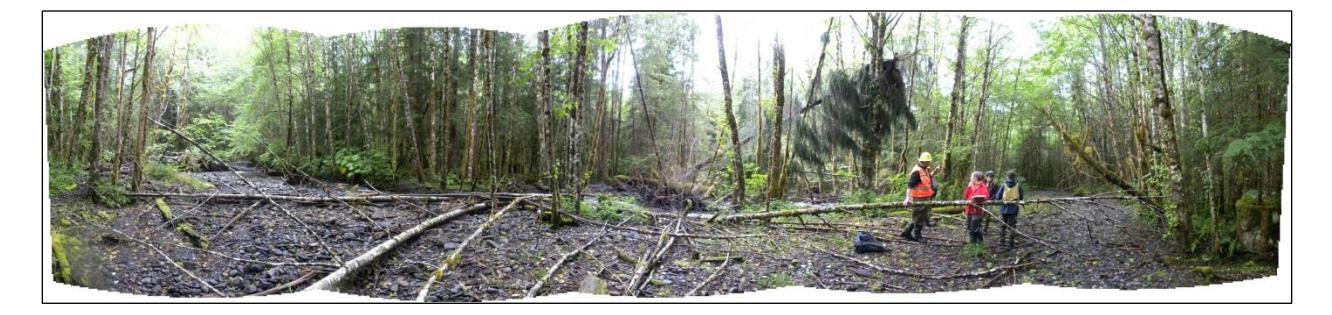
Channel stability and morphology differed dramatically between the upper and lower reaches of the active alluvial channel (Figure 6). Sediment aggradation in the upper half of the alluvial fan was evidenced by large depositional bars of coarse sediment, relatively high width-to-depth ratios, and extreme bank erosion. At several locations within this reach numerous mature red alder had recently fallen or were in the process of falling into the channel (Figure 7). Most of the recently active avulsion channels originate from the upstream half of the fan.

Figure 7. Panoramic view of the upper reaches of the East Fork alluvial channel (Photo point 4 in Figure 6). Large deposits of unvegetated substrate on the floodplain indicate recent sediment aggradation. Stream flow is from left to right.

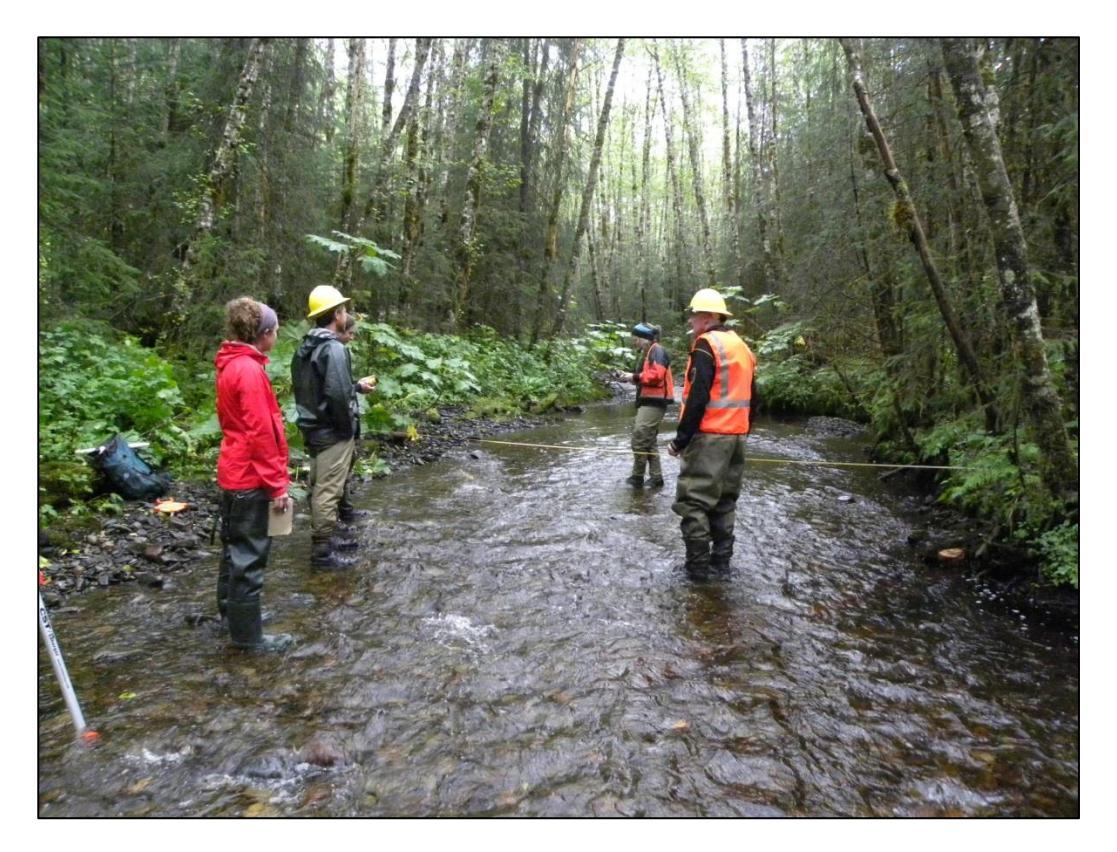
In contrast to the upper reach, the lower half of the active alluvial channel appeared stable. There was no evidence of channel incision or bank erosion and the width-to-depth ratio appeared to be considerably lower than in the upper half of the channel (Figure 8). Evidence of recent bedload aggradation was limited to a 150 foot long reach directly downstream of the upper reach. The upper-lower reach transition point is located at Photopoint 2 in Figure 6. At this location a 6-foot tall stable debris dam consisting of a large stump and other wood debris appears to have caused a channel avulsion to the west (Figures 6 & 9). Prior to the avulsion the active channel connected to the West Fork upstream of the current confluence of the two forks. Given the apparent stability of this channel, instream wood amendments may be possible. The lower reach channel should be monitored to determine the extent and impacts of recent sediment aggradation from upstream inputs.

Figure 8. Upstream view of the East Fork of Pat Creek near its confluence with the West Fork (Photopoint 1 in Figure 6).

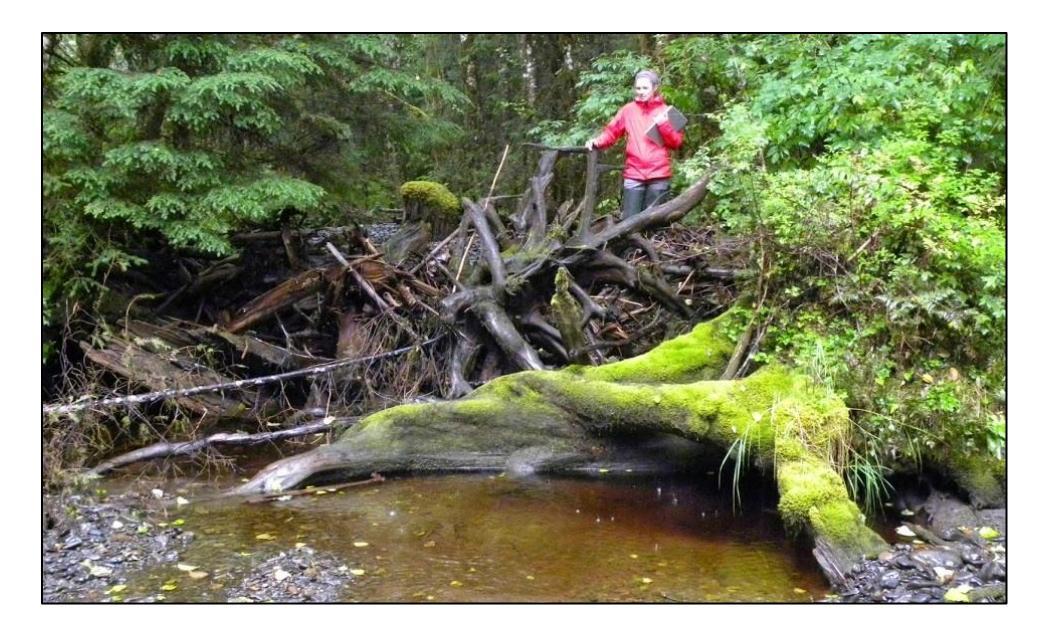
Figure 9. A 6-foot tall debris dam on the East Fork has resulted in significant upstream sediment aggradation resulting in a westward avulsion of the active channel (Photopoint 2 in Figure 6). View looking upstream.

Floodplain Roughening: Because of the dynamic nature of this fork of the stream, attempts at restoring habitat with placement of key pieces of large wood are risky and may prove to be a wasted effort if the stream continues to change course. A possible solution to consider is floodplain roughening as a method of stabilizing the stream's alluvial fan.

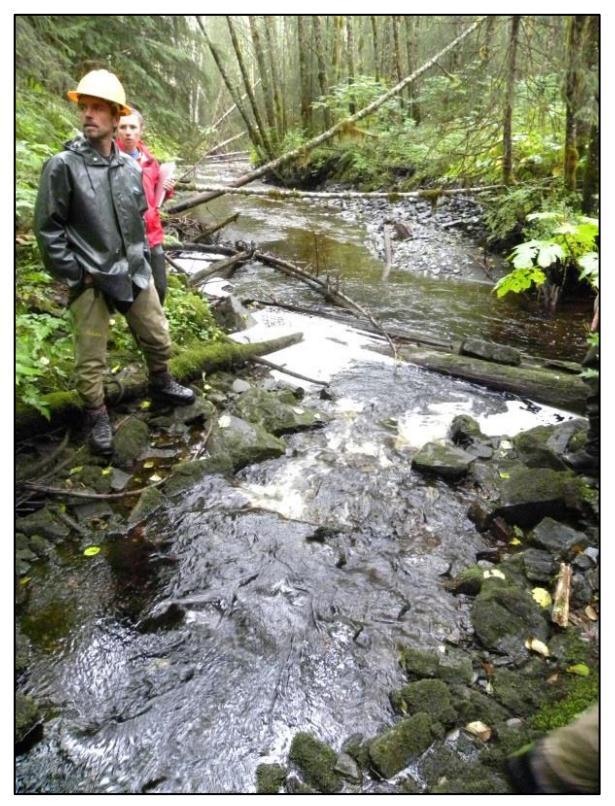
An abandoned logging road parallels the lower reaches of the East Fork on its west side (Figure 6). A small portion of the road is eroding into the active alluvial channel at its confluence with a tributary entering from the west side of the channel (Figure 10). Existing and potential effects of this road on lateral channel migration should be investigated in the future.

Figure 10. At its confluence with the East Fork, a tributary flows over an abandoned logging road (Photopoint 3 in Figure 6). View looking downstream.

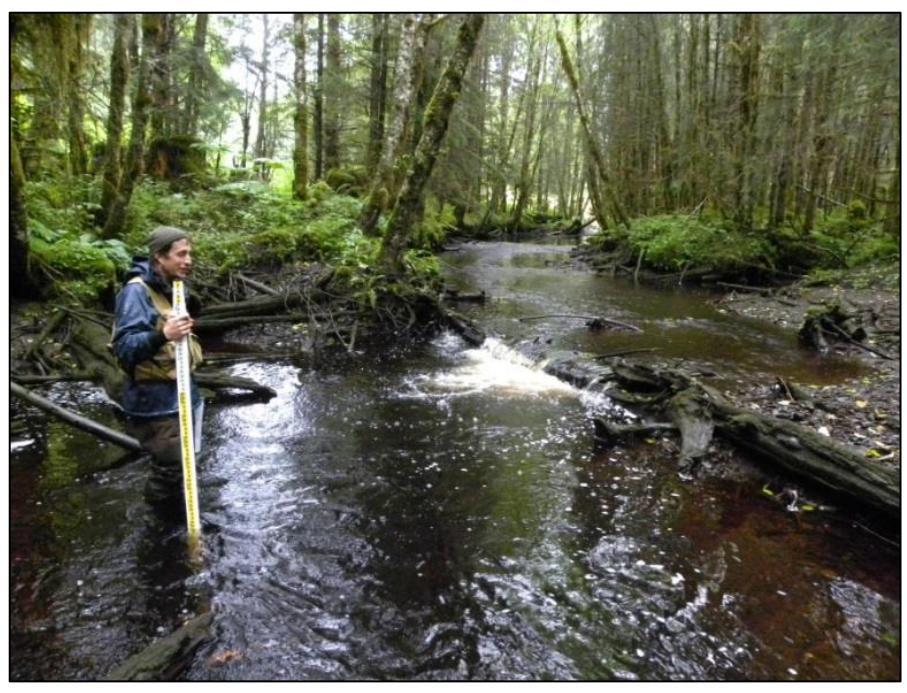
Figure 11. A scour pool in the West Fork created by a key piece of legacy wood.

- Large wood placement: Large wood structures could be placed in the West Fork of Pat Creek downstream of FS Road 6259 to maintain or enhance fish habitat as existing legacy wood degrades. The design and placement of structures should take into consideration protection of the adjacent road and enhancement of existing fish habitat created by decaying legacy wood. Channel aggradation at the confluence of the two forks (a terminus of the East Fork alluvial fan) has backwatered an 80 m reach of the West Fork upstream of the confluence. Wood placement in this reach may not be warranted due to the backwatered condition of the channel. Low channel slope and low width-to-depth ratio in this reach may limit the hydraulic capacity of the channel to scour the streambed and affect sediment transport.

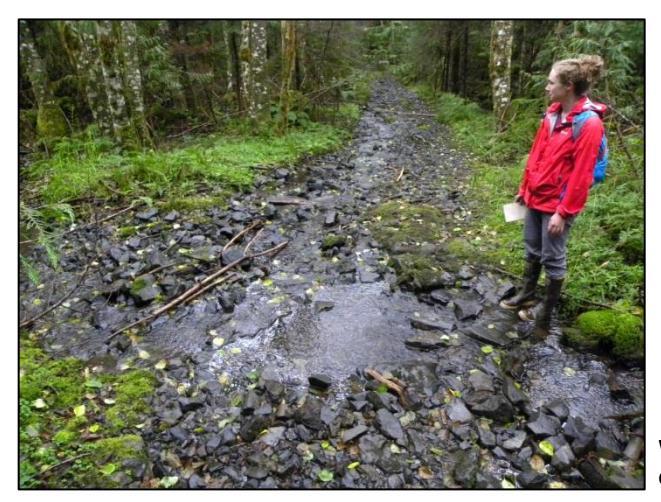
WP176. Stream flow from right to left. View looking downslope.

WP176 (56.3652, -132.3109): Small stream captured by road. Half of stream volume flowing on road surface; captured flow joins another stream crossing the road at WP177.

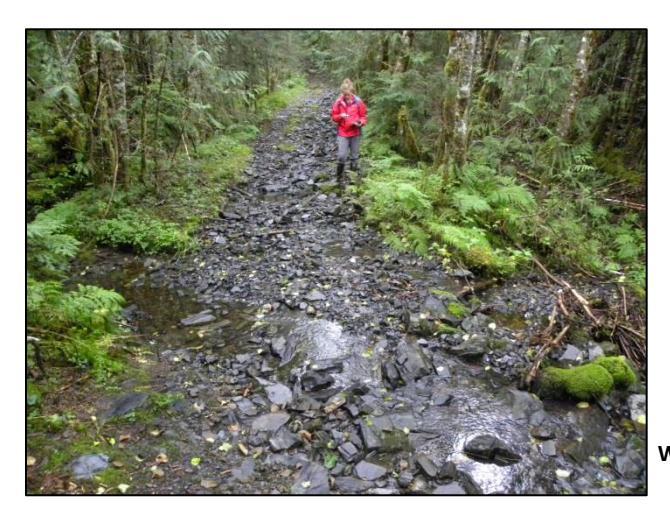
WP177. Stream flow from left to right. View looking upslope.

WP177 (56.3649, -132.3110): Small stream crossing over road; receiving road-captured flow from stream crossing at WP 176.

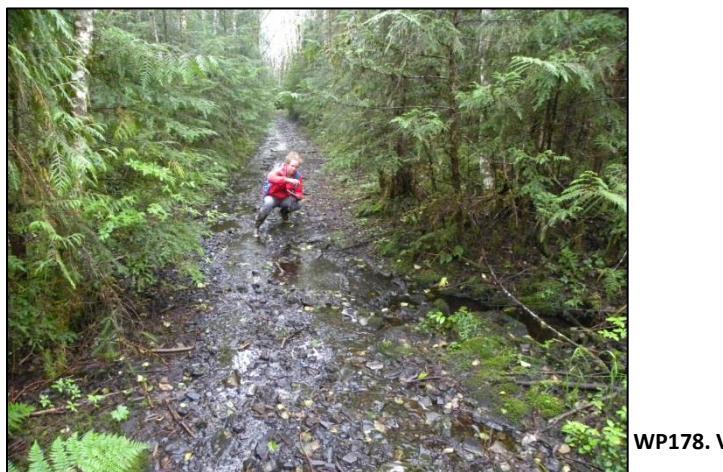
WP178. View looking downslope.

WP178 (56.3640, -132.3115): Several small surface flows and seeps upslope of the road coalesce in this area to form a single stream which flows down center of road.

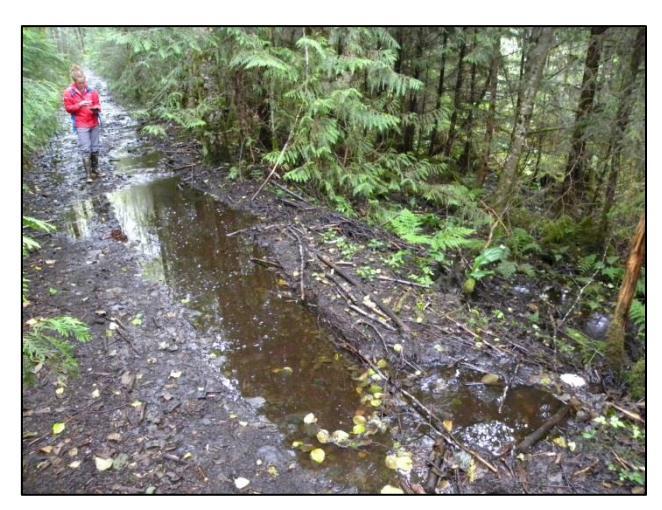
WP179. Stream flow from upper left to lower right.

WP179 (56.3636, -132.3116): Streams captured at WP 178 exits road downslope at this waypoint.

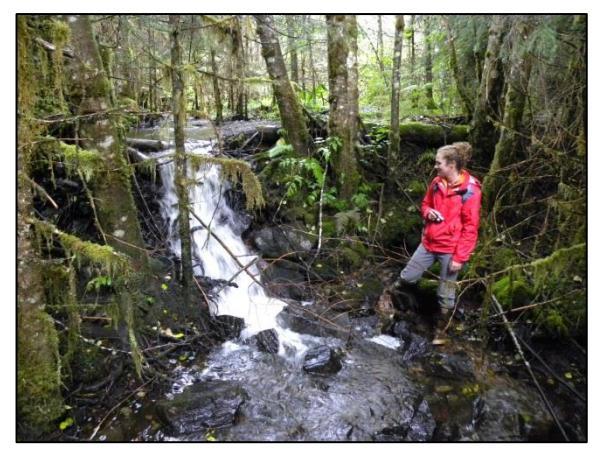
WP180 (56.3625,-132.3137): Sediment-plugged culvert. The entire volume of the stream is flowing over

the road surface. A 6- foot deep sediment deposit has formed upstream of the road.

WP180. Stream flow cascading over road embankment. The outlet of a plugged culvert (not visible in photo) is located on the right side of the cascade.

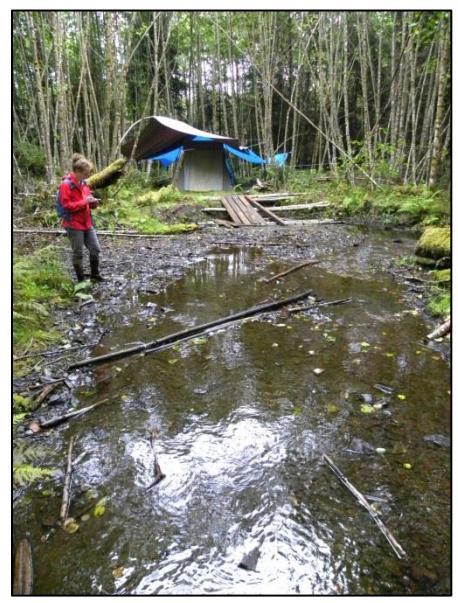
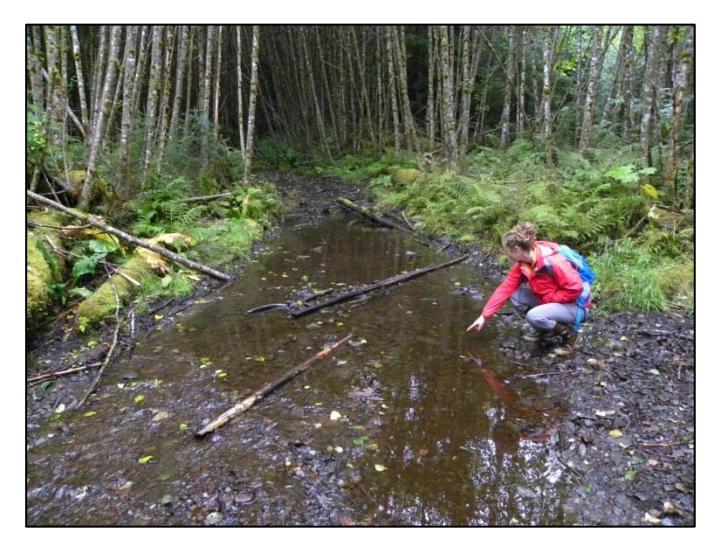
WP181 (56.3621,-132.3135): Landslide deposit zone. At mile 0.6 of the Tunnel Road, a landslide originating in the headwaters of a West Fork tributary (hereafter referred to as Landslide Creek) crossed over Tunnel Road. Aerial photography suggests that the landslide occurred in 1994 (Dennis Reed, personal communication). Landslide Creek flows down the slide path and splits into two channels approximately 300 feet upstream of the road. The more northerly flow leaves the landslide and enters the original channel and crosses over Tunnel Road at WP180. The southerly flow continues down the landslide and is partially captured by Tunnel Road. The captured flow travels 450 feet down the road before entering the West Fork at WP183. The path of stream flow not captured by Tunnel Road was not investigated. In August 2014, we observed young-of-the-year juvenile salmonids (cutthroat trout or Dolly Varden char) where Landslide Creek flows onto the deposition zone. An encampment present at the site in August 2014 was gone in March 2015.

WP181. View looking downstream

WP181. View looking upstream.

- Install culverts or bridges at the Landslide Creek crossings of Tunnel Road to stop road degradation, restore fish passage and natural sediment transport, improve water quality, and protect fish habitat.
- Consider establishing Tunnel Road as a designated ATV/snow machine trail (i.e. closed to highway vehicles when not in use for State Forest timber harvest) to provide recreational opportunities for residents of the Wrangell community and to reduce garbage and yard waste dumping along sensitive riparian areas.
- Install culverts or construct hardened fords where non-fish bearing stream flow has been captured by the road to restore hydrology and sediment transport.

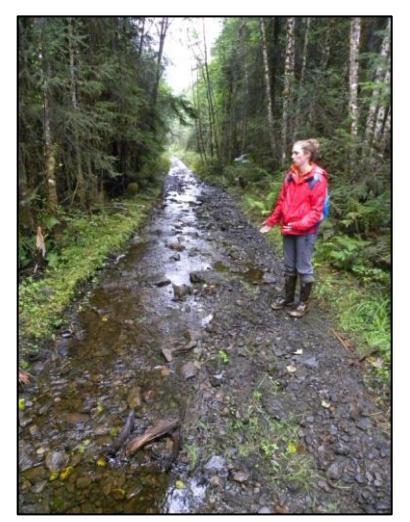
Water from Landslide Creek flows south down Tunnel Road between WP181 and WP183.

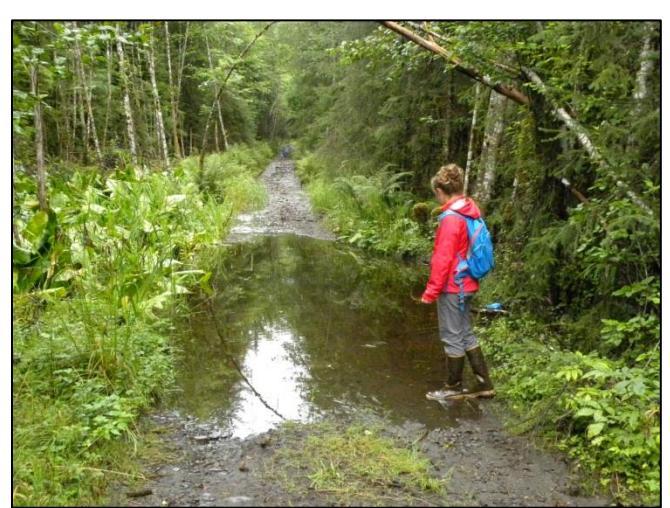
WP183 (56.3608, -132.3144): Stream flow captured at WP 181 flows from the road into the West Fork of Pat Creek at this location. A 30-foot long, 1-foot deep pool has formed on the road at this location. The pool also receives water from a ditch that extends north to the slide zone on the west side of the road. There is a plugged cross-drain culvert between the ditch and the West Fork along this reach of road.

WP183. Road-captured stream flows from top of image to bottom; West Fork of Pat Creek to right of view.

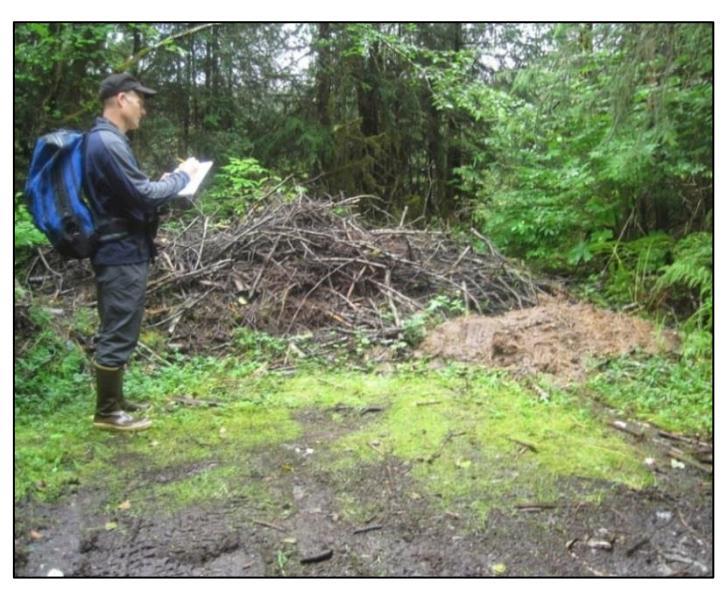
WP184 (56.3580, -132.3158): Yard waste dump site (chicken manure, straw, etc.) on the east side of Tunnel Road. Invasive reed canarygrass, creeping buttercup, chickweed present. Portions of the Tunnel

Road have been used for unauthorized dumping of garbage and yard waste. The Wrangell Cooperative Association removed waste from multiple sites in the Pat Creek watershed in the last year.

WP184. Yard waste pile on east side of Tunnel Road.

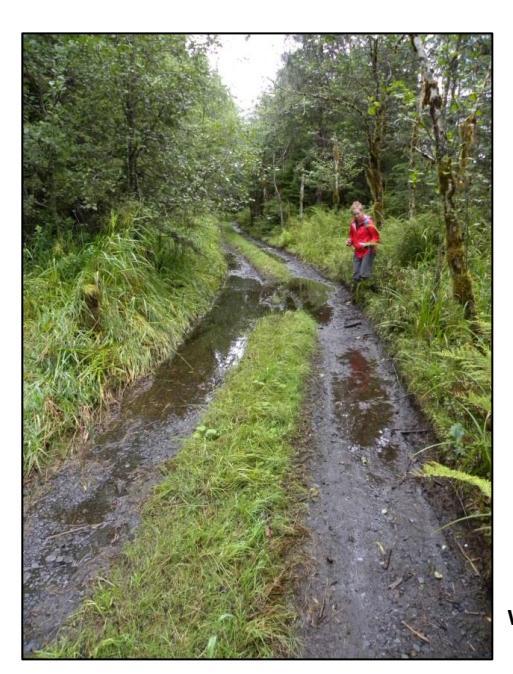
WP185. View looking north.

WP185 (56.3559, -132.3181): Ponded water on road surface in several places. Reed canarygrass growing on sides of road.

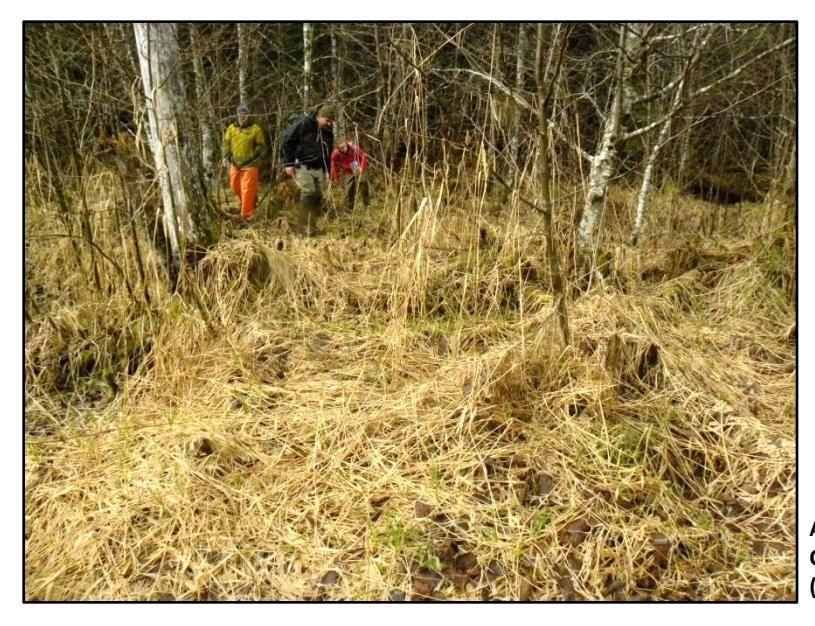
A reed canarygrass infestation on the West Fork of Pat Creek upstream of FS Road 6259 in March 2015 (56.3552, -132.3193).

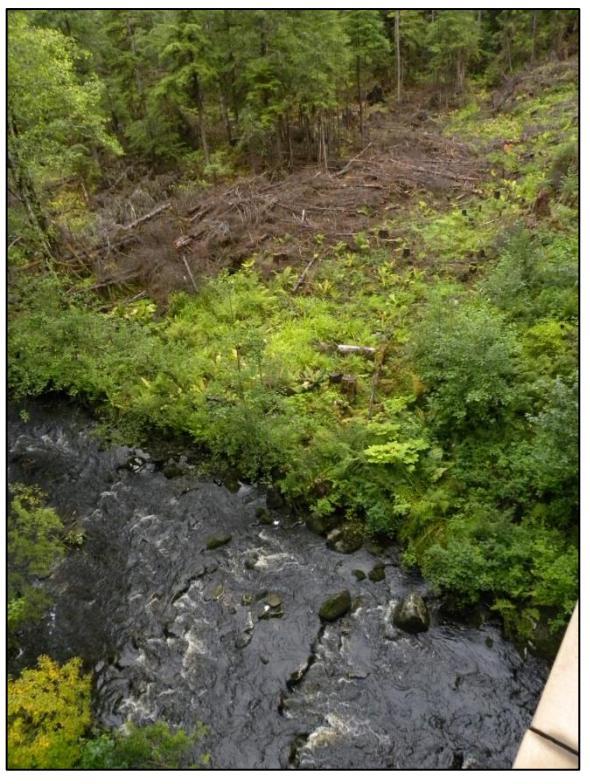
Trees and other vegetation on the banks of Pat Creek were removed from an electric transmission corridor upstream of Zimovia Highway in 2013 (Figure 13). Recovery of the riparian plant community will be inhibited by slash discarded next to the stream.

Figure 13. Riparian forest cleared in a utility corridor upstream of Zimovia Highway.

Riparian vegetation recovery: All remaining slash within 100 feet of the stream should be removed to accelerate recovery of the riparian forest in this area. Encourage utility crews to remove only vegetation that threatens the integrity of overhead utilities.
