NANCY STREET WETLAND ENHANCEMENT, JUNEAU

Introduction / Objective:

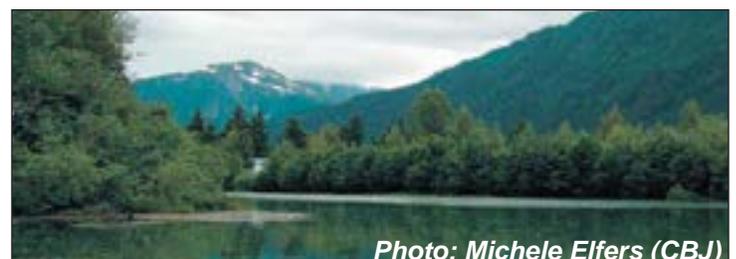
Photo: Michele Elfers (CBJ)
 Nancy Street Pond 2005, prior to reclamation

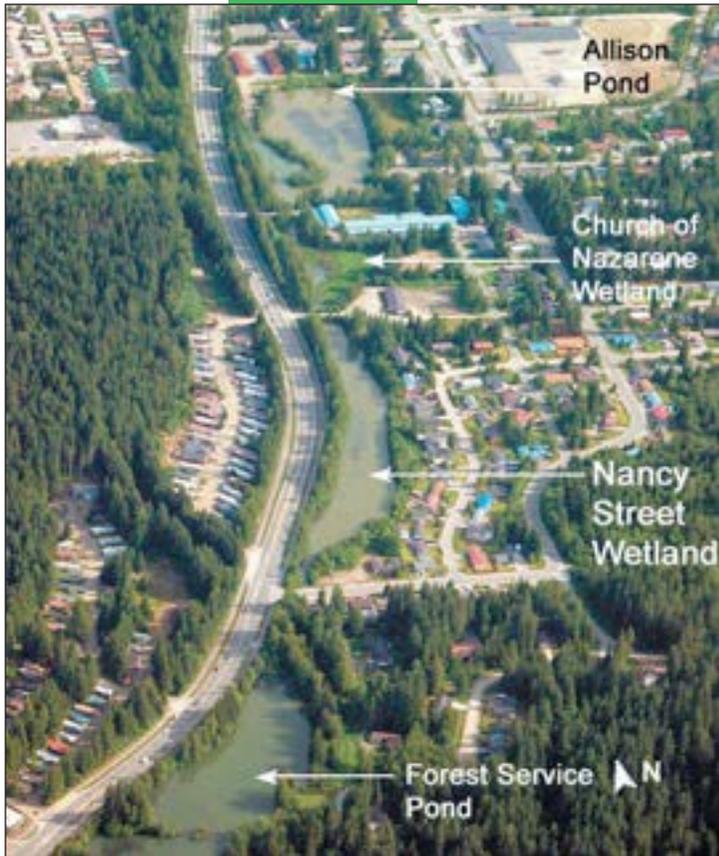
Aerial view of Nancy Street wetland area.

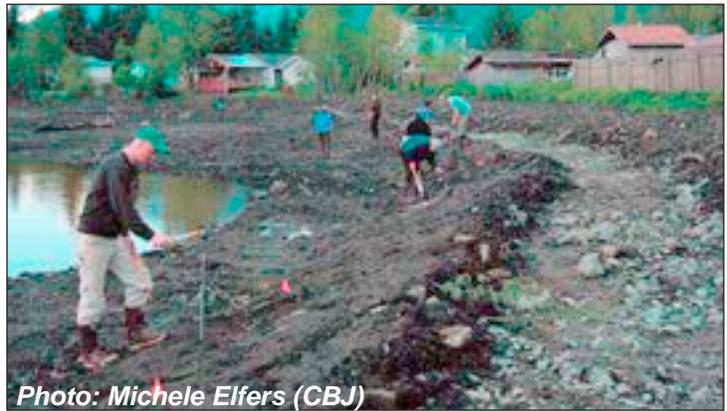
Planting willow & cottonwood cuttings - June, 2006

Cuttings were taken on April 8. Barclays Willow, High Bush Cranberry and Black Cottonwood stakes were collected using hand pruners. These cuttings were kept in a cold storage facility until they were planted on June 7. Unfortunately, all of

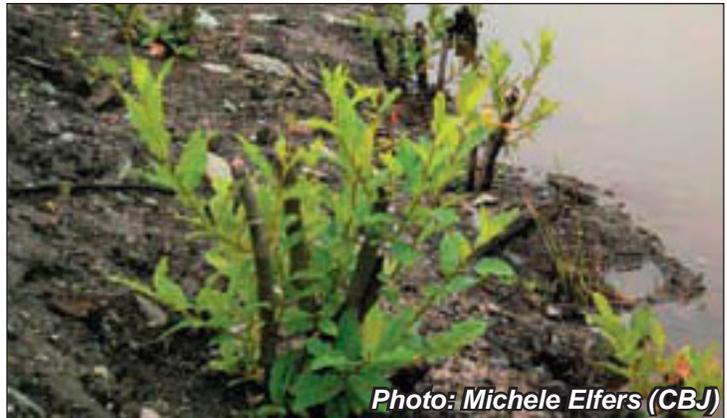
Leaves emerge from cuttings - August, 2006

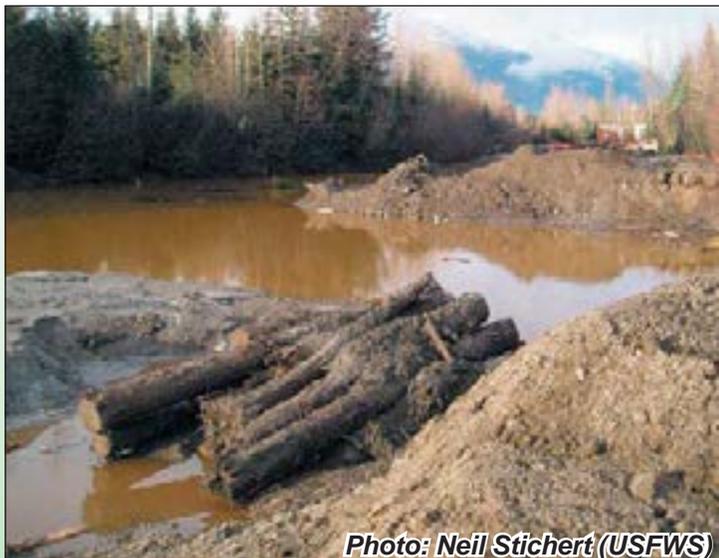
Early stages of filling - November, 2005

The manner in which fill was added to the Nancy Street wetland determined habitat diversity. Protruding fingers were created to allow access for equipment dumping the fill material in the middle of the wetland. The fingers became the low and high marsh habitat zones. Hauling and placing of fill material took place in September 2005. The fingers then received 6 to 8 inches of low organic rock/cobble topsoil to aid revegetation efforts.

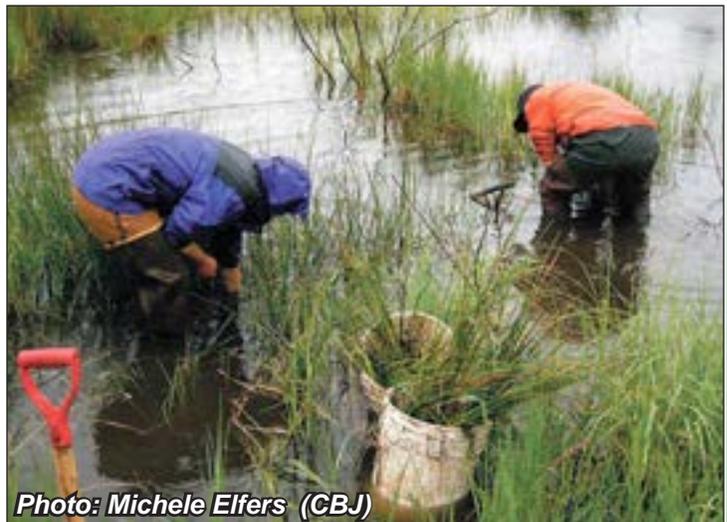
Sedges being extracted from nearby wetland - 2006

A SAGA crew contracted by the US Fish & Wildlife Service planted 3,600 plugs, shrubs, and small trees, and also seeded some of the wetland area. Plants were taken and moved from the source wetland and replanted on the remediation site.

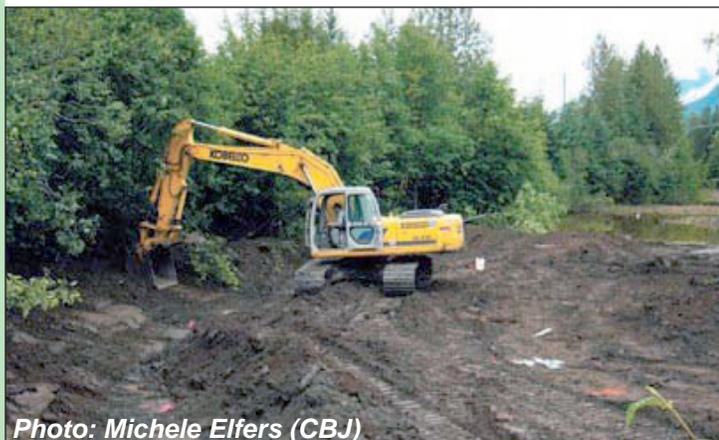
Digging outlet stream channel - July, 2006

Dam and channel outlet construction began in July 2006. Fill material was placed, the stream channel excavated, and the dam shaped in less than 2 weeks.

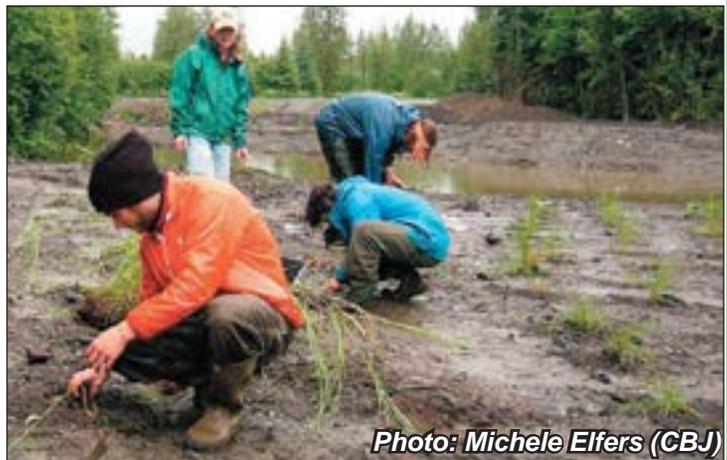
Volunteers planting wet meadow grasses - 2006

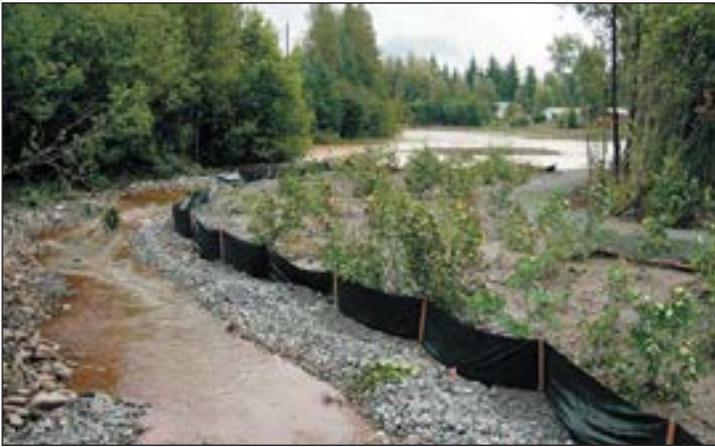
Alders transplanted along stream channel - 2006

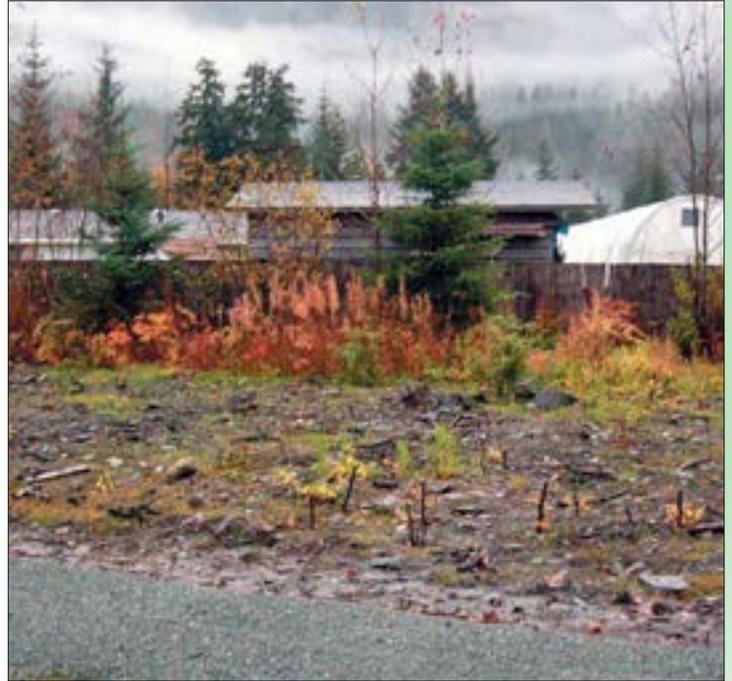
Transplanted cuttings bordering trail - October, 2006

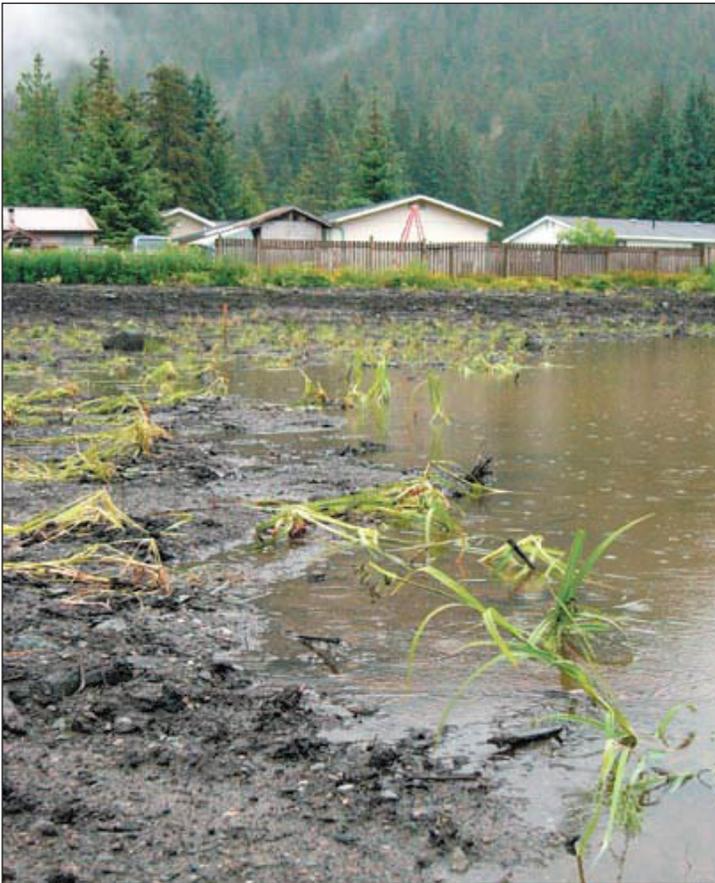
Low marsh & high marsh sedges, bulrushes - 2006

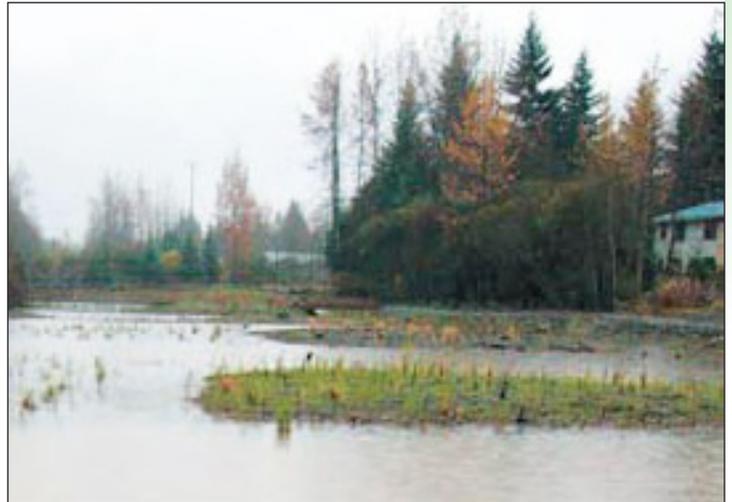
Created fingers, view to the south - October, 2006

Choosing to fill and complete each finger and section of wetland individually allowed the species habitat to thrive. The other option; filling the entire site and returning to dredge the stream channel later would have resulted in less diversity of habitat.

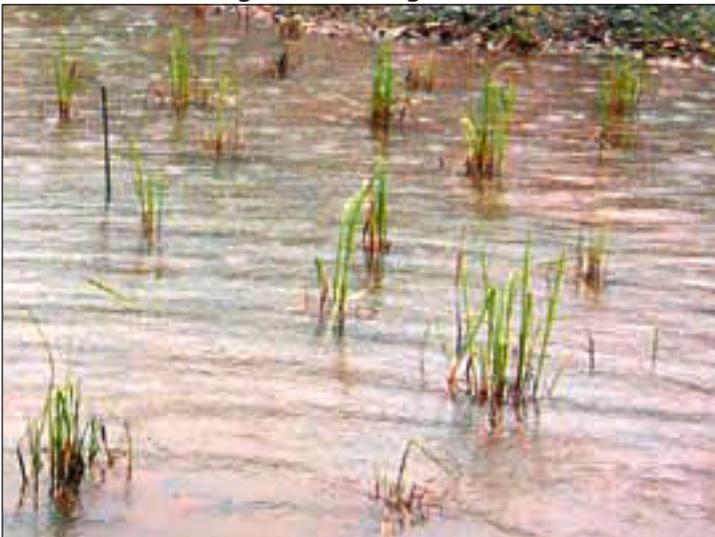
Wetland vegetation establishment - October, 2006

At the end of the 2006 planting season there was approximately 70% survival rate of transplanted species.
