AN INVENTORY OF INVASIVE PLANTS IN THREE JUNEAU WATERSHEDS

MONTANA CREEK, PETERSON CREEK, AUKE LAKE

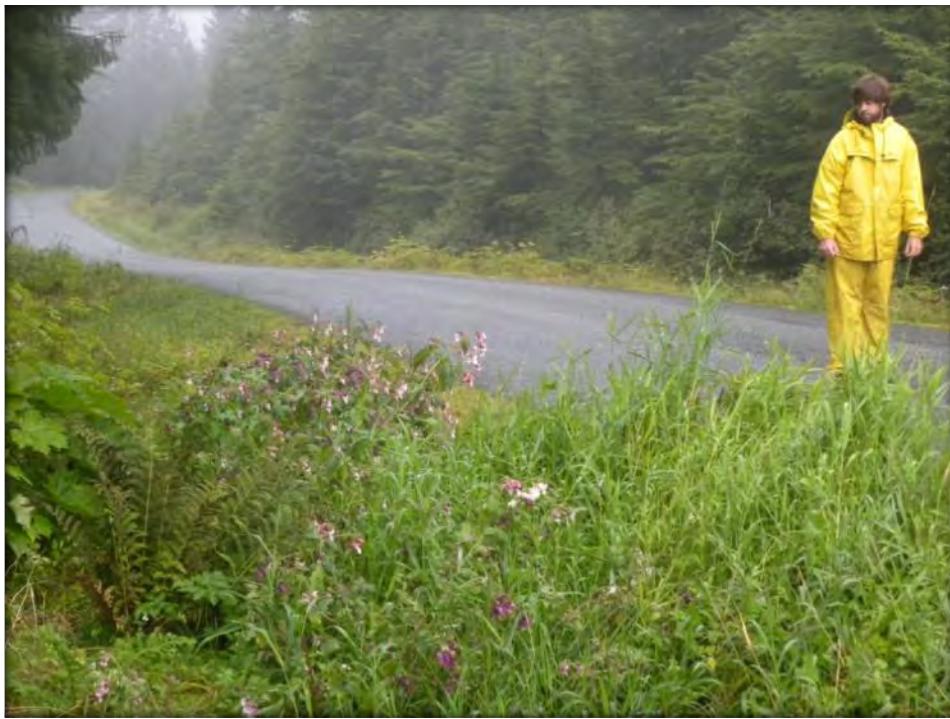
Figure 5. An invasive plant infestation containing ornamental jewelweed, creeping buttercup, and reed canarygrass alongside Montana Creek Road near the rifle range.

- All infestations of oxeye daisy, orange hawkweed, Bohemian knotweed, and ornamental jewelweed should be controlled in 2013 using mechanical or chemical means until all plants have been eradicated.

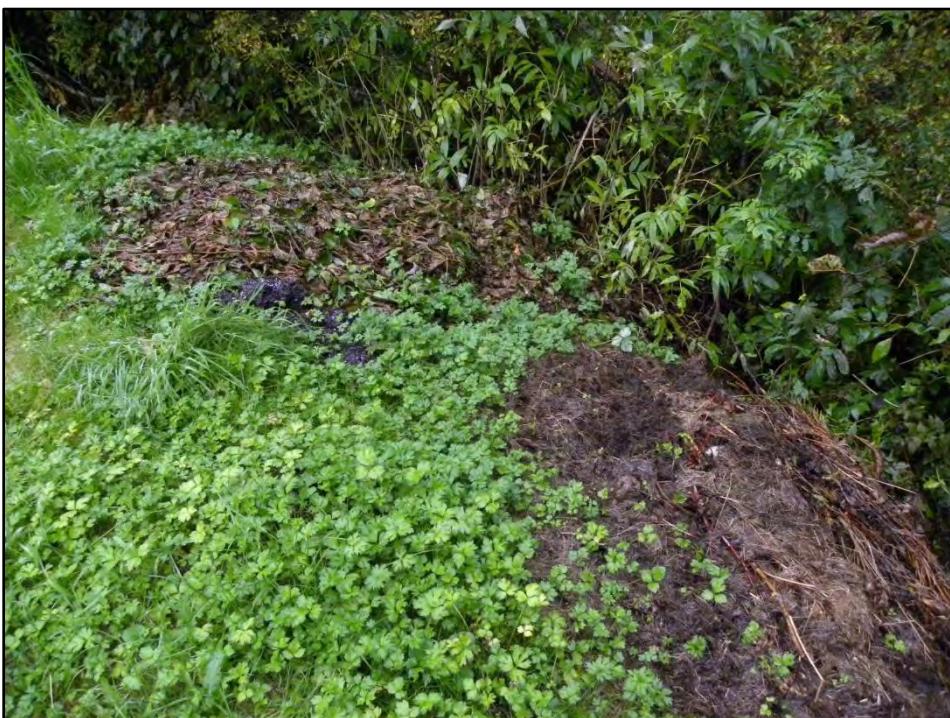
The Montana Creek survey area encompassed 31 acres consisting primarily of road and trail corridors extending from the McGinnis Creek area to the Mendenhall River (Figure 2). Invasive plants were distributed throughout the survey area, although infestations were rare in the surveyed portions of upper Montana Creek and McGinnis Creek (Figure 9). Most invasive plant infestations occurred at sites disturbed by human activities and infrastructure (e.g. roads, trails, land development) (Figures 5 & 6) or natural processes (e.g. tree uprooting, bank erosion, fluvial sediment deposition) (Figure 7). While roads and trails are the principal routes of invasion, water appears to transport some species (e.g. creeping buttercup, marsh forget-me-not) from transportation corridors to relatively pristine and semi-remote areas. Some invasive species, such as creeping buttercup, are introduced to new sites when yard waste is disposed in roadside ditches (Figure 8).

Figure 8. Invasive plant species such as creeping buttercup (above) are likely introduced into the Montana Creek Watershed in yard waste that is dumped into roadside ditches.

- During the survey, disposal of yard waste into roadside ditches and importation of soil and plants into the community garden were identified as likely vectors for invasive plant introductions into the Montana Creek watershed. Members of the community garden and general public should be informed of their role in preventing the introduction and spread of invasive plants by these means. Yard waste disposed of in inappropriate areas should be removed, double bagged, and disposed in the landfill.

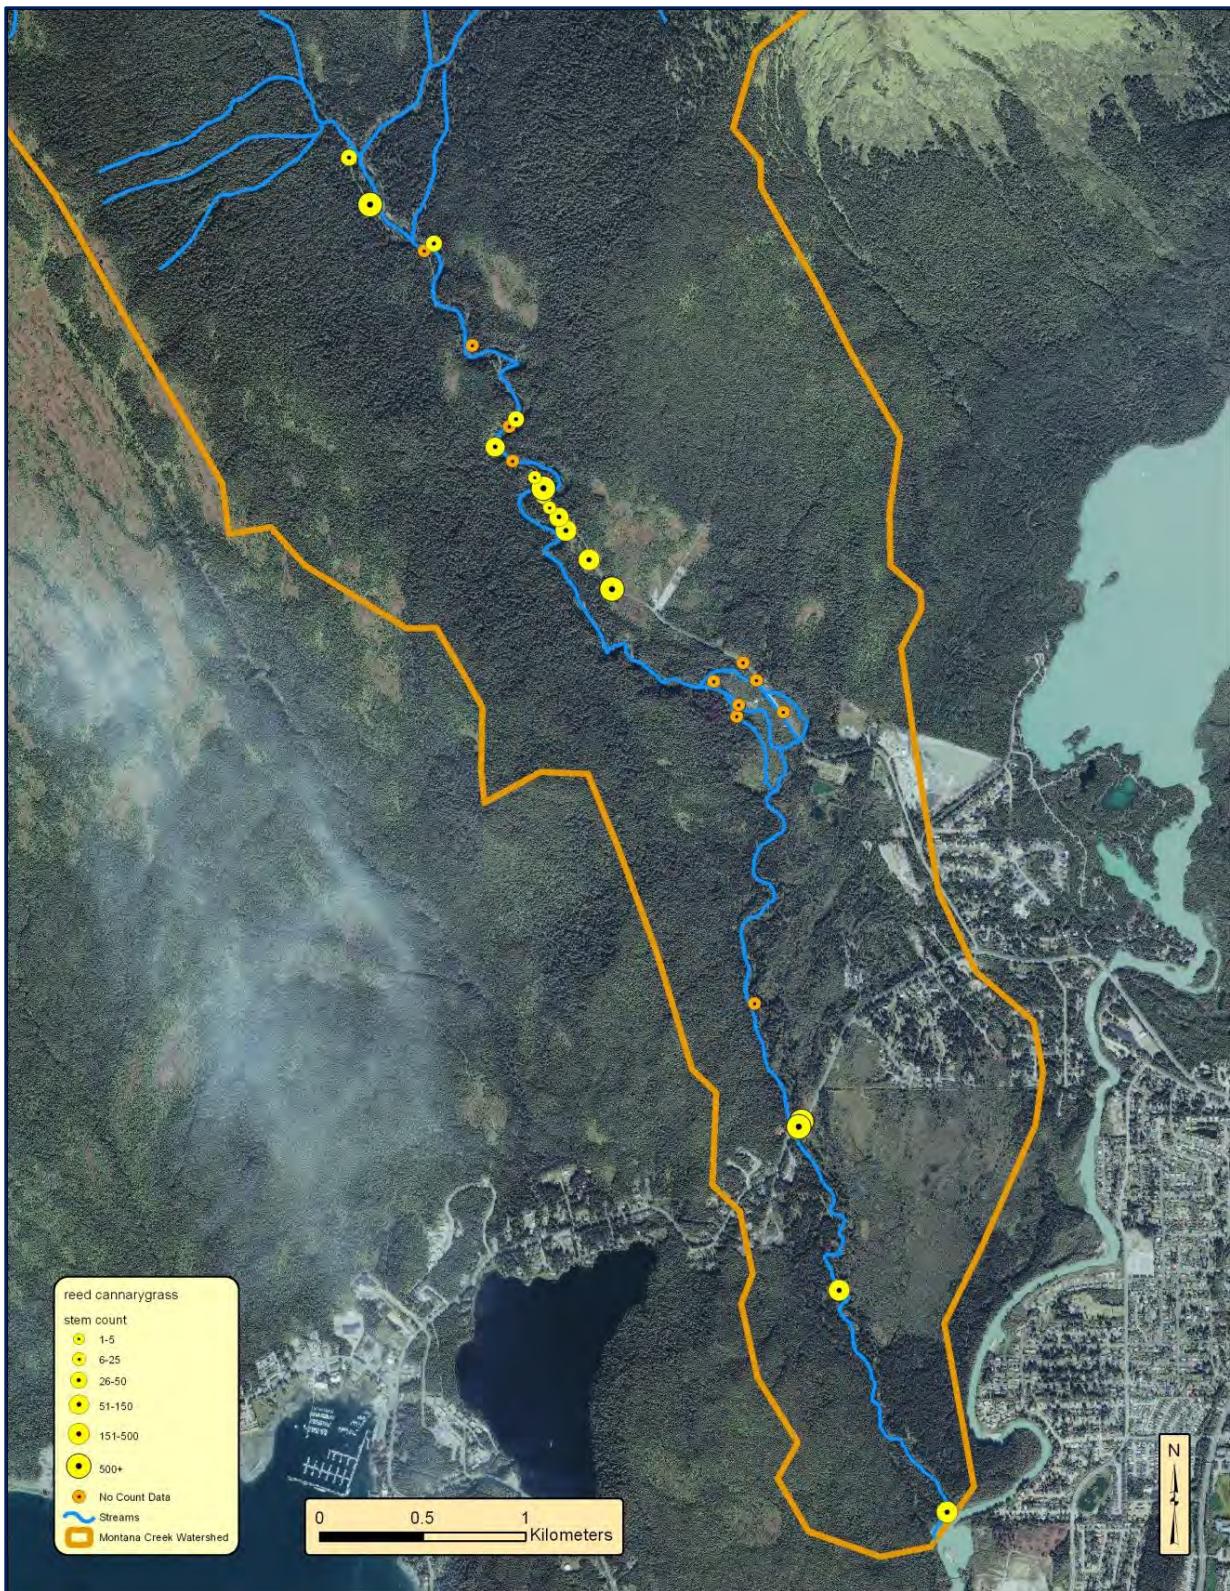
Figure 16), and reed canarygrass (2.6% of the total infestation area, Figure 11).

Figure 11. Reed canarygrass (rank = 83) infestations within the Montana Creek watershed survey area.

- Reed canarygrass can become the dominant species in emergent wetlands and riparian habitat and can degrade or eliminate open-water aquatic habitat used by rearing salmonids and other species. Reed canarygrass infestations should be a high priority for eradication to prevent continued expansion in wetlands where it occurs and to prevent spread into high value wetland habitat on the east side of Montana Creek, between the community garden and Mendenhall Loop Road.

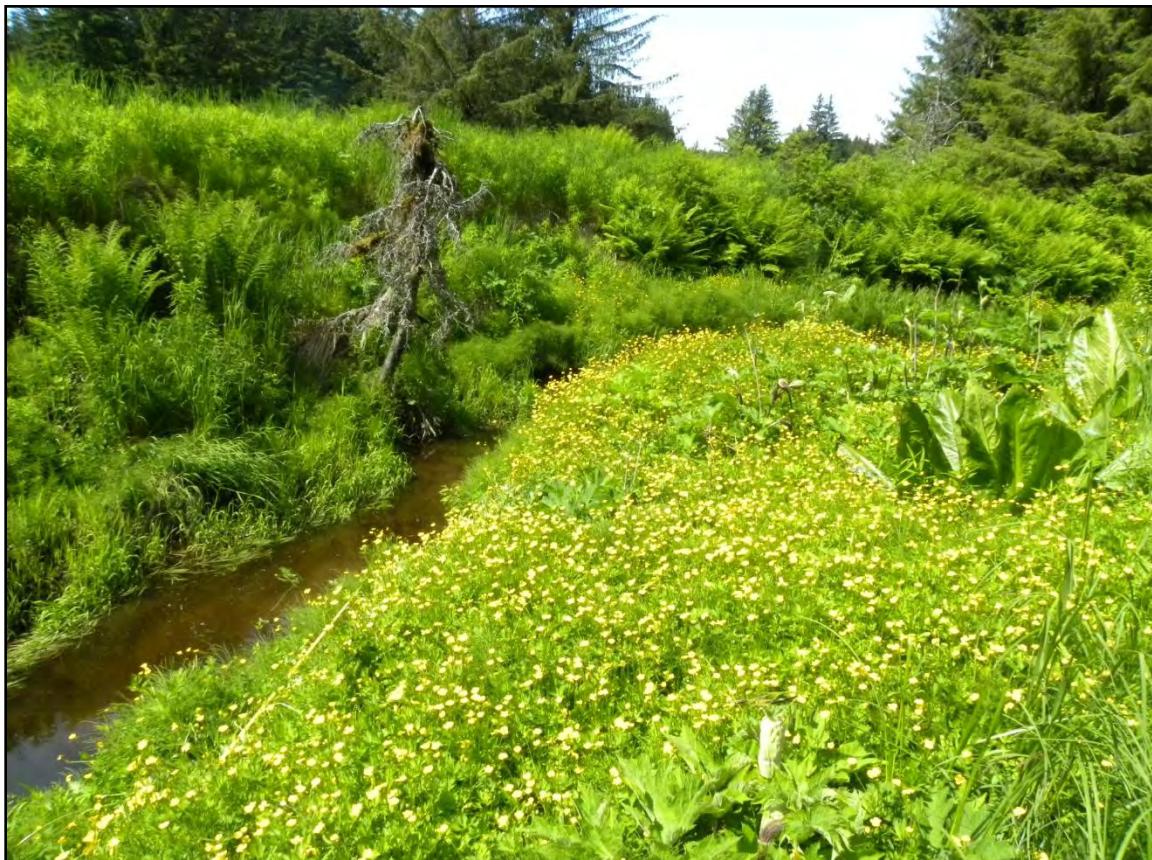
Figure 18. Creeping buttercup infestation along a tributary used by rearing coho salmon in the lower Peterson Creek watershed (June 2012).

- Creeping buttercup is well establish throughout the riparian corridor of the survey area. This species is forming monotypic stands that have displaced native plant communities, especially in areas with moist soil and lacking tree and shrub canopies. The uplifted meadows in the lower Peterson Creek watershed represent a relatively uncommon and important type of wildlife habitat in the CBJ. Although considered only a moderately invasive species, expansion of existing creeping buttercup infestations and establishment of new ones in the survey area could result in significant ecological impacts. Additional study of the potential threats of this species to riparian and meadow habitat and ecological functions is necessary to determine if control is warranted.

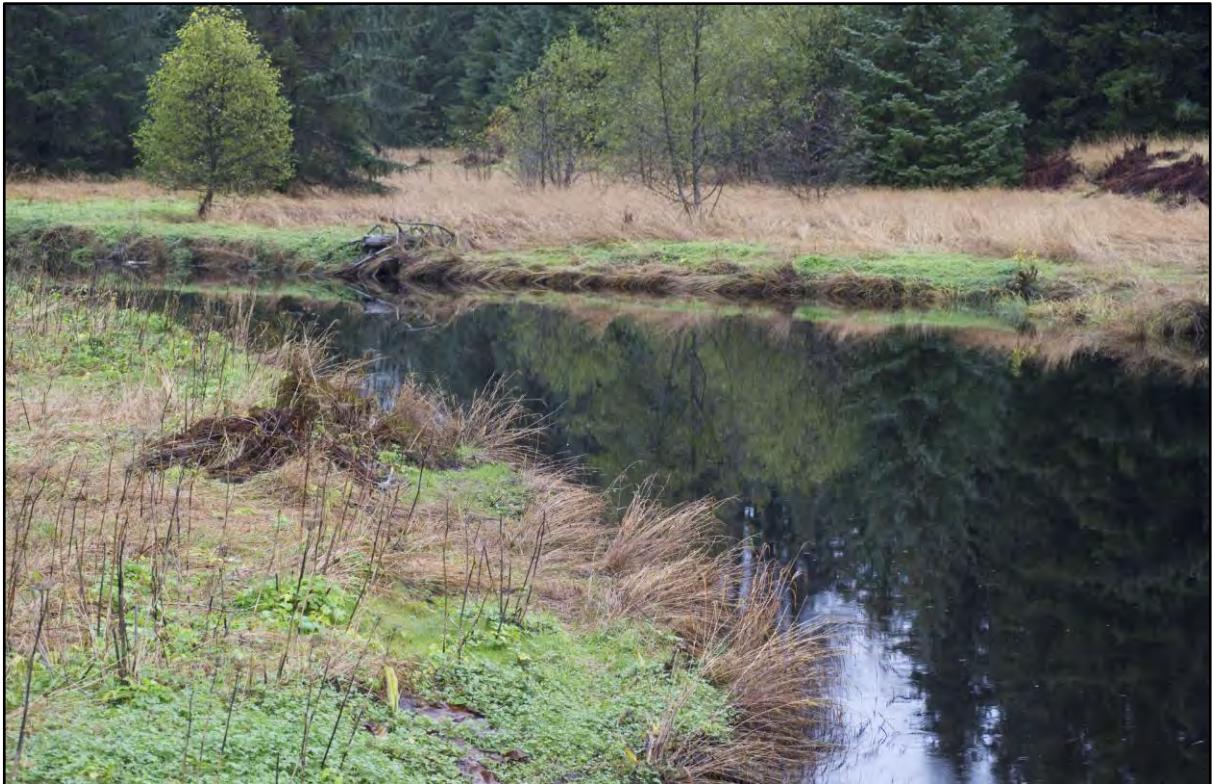
Figure 19. Green patches of creeping buttercup infestations contrast against the dead foliage of native plants along the lower reaches of Peterson Creek (view looking upstream near Amalga Harbor Road, October 2011).

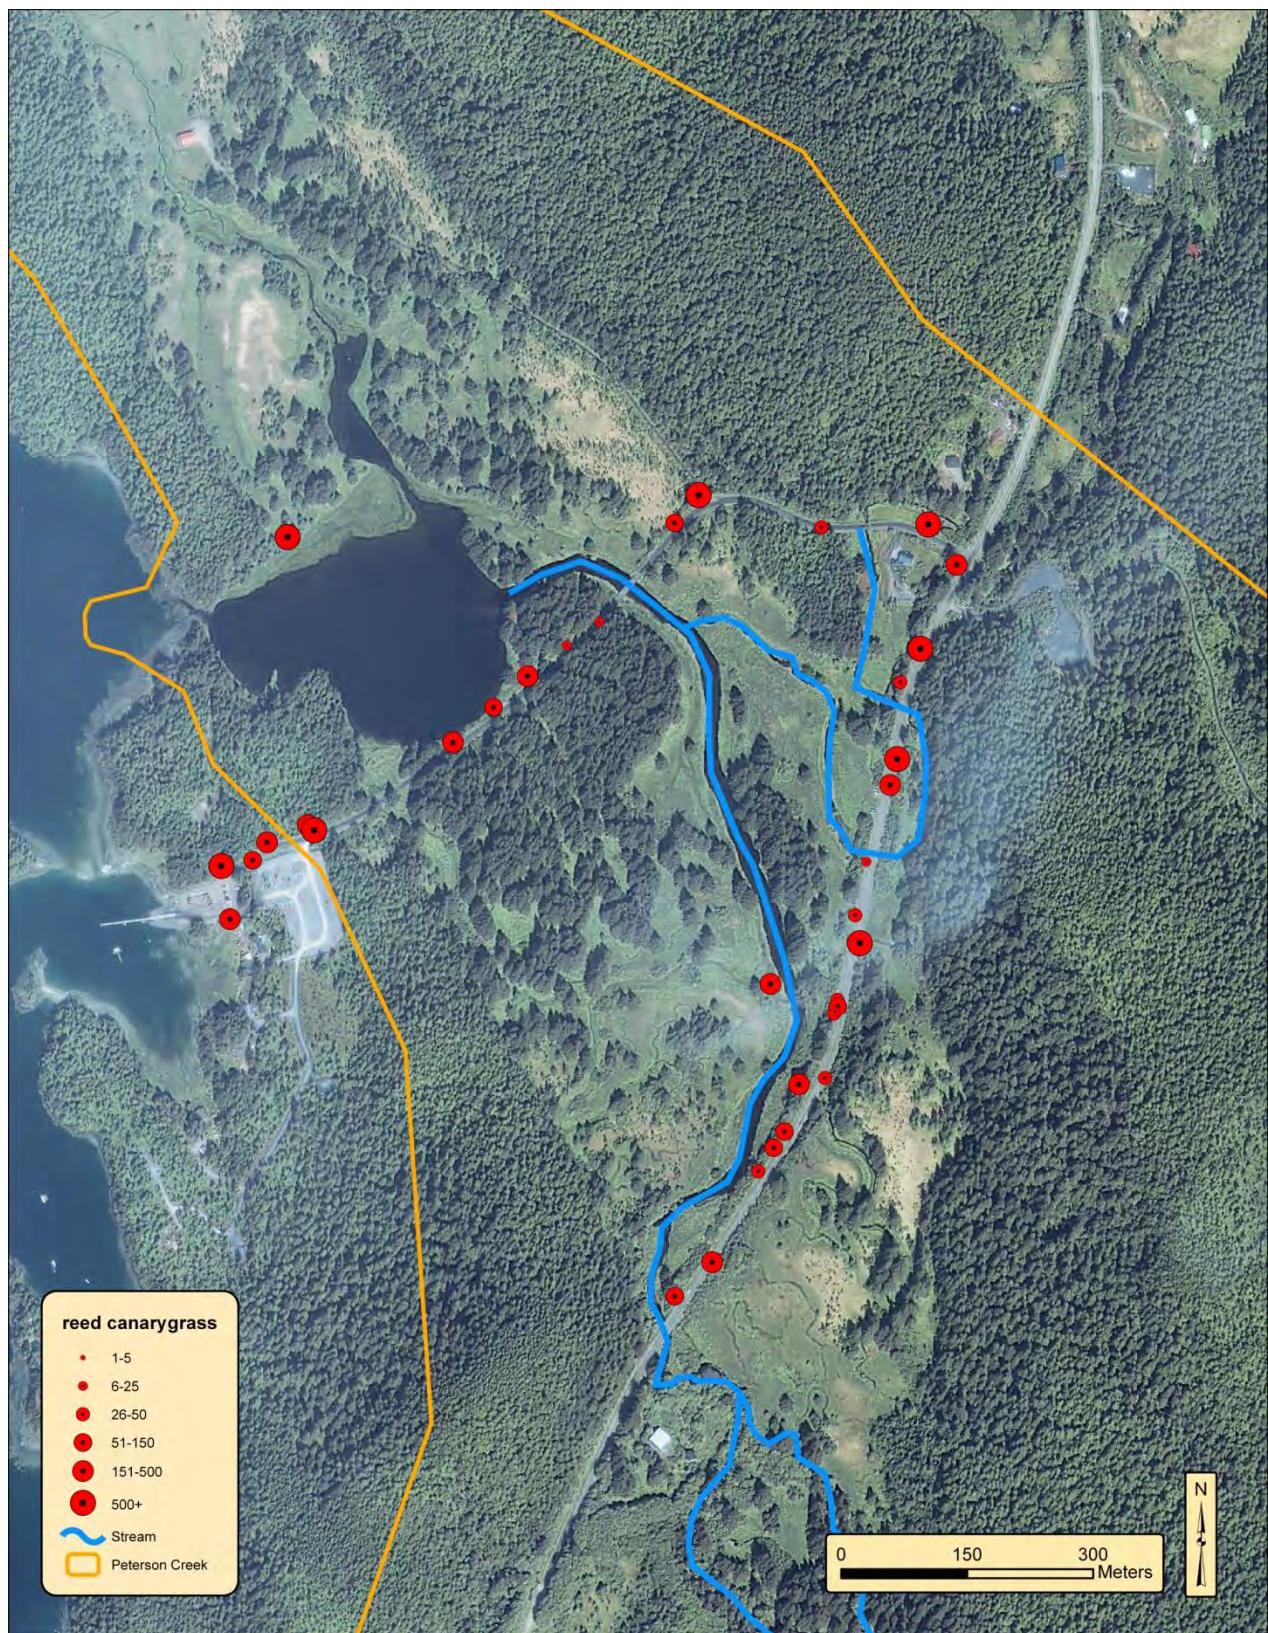
Figure 25. Reed canarygrass infestations within the Peterson Creek watershed survey area.

- Although distributed throughout the survey area, reed canarygrass is primarily limited to roadside areas. This extremely invasive species will likely move outward from existing infestation areas into adjacent open-canopy riparian habitats and meadows in the lower watershed, eventually establishing monotypic stands. Reed canarygrass infestations in riparian habitat near the lake and stream channel should be eradicated as soon as possible, followed by eradication (in order of priority) of infestations near bridge and culvert crossings of stream channels, trailheads, and within road corridors.

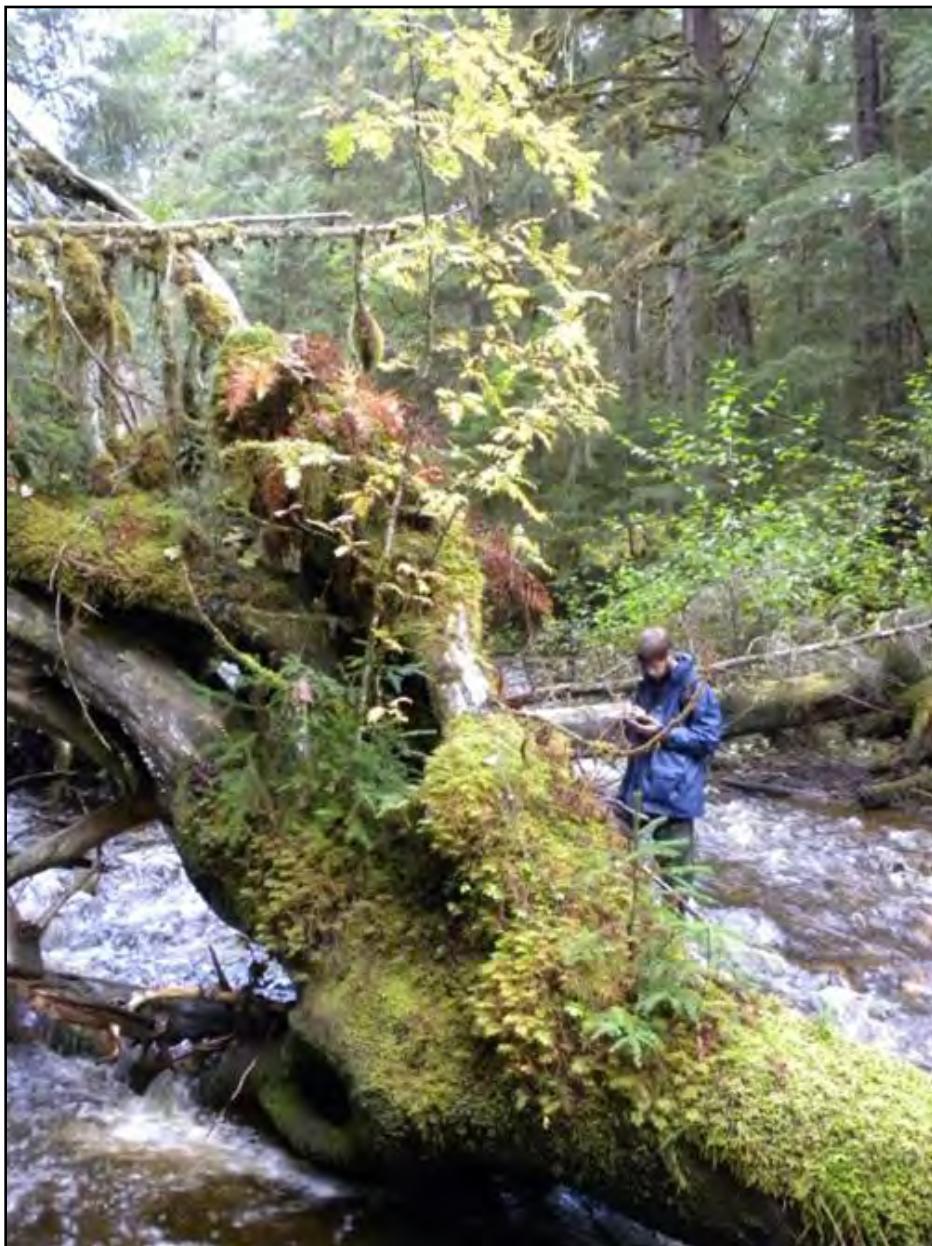
Figure 27. A European mountain ash tree (light colored foliage) growing on the root wad of a downed tree in Lake Creek, the main tributary to Auke Lake.

- All wild European mountain ash trees found in this survey should be removed. Small trees may be pulled from the ground; large trees can be cut down followed by annual monitoring for new growth from the stump. Encourage UAS to replace ash trees used for landscaping with other non-invasive tree species, such as maple.

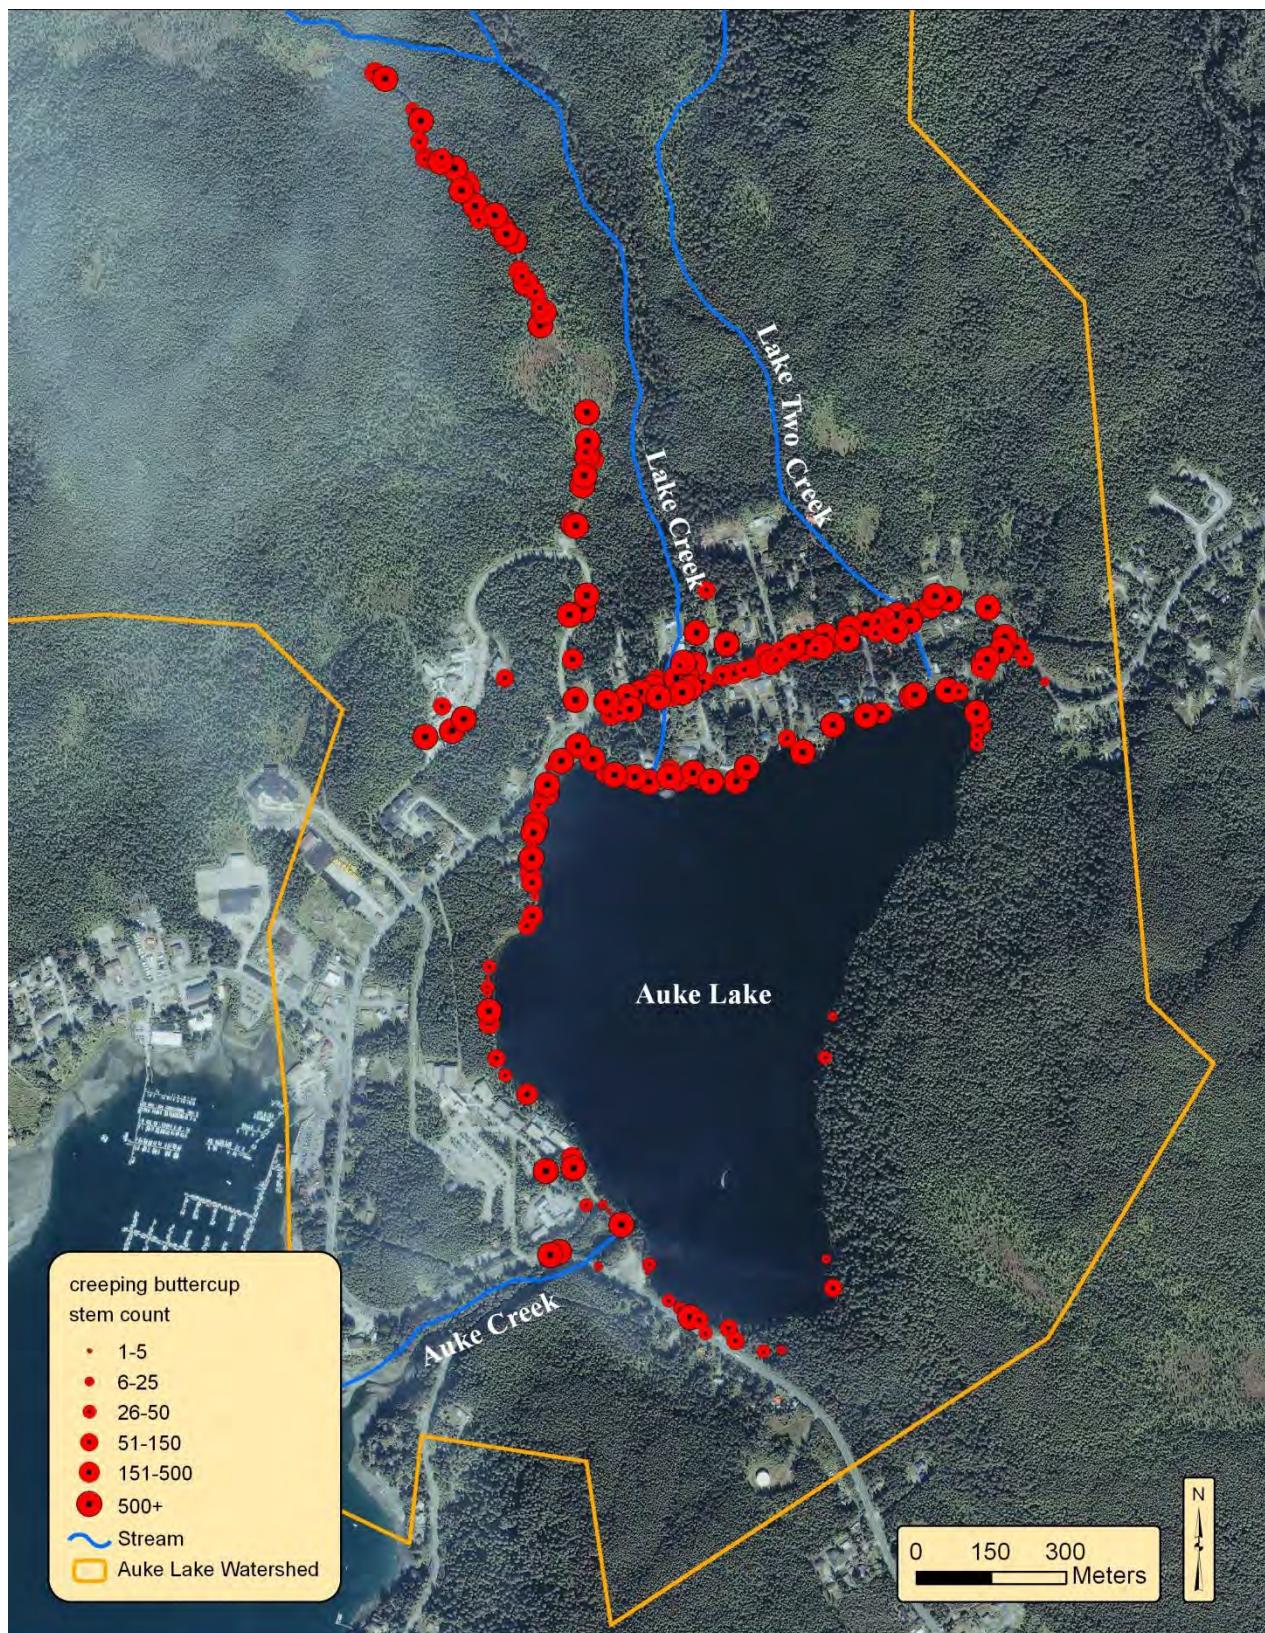
Creeping buttercup accounted for nearly one-third of all infestations and almost half of the total area of all infestations (Table 3). Large infestations (500+ stems) of creeping buttercup occurred extensively along Mendenhall Loop Road; along the north, west, and south shorelines of Auke Lake; and along the lower portion of the Spaulding Meadows snowmobile access trail (Figure 29).

Figure 29. Creeping buttercup (rank = 54) infestations within the Auke Lake Watershed survey area.

- Determine the impact of creeping buttercup on native plant communities, especially within riparian habitats. Investigate control techniques suitable for buttercup infestations near sensitive aquatic habitats.

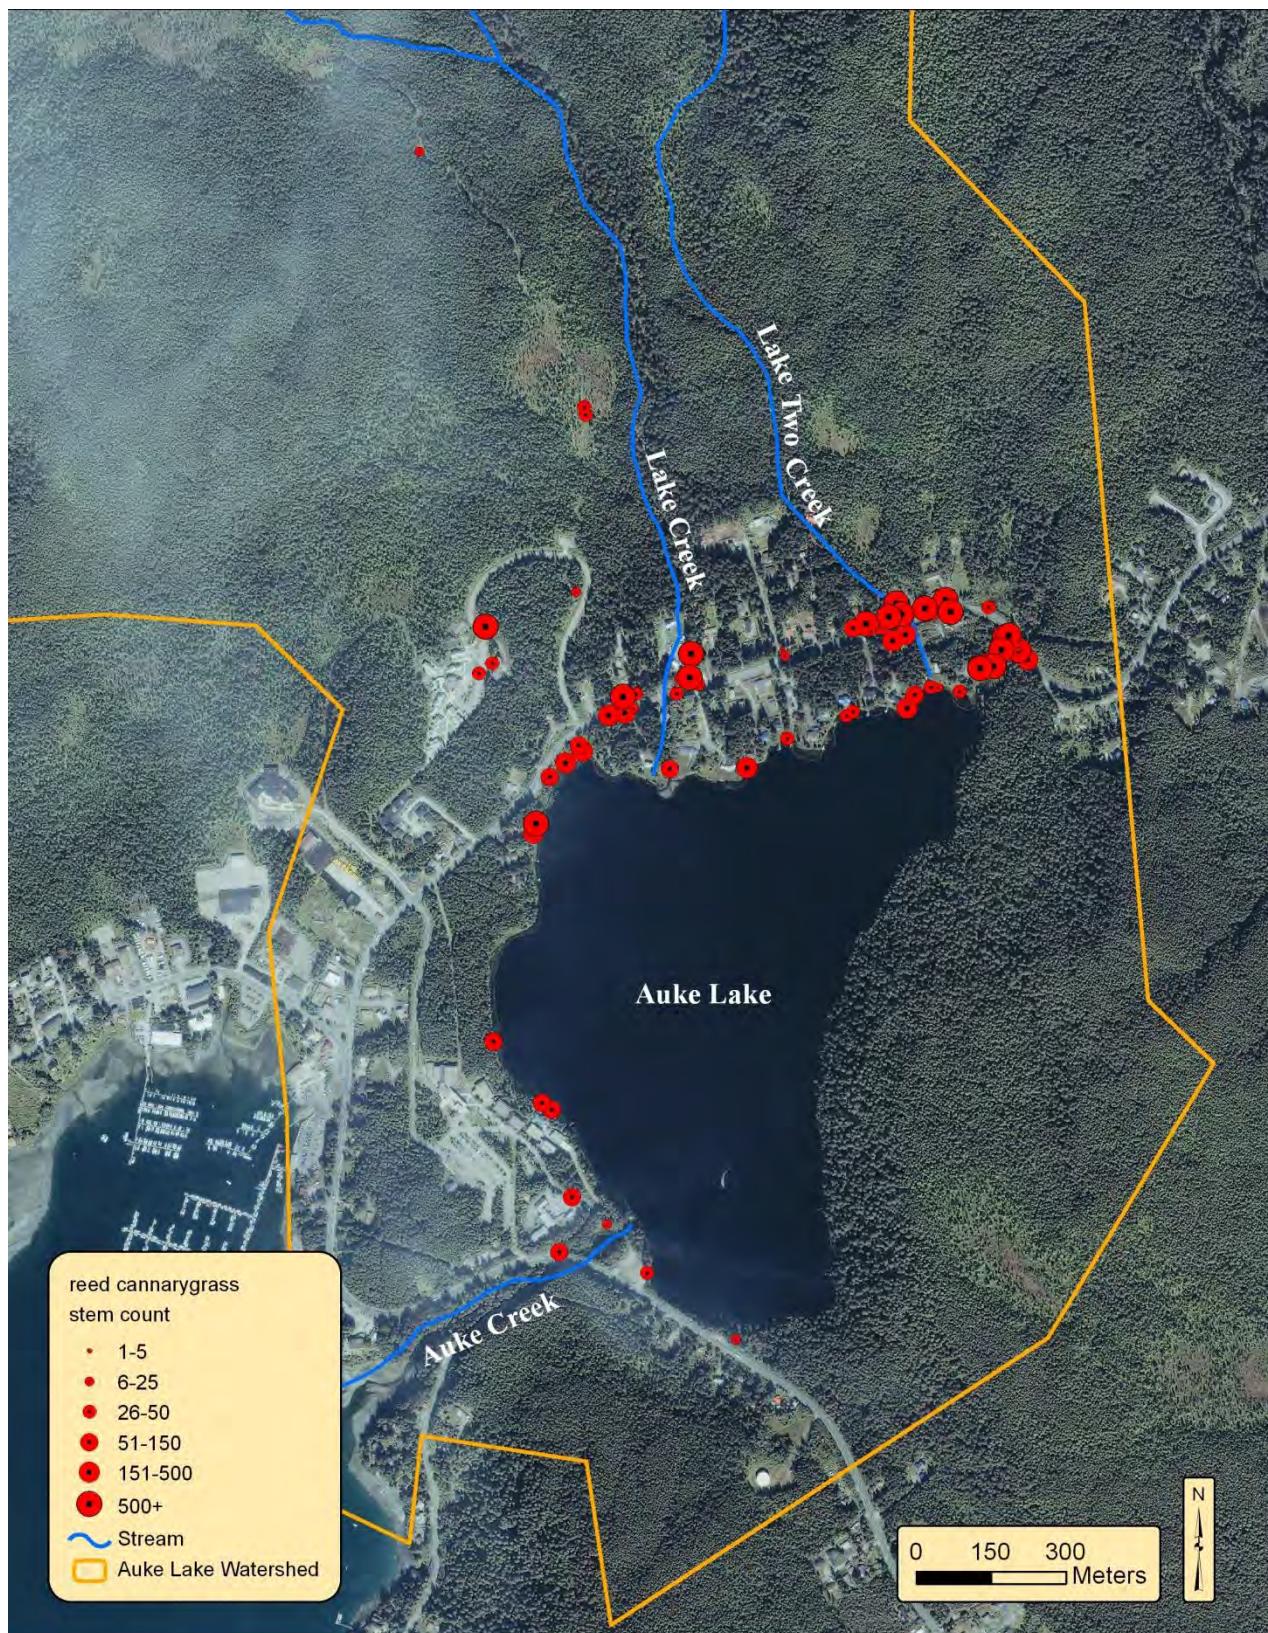
Figure 31. Reed canarygrass (rank = 82) infestations within the Auke Lake Watershed survey area.

- Reed canarygrass appears to be outcompeting and displacing native plant communities in riparian and aquatic habitats around Auke Lake. Reed canarygrass infestation along the shoreline should be eradicated to prevent impacts to riparian and aquatic species, including juvenile salmonids that use nearshore habitat. Eradicate infestations near stream crossings along Mendenhall Loop Road to prevent plants from spreading downstream into marshes and side-channels containing high-value fish and wildlife habitat.

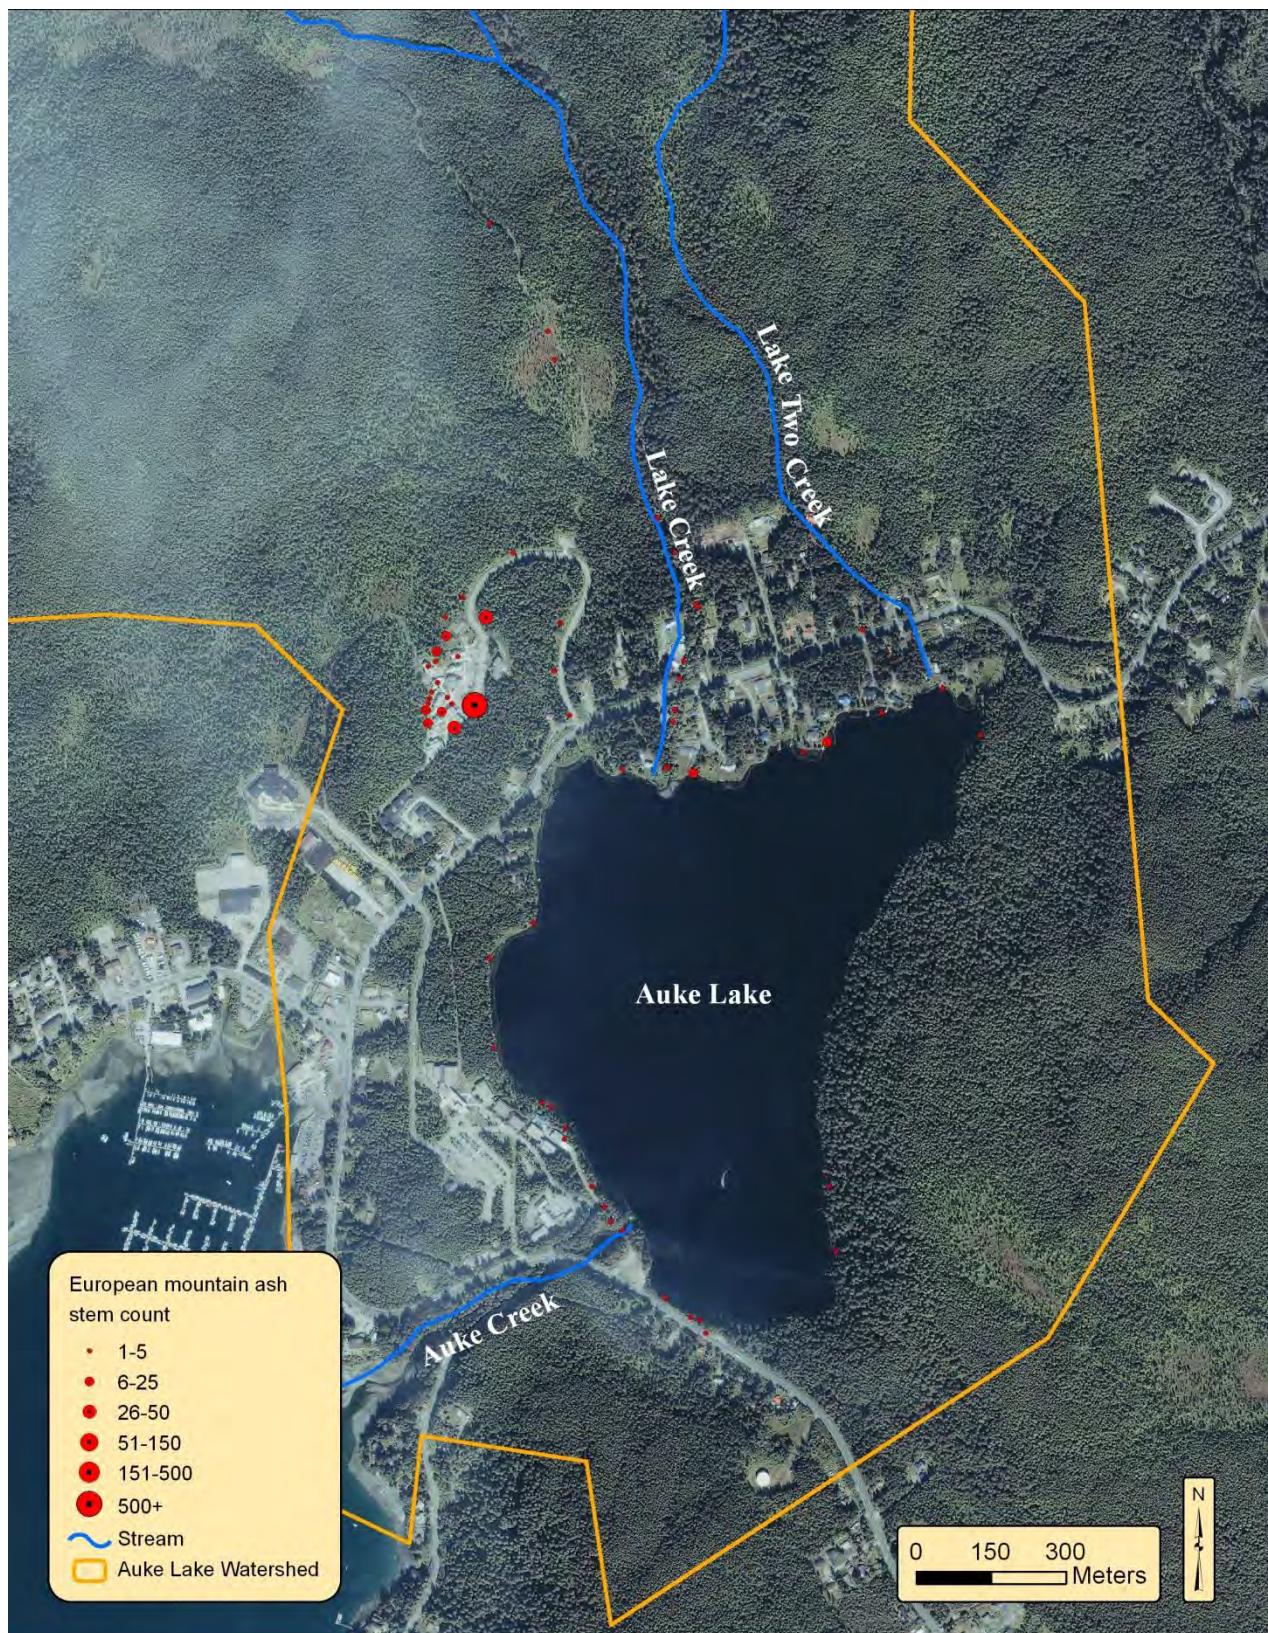
European mountain ash trees occurred primarily as single-tree (\leq 2- inch diameter) infestations scattered around the north, west, and south shorelines of Auke Lake and along the lower reaches of Lake Creek (Figure 36). A concentration of single- and multiple-tree infestations was found at the UAS Student Housing Facility (Figure 36). Several large ash trees growing on the facility grounds appeared to have been planted

Figure 36. European mountain ash (rank = 59) infestations within the Auke Lake Watershed survey area.

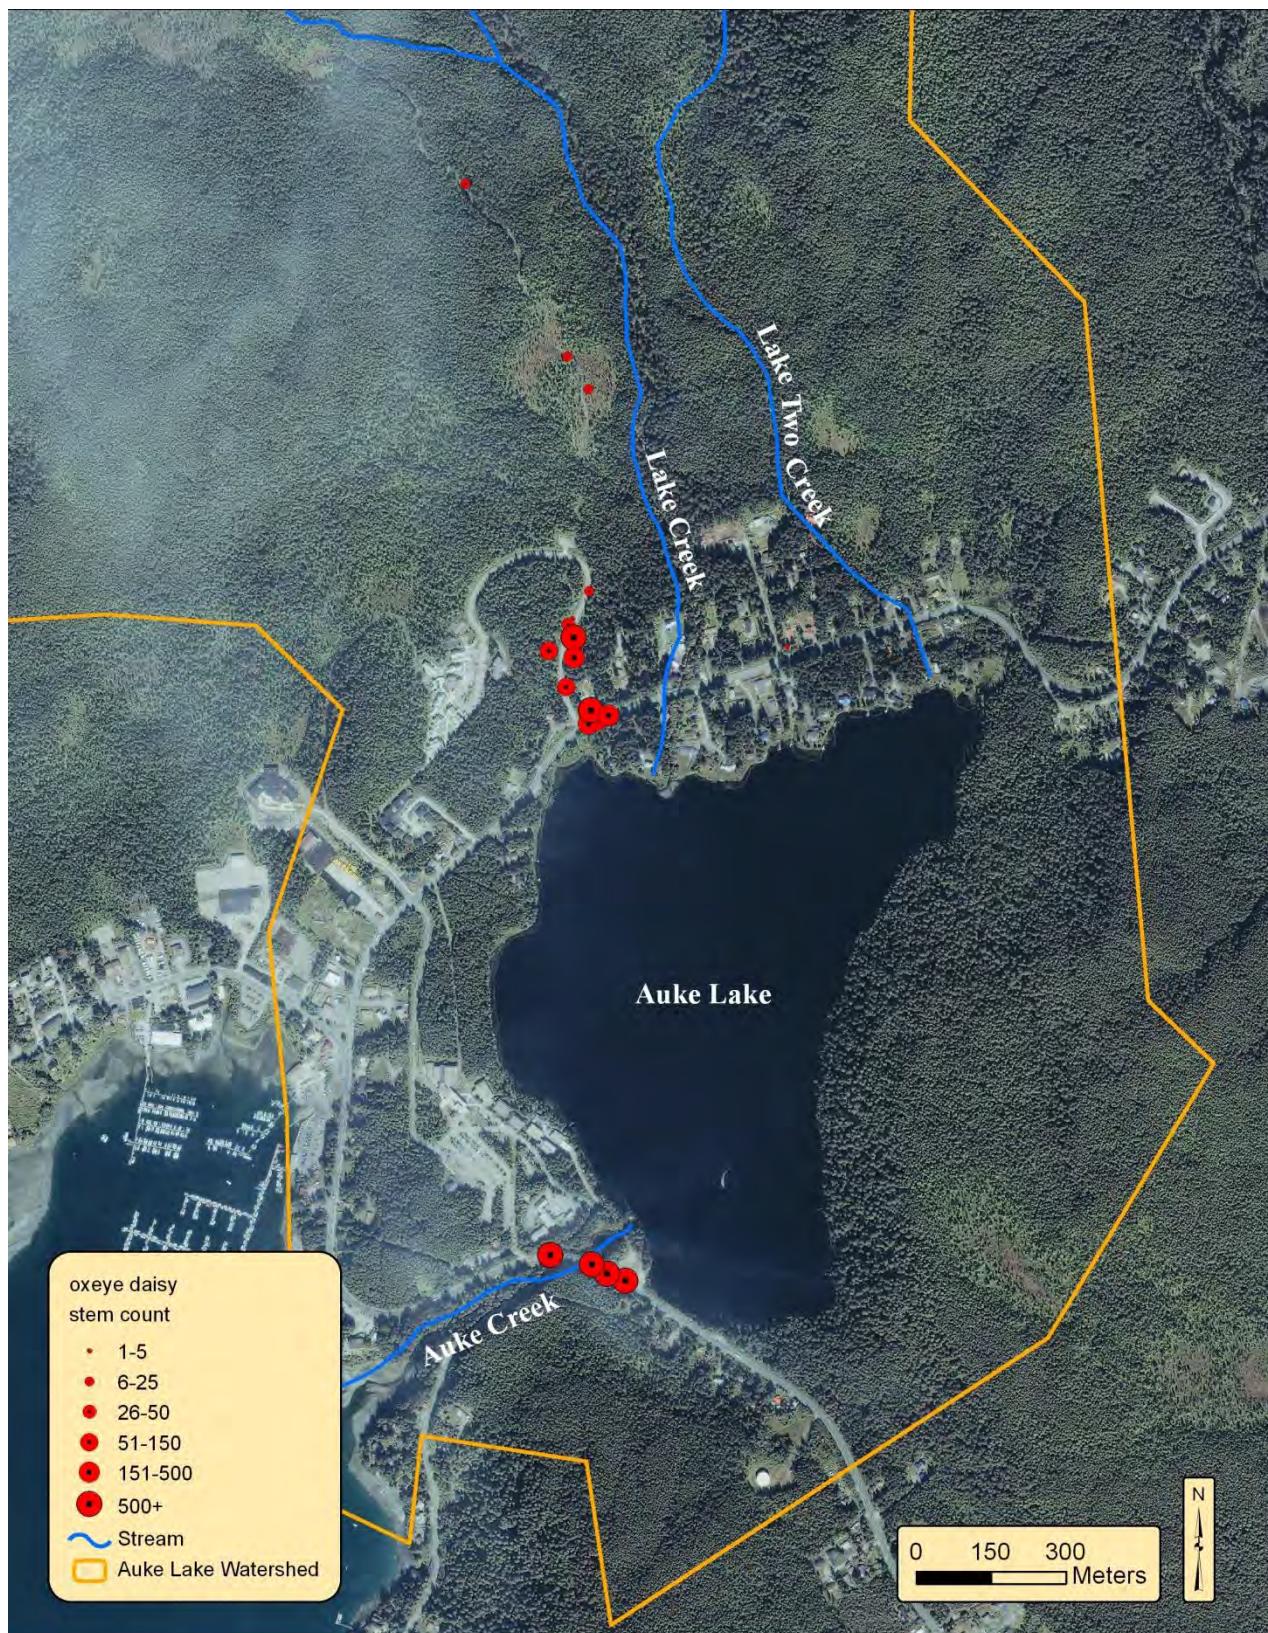
Figure 38. Oxeye daisy (rank = 61) infestations within the Auke Lake Watershed survey area.

- Eradicate oxeye daisy infestations through mechanical means (i.e. pulling) or herbicide application. Encourage UAS to control oxeye daisy infestations on campus property.
