Stormwater in the Lower Jordan Creek Watershed

Stormwater maps and recommendations for managing stormwater to improve habitat and water quality in Jordan Creek

U.S. Fish and Wildlife Service, Juneau
November 2015

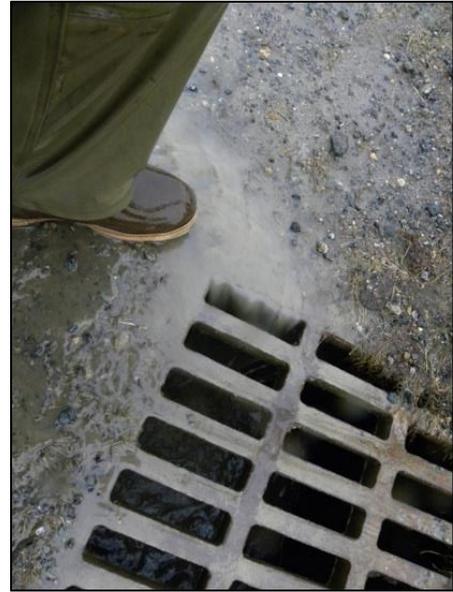
Figure 2. Stormwater containing suspended sediment flows into a catch basin in the Lower Jordan Creek Watershed.

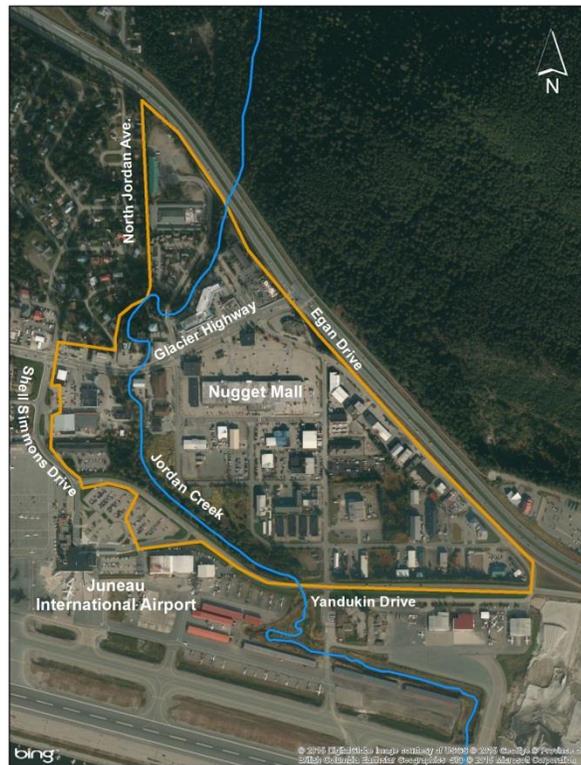
Figure 3. Assessment area.

The assessment area consisted of the land encompassed by Egan Drive, Yandukin Drive, Shell Simmons Drive, Glacier Highway (between Shell Simmons Drive and Jordan Avenue) and Jordan Avenue north of Glacier Highway (Figure 3). This area includes all of the land between Egan Drive and Yandukin Drive that contributes runoff to Jordan Creek.

Seventeen stormwater systems were identified in the assessment area (Figure 3, Table 1). Thirteen (13) of these systems discharge stormwater from a 106 acre area directly into Jordan Creek (Map A-14). Three systems direct stormwater into the ground and one system discharges stormwater to an estuary channel outside of the assessment area (Map A-13).

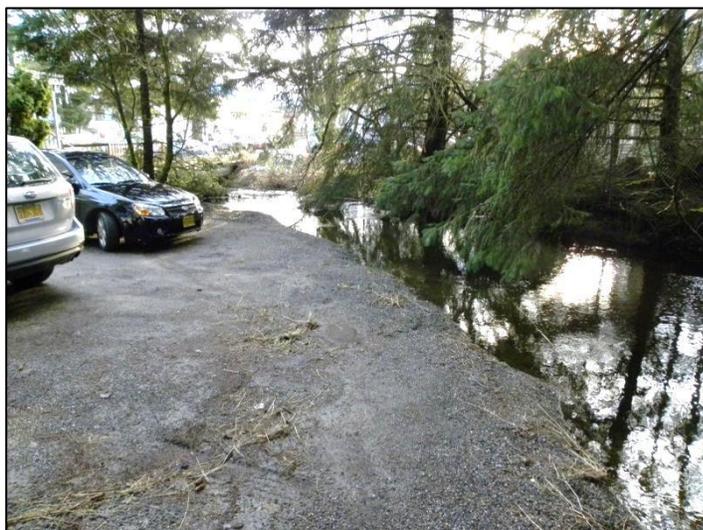
Figure 4. A gravel parking lot on the banks of Jordan Creek between Glacier Hwy. and Jordan Avenue. View looking downstream.

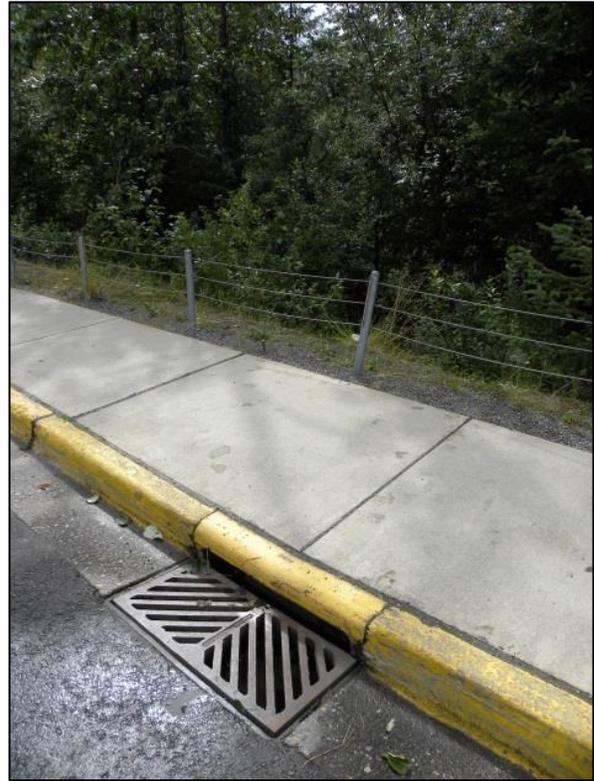
- **Curb and gutter** – a concrete channel constructed at the edge of a street or road to collect stormwater runoff and convey the runoff to catch basins, ditches, or swales (Figure 5).
- **Catch basin** – a subsurface vault with a grated inlet (Figure 5); installed in curb and gutter systems, parking lots, and swales to convey stormwater runoff to a subsurface pipe system.

Figure 5. Curb and gutter systems are commonly used to direct runoff from roads and parking lots into catch basins.

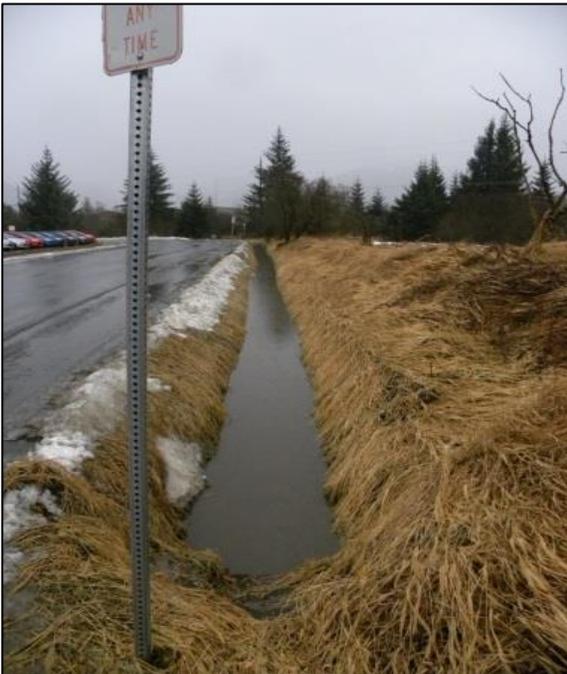
Figure 6. A ditch on the west side of South Jordan Avenue carries stormwater southward to Jordan Creek.

- **Pipe** – a subsurface conduit that conveys stormwater from a catch basin to the stream, a swale, or a ditch.
- **Ditch** – a narrow channel along a street or road that receives stormwater from pipes or from adjacent impervious surfaces in the form of sheet flows or streamlets (Figure 6). Ditches convey stormwater to swales, retention and infiltration basins, or directly to the stream. Some ditches are functionally swales when vegetation is allowed to persist.
- **Culvert** – a plastic or metal pipe that conveys stormwater from ditches under roads, streets, or driveways.

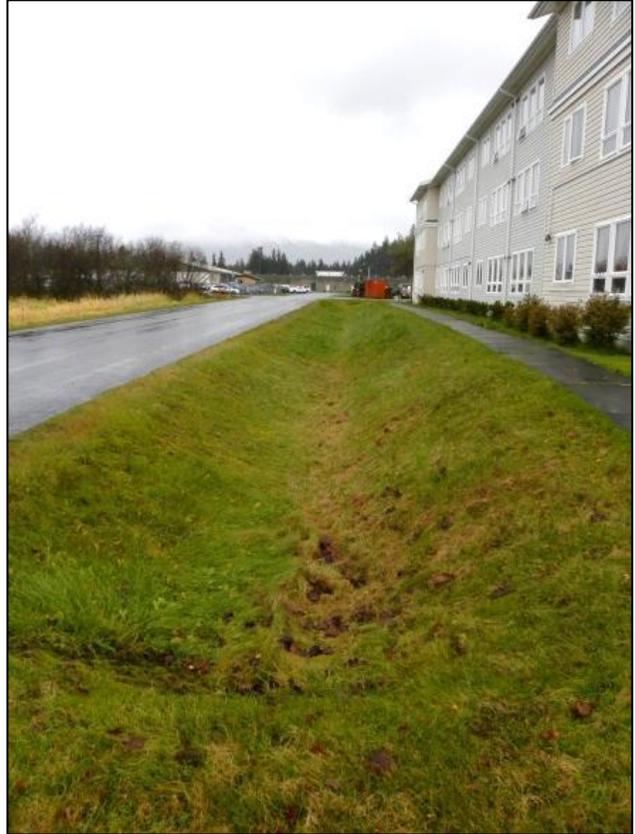
- **Swale** – a grass covered depression designed to slow water velocity and allow surface runoff to infiltrate the ground (Figure 7).
- **Hydrodynamic separator** – a stormwater treatment device designed to trap sediment, floatables, and oils.
- **Retention basin** – a permanently ponded water body that temporarily stores stormwater to reduce flooding and to capture sediment and associated pollutants.

Figure 7. A swale at the south end of Alpine Avenue.

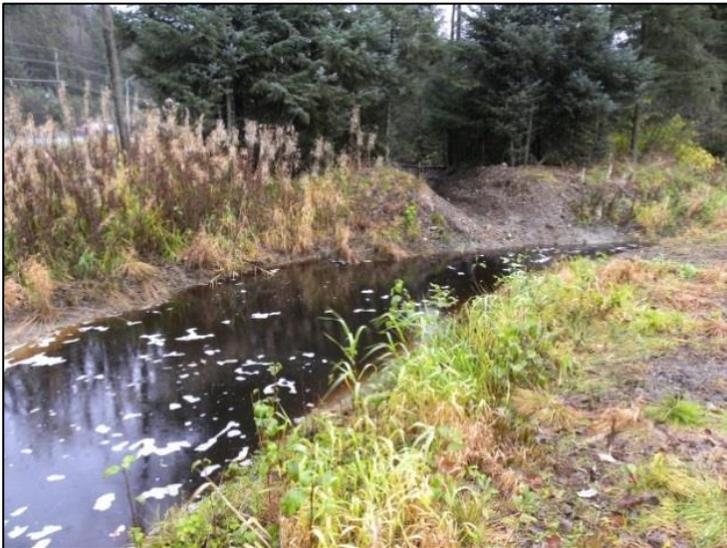
Figure 8. An infiltration basin at the north end of Jordan Avenue during a runoff event.

- **Infiltration basin** – a basin that temporarily stores stormwater until it infiltrates the ground (Figure 8).
- **Outfall** – the point at which a ditch or pipe discharges stormwater to a water body, stormwater basin, or swale.
- **French drain** – a trench containing perforated pipe, gravel, and rock that directs surface and groundwater away from an area.

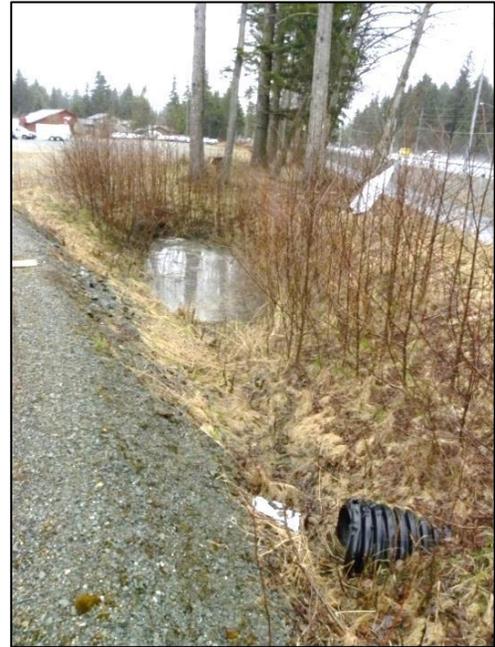
Outfall 1. North Jordan Avenue Outfall #1 (Map A-1) – This ditch outfall is located on the west side of Jordan Creek near a pedestrian bridge immediately downstream of Egan Drive. The ditch extends northwest from the outfall along the west side of Egan Drive and receives runoff from the south bound lane and a paved cul-de-sac and parking area at the north end of Jordan Avenue. Runoff from paved and unpaved surfaces in the North Jordan Avenue area enters the stormwater system through six storm drains before flowing into a 150 square-foot infiltration basin (Figure 9). Overflow from the basin enters a vegetated ditch on the south side of Egan Drive and flows 250 feet to Jordan Creek.

Figure 9. An infiltration basin near the north end of Jordan Avenue. The outlet pipe (lower right) connects the basin to a ditch along Egan Drive.

- ***Monitor infiltration capacity by noting the surface area of pooled water relative to the size of the basin between runoff periods. An enlarging area of pooled water indicates reduced infiltration capacity and the need to excavate fines from basin to enhance infiltration rates.***

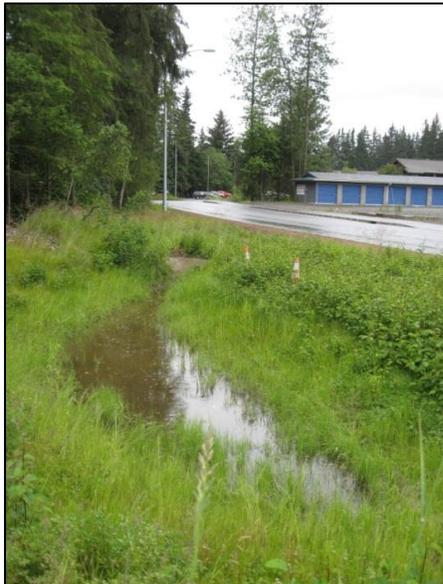
Outfall 2. North Jordan Avenue Outfall #2 (Map A-1) – This ditch outfall is located on the west bank of the Jordan Creek, approximately 80 feet downstream of Egan Drive. The contributing area includes approximately 200 feet of Jordan Avenue, the rooftops of a self-storage facility and surrounding pavement. Runoff from this area flows to an infiltration basin (Figure 10) before entering Jordan Creek through a 50-foot long cobble-lined overflow ditch.

Figure 10. An infiltration basin located near the north end of Jordan Ave receives stormwater runoff from roof tops and asphalt surfaces (view looking south).

- **Monitor infiltration capacity by noting the surface area of pooled water relative to the size of the basin between runoff periods. An enlarging area of pooled water indicates reduced infiltration capacity and the need to excavate fines from basin to enhance infiltration rates. Vegetation and sediment was removed from the basin in the fall of 2014.**

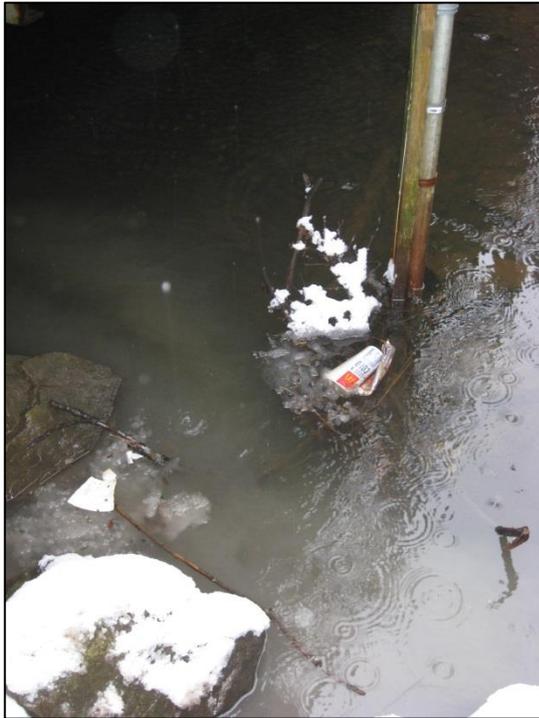
Figure 11. Stormwater containing trash compactor effluent mixes with water in Jordan Creek upstream of the Trout Street Bridge.

- **Effluent from the McDonalds’ trash compactor sump has been observed mixing with stormwater and flowing into the Trout Street ditch (Figure 11). Large accumulations of litter and a dark residue are frequently observed in the ditch (Figure 12). Prevent trash compactor effluent from mixing with stormwater.**

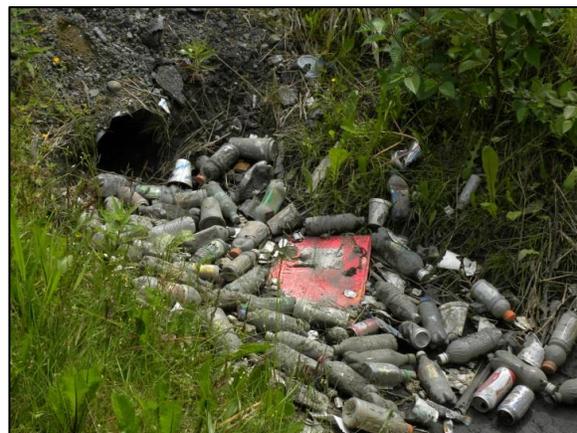
Figure 12. Litter from the Trout Street ditch accumulates at a culvert outfall (Outfall 3) next to Jordan Creek.

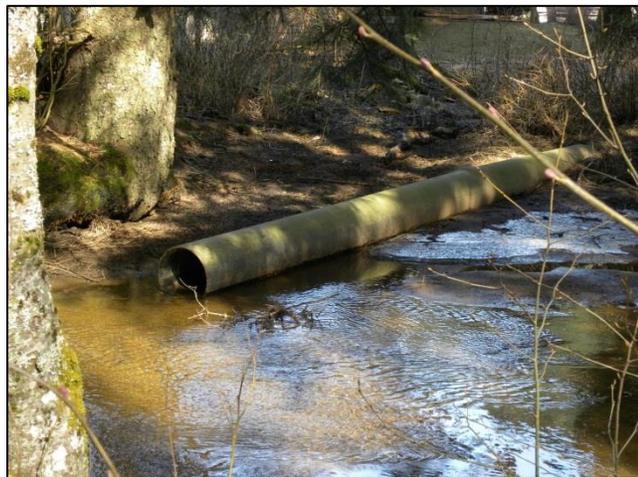
Figure 13. North Jordan Avenue Outfall #3.

Outfall 5. North Jordan Avenue Outfall #3 (Map A-3) – This pipe outfall is part of a stormwater system that receives runoff from streets and parking areas in the Jordan Creek Office Condominiums complex as well as from adjacent portions of Jordan Avenue. Eight catch basins in the system direct runoff to an outfall pipe on the north bank of Jordan Creek, approximately 140 feet downstream of Jordan Avenue. A 340-foot long swale on the east side of Jordan Avenue and south of Trout Street receives runoff from the adjacent road and parking lot. All runoff entering the swale appears to infiltrate the ground.

- ***Shorten outfall pipe (Figure 13) and construct a retention or infiltration basin between Jordan Avenue and the outfall to remove sediment and other pollutants from runoff. Thin or prune adjacent trees to ensure adequate light levels for wetland vegetation.***
- ***Four catch basins in this system are located in grass swales which provide an opportunity for sediment capture and runoff infiltration before excess runoff enters the basin. However, the basins are located near the ends of the swales – a few feet from impervious surfaces - providing minimal space for infiltration or sediment capture to occur. When catch basins are installed in swales, place basins as far from the swale edge as possible to maximize opportunity for infiltration and pollutant capture.***

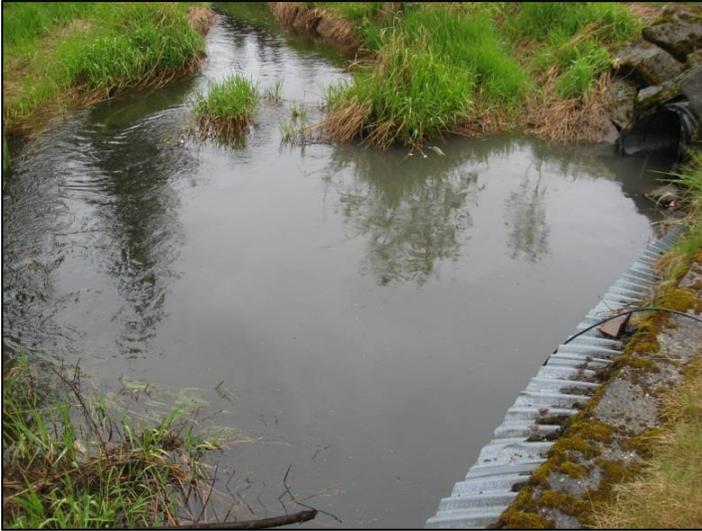
Figure 14. Suspended sediment in stormwater from the Glacier Highway East Outfall (upper right of photo) mixes with clear water in Jordan Creek upstream of Glacier Highway.

- ***Identify sites along Glacier Highway where stormwater can be diverted away from catch basins into infiltration areas (e.g. tree trenches, planters, swales) constructed in green spaces between sidewalks and parking lots.***
- ***Inspect the hydrodynamic separator two times per year and within 48 hours of a major storm event. (Refer to the Maintenance Checklist for Hydrodynamic Separators (Table C-7) and maintenance schedule in the CBJ Manual of Stormwater Best Management Practices).***

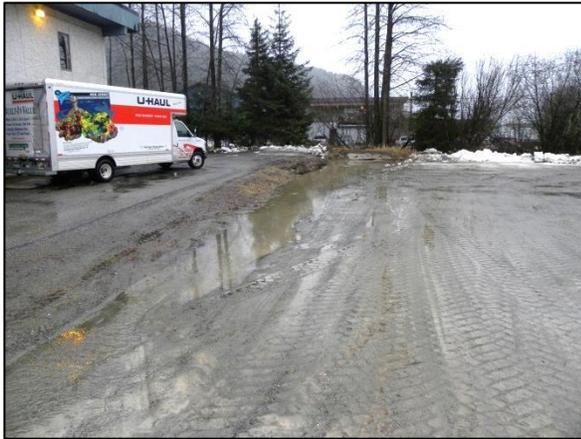
Figure 15. Stormwater runoff from a portion of the Airport Shopping Center parking lot flows over an unpaved area used to train truck drivers next to Jordan Creek. (view looking east).

- **Construct an infiltration basin on a portion of the gravel parking area to promote stormwater infiltration and trap sediment and other pollutants before they reach the stream (Completed fall 2015).**
- **Pave the remaining portion of the gravel parking area to eliminate sediment sources.**
- **Use fencing to establish a 25 foot wide riparian setback from the outfall upstream to Glacier Highway to protect riparian area (Completed fall 2015).**

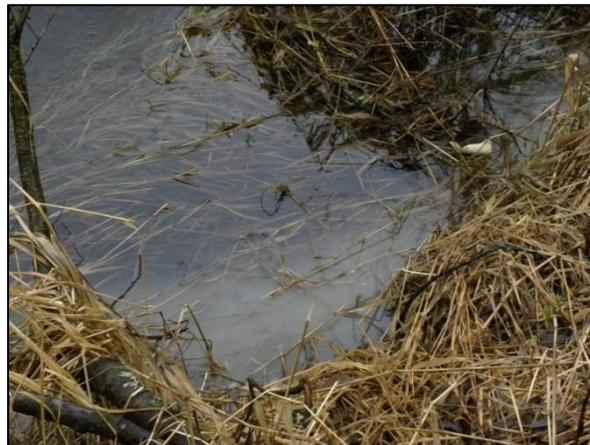
Figure 16. Sediment laden runoff flows into Jordan Creek at ditch outfall #8.

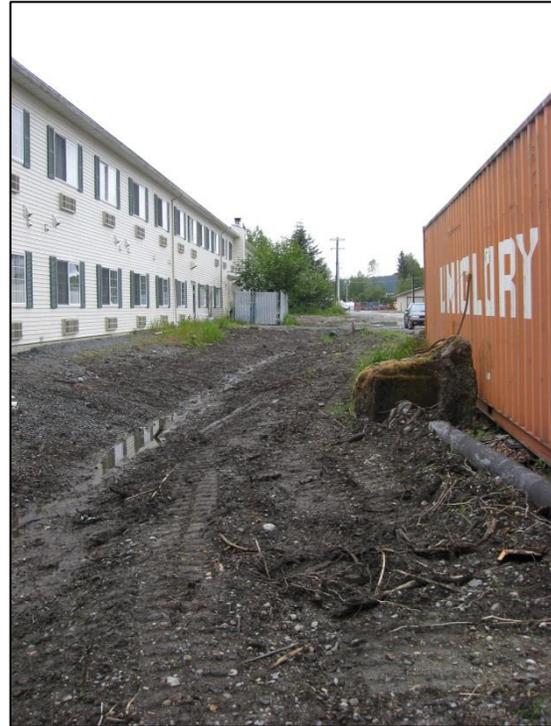
The area above the drain on the north side of the hotel was cleared of dense trees and shrubs that were salvaged from the hotel footprint prior to construction.

Figure 17. This shallow ditch on the north side of the Extended Stay Hotel is underlain by a french drain (view looking west).

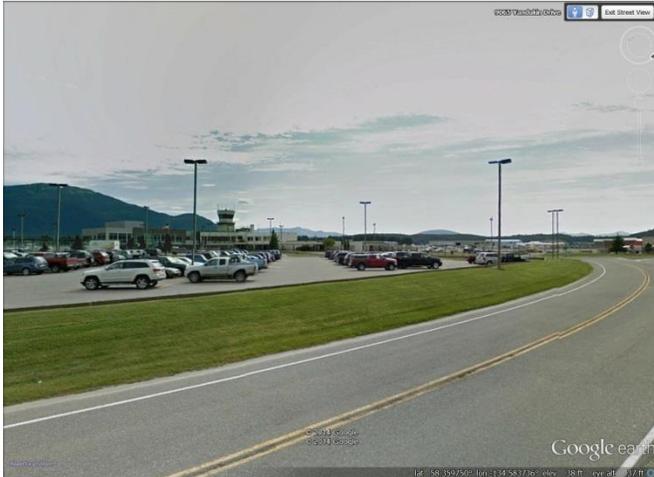
Outfall 10. West Yandukin Drive #1 (Map A-6) – This ditch outfall drains a retention basin located in a stand of spruce trees on the north side of Yandukin Drive, across from the airport parking lot. The basin receives stormwater from a 200 foot long section of Yandukin Drive via a catch basin on the south side of the road.

Figure 18. Constructing a filter strip on the south side of West Yandukin Drive would eliminate stormwater runoff into Jordan Creek from this section of road.

- **Stormwater runoff to Jordan Creek from this portion of West Yandukin Drive can be eliminated by constructing a vegetated filter strip along the toe of an existing grass-covered embankment, between the road and the airport parking lot (Figure 18). To create the strip, excavate a shallow ditch at the toe of the slope that is below the grade of the road edge. Design the strip so that stormwater inputs that exceed infiltration capacity overflow into the existing catch basin.**

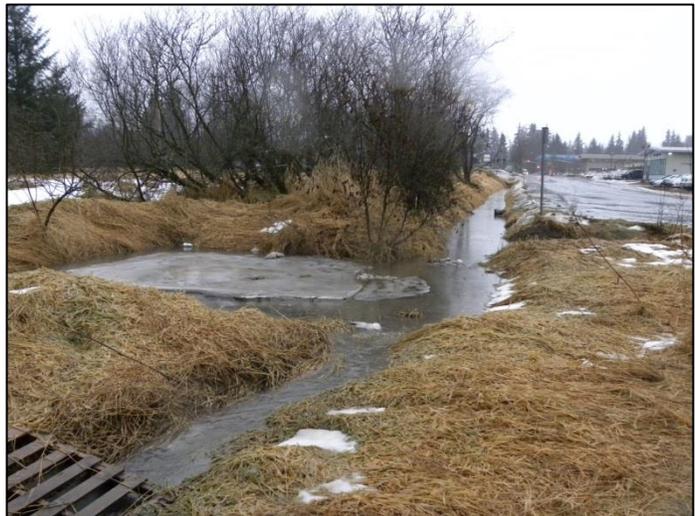
Outfall 11. South Nugget Mall (Map A-7) – This ditch outfall is located in CBJ parkland near the south end of Jordan Avenue. The stormwater network includes six catch basins on south Jordan Avenue, twelve catch basins on Mallard Street, and ditches and ditch swales on both sides of west Teal Street and the west side of north Alpine Avenue. The contributing area includes the streets as well as impervious surfaces on adjacent commercial properties. Parking areas on the south and west sides of Nugget Mall also contribute stormwater to this outfall ditch. Runoff from these areas enters the ditch from a pipe outfall located on the west side of Jordan Avenue, approximately 350 feet south of the Mallard Street intersection. Stormwater flows from the ditch into a 300-square foot retention basin before entering Jordan Creek (Figure 19). A new development was constructed near the south end of Jordan Avenue in 2015.

Figure 19. The Nugget Mall South stormwater ditch conveys stormwater from the south side of the mall into a small retention basin (center left in photo) before it flows into Jordan Creek at the south end of Jordan Avenue (view looking north from Jordan Creek).

- ***Identify sites where runoff from parking lots and curb/gutter can be diverted from catch basins into infiltration areas.***
- ***The contributing area is almost entirely impervious and experiences high levels of vehicle use. In addition to suspended sediment, stormwater runoff from this area likely contains high levels of petroleum hydrocarbons and other pollutants associated with vehicles. Periodic maintenance (i.e. excavation and removal of sediment) from this ditch exposes soil to erosion and removes vegetation that may trap sediment before it reaches the stream. Educate CBJ Streets Division personnel on ditch cleaning practices that minimize impacts to water quality.***

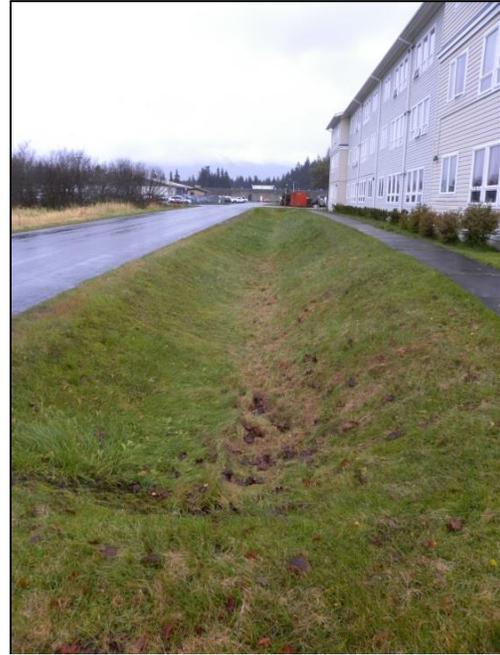
Figure 20. A swale at the south end of Alpine Avenue (view looking north).

- ***The grass-covered swale along the south end of Alpine Avenue provides an example of how to construct and manage swales (Figure 20). However, very little runoff flows into the swale. Direct stormwater from ditches on the north end of Alpine Avenue and the east end of Teal Street to this swale. Currently, these ditches convey stormwater to the Crest Street stormwater system which discharges runoff into Jordan Creek.***

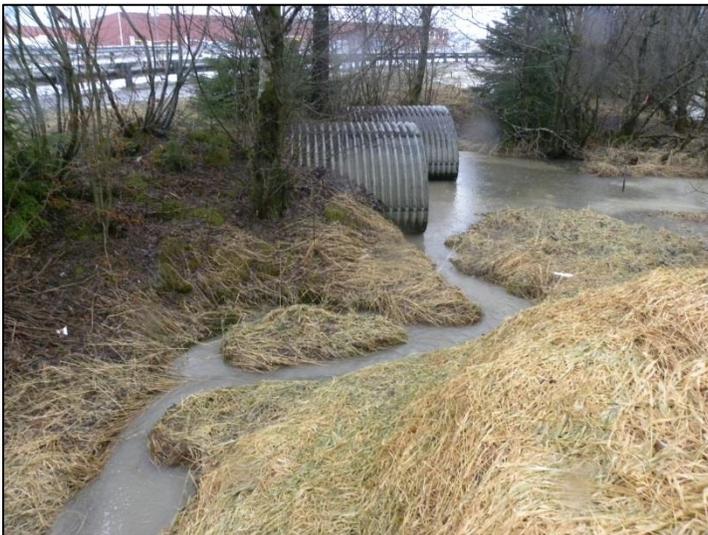
Outfall 15. Crest Street (Maps A-10 & A-11) – This is the most downstream stormwater outfall in the assessment area discharging runoff directly to Jordan Creek. The contributing area of the system is larger than any other in the assessment area. The outfall is a ditch located on the east side of the channel immediately

Figure 21. Turbid stormwater from the Crest Street stormwater system flows into Jordan Creek west of the Yandukin Drive and Crest Street intersection (view looking west).

upstream of Yandukin Drive (Figure 21). The ditch receives stormwater from a pipe outfall on the west side of Crest Street, approximately 70 feet north of Yandukin Drive. The stormwater system is extensive reaching to Glacier Highway, Alpine Avenue, and Old Dairy Road and includes 49 catch basins. The contributing area is comprised of Crest Street, Old Dairy Road between Glacier Highway and Juneau Urgent Care (8508 Old Dairy Road), the east side of Alpine Avenue (north of Teal Street), the north and south sides of Teal Street (east of Alpine Avenue), Mallard Street between Alpine Avenue and Crest Street, and most of the east end of Airport Boulevard between Crest Street and Aspen Suites Hotel (8400 Airport Boulevard), as well as commercial properties adjacent to these streets, including the eastern half of Nugget Mall. The fate of stormwater flowing into 4 catch basins near the north end of this system (8585 Old Dairy Road) was not assessed.

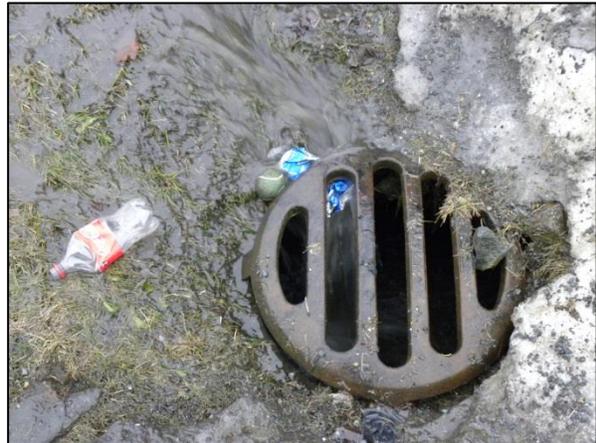
Figure 22. Stormwater flows into a catch basin in the northeast corner of the Nugget Mall parking lot.

- ***A catch basin located at the northeast corner of the Nugget Mall parking lot receives stormwater from the northeast quadrant of the lot (Figure 22). Direct parking lot runoff into an infiltration basin in this area to reduce or eliminate runoff into the catch basin.***

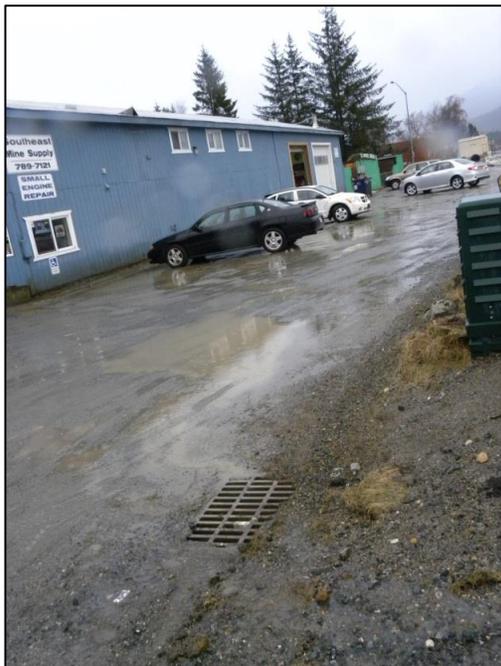
Figure 23. Turbid stormwater from a gravel parking area flows into a catch basin at the intersection of Crest Street and Airport Blvd.

- ***This stormwater system receives turbid runoff from gravel covered surfaces on several properties along Crest Street and east Airport Boulevard (Figure 23). Encourage property owners to pave gravel surfaces or convey runoff away from catch basins and into swales or infiltration basins.***

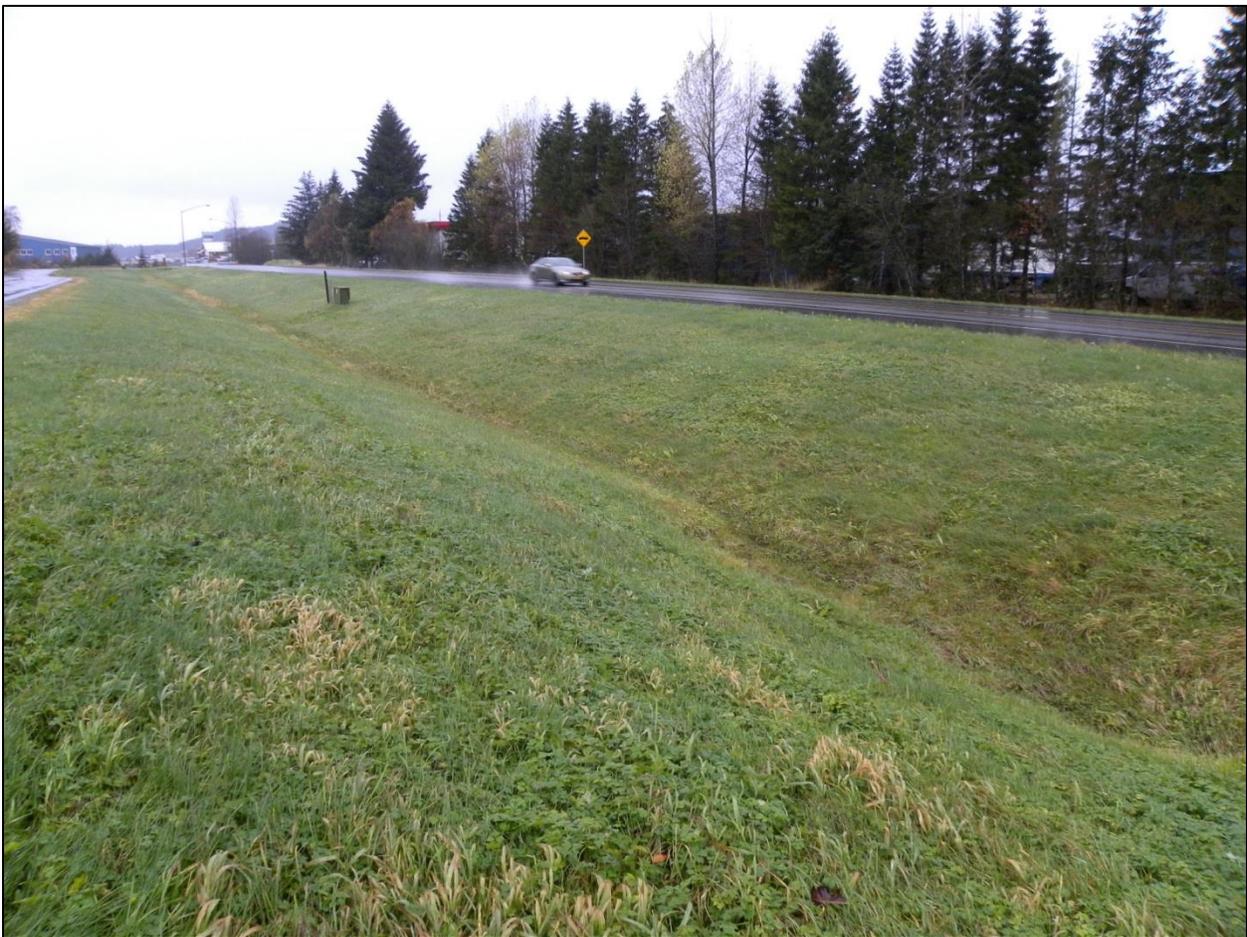
Figure 24. A 1,500 foot long swale at the east end of Yankukin Drive. If feasible, stormwater from the Crest Street stormwater system - the largest system in the assessment area - could be routed to this swale instead of flowing directly into Jordan Creek.

- ***This stormwater system receives highly turbid runoff from a lumberyard, which is covered with gravel. Work with the owners to direct stormwater runoff away from catch basins.***
- ***This stormwater system is the largest in the assessment area and discharges directly to Jordan Creek. Move the outfall to a 1,400-foot long grassy swale on the south side of Yandukin Drive east of Crest Street (Figure 24). If necessary, elevate the inlet of an existing catch basin (part of the Old Dairy Road Stormwater System) in the center of the swale to increase swale capacity.***

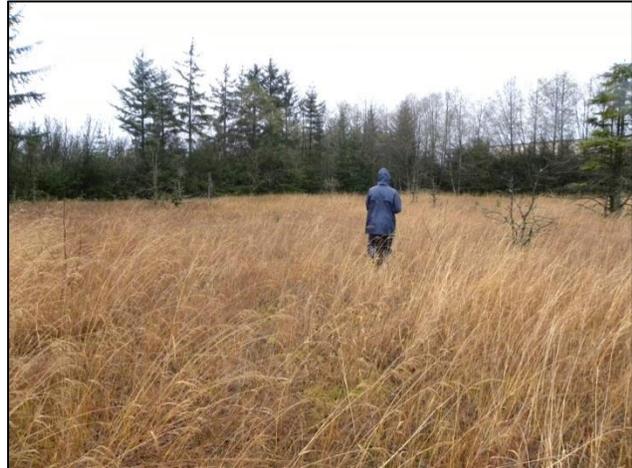
Figure 25. A wetland/meadow complex on the east side of the assessment area conveys groundwater and stormwater runoff into a swale on the north side of Yandukin Drive.

The wetland complex does not have a surface connection to Jordan Creek. Water flows south through the wetland and discharges to a swale on the north side of Yandukin Drive east of Crest Street. Two culverts under Yandukin Drive connect the swale to a large swale on the south side of Yandukin Drive (Figure 24). Stormwater was not observed flowing through these culverts during periods of heavy rain.

- ***Protect the wetlands from development through purchase or a conservation easement.***
- ***Snow pushed from adjacent properties into the wetland damages vegetation and introduces sediment and other pollutants (Figure 26). Encourage property owners to store snow in upland areas.***

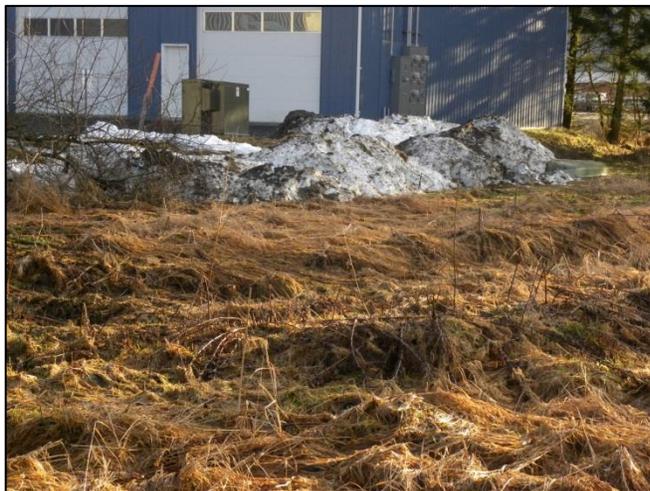
Figure 26. Snow stored on the edge of a palustrine wetland on the south side of Airport Boulevard near its eastern end.

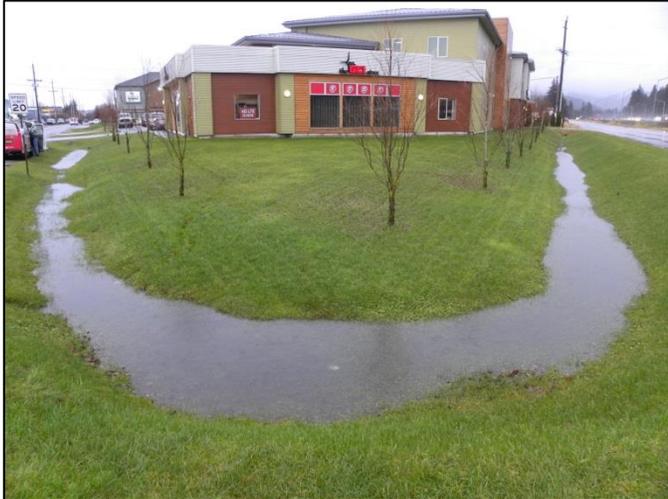
properties. There are eleven catch basins in this stormwater system. Five catch basins are located on the west side of Old Dairy Road and five catch basins are located in a parking lot at 8390 Airport Boulevard. Another catch basin is located in a large swale on the south side of Yandukin Drive (Figure 24). Stormwater flow into the Yandukin Drive swale is infrequent and infiltrates the ground before reaching the catch basin.

Figure 26. Grass-covered swales at the intersection of Airport Boulevard (left) and Old Dairy Road (right) promote infiltration of stormwater runoff when the ground is unfrozen.

- ***Stormwater ponding occurs in the two swales that connect at the intersection of Airport Boulevard and Old Dairy Road (Figure 26); this stormwater then flows through a culvert under Airport Boulevard. Assess the potential for increasing infiltration rates in these swales.***

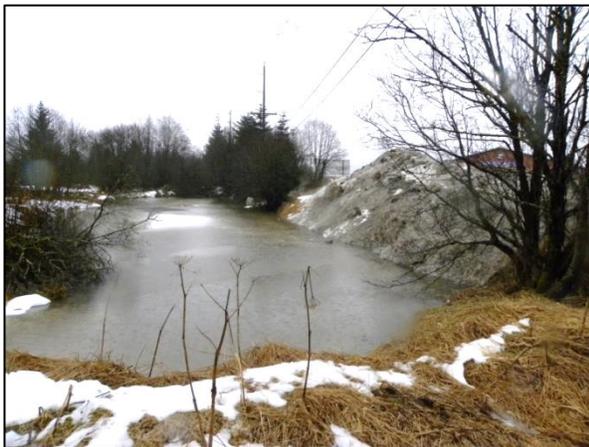
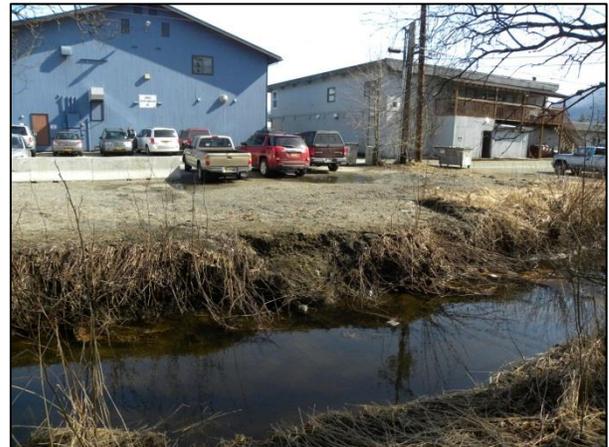
Snow is stored within the Jordan Creek riparian zone or pushed into the stream channel at numerous locations in the assessment area (Figure 27). This practice damages or destroys riparian vegetation and introduces gravel, fine sediment, and pollutants into the stream. Riparian plant communities provide habitat for fish and wildlife, buffer the stream from the urban environment, and provide a variety of ecological functions (e.g. nutrient and energy cycling).

Figure 27. Storing snow on stream banks can damage or destroy riparian vegetation and introduce sediment and other pollutants into the stream channel. Snow from the airport is routinely stored on the banks of Jordan Creek north of Yandukin Drive (left). Snow storage on the banks of Jordan Creek downstream of Glacier Highway damages or destroys vegetation resulting in bank erosion (right).

- **To protect riparian habitat, avoid storing snow within 25 feet of the stream channel. Use fences or snow barrier walls to prevent snow storage in the stream channel and riparian zone (Figure 28).**
- **Construct snow barrier fences or walls at least 25 feet from the stream bank in locations where snow is stored on riparian habitat or pushed into the stream channel.**

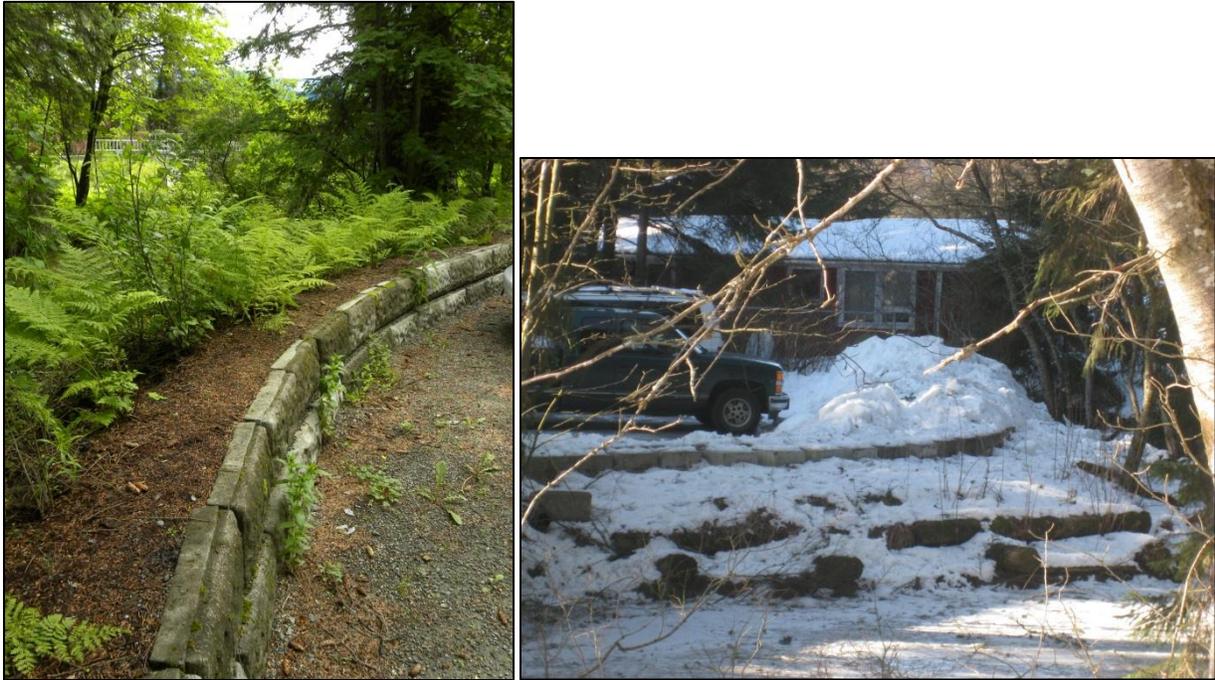
Figure 28. A snow barrier constructed of precast concrete blocks prevents snow from being plowed onto riparian habitat at a business parking area next to Jordan Creek.

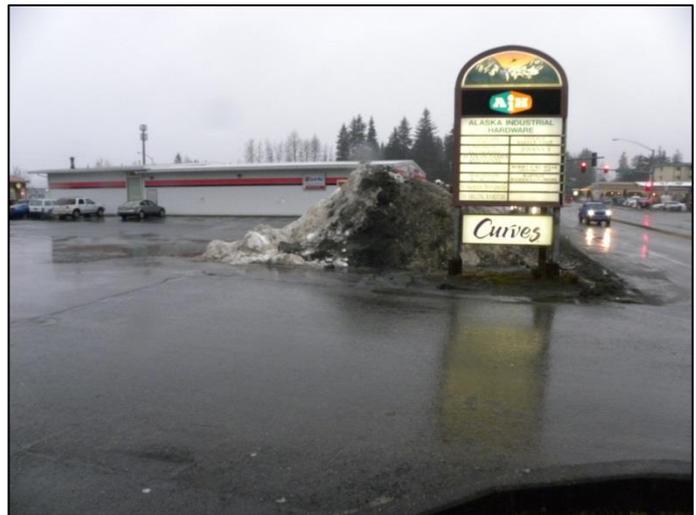
Meltwater from snow storage areas, which may contain debris, sediment and other pollutants, was observed flowing directly into Jordan Creek, into stormwater networks that discharged to Jordan Creek, or into swales and ditches that were functioning as swales.

Figure 29. Suspended sediment from a snow pile is carried by meltwater runoff into catch basins within the West Glacier Highway stormwater system.

- **Avoid storing snow where meltwater will flow directly into the stream or a catch basin (Figure 29). Store snow where meltwater flows to a swale, retention basin, or infiltration basin.**

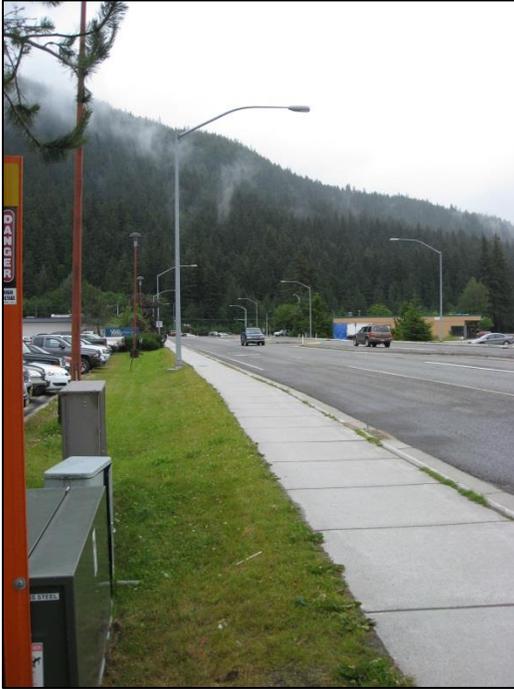
Figure 30. Route curb and gutter stormwater away from catch basins and into filtration strips constructed in green spaces next to roads (view looking east along Glacier Hwy. near Jordan Avenue).

- Identify opportunities for diverting runoff away from catch basins and into existing or constructed swales, filter strips, and infiltration basins (Figures 30 and 31).

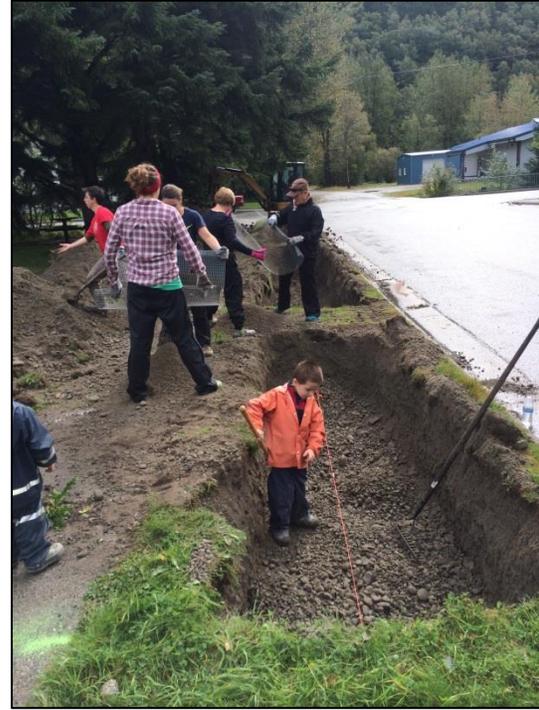
Figure 31. Infiltration basins under construction near Pullen Creek in Skagway. Curb cut-outs intercept runoff in the gutter allowing stormwater to flow into the basins rather than flowing directly into Pullen Creek.

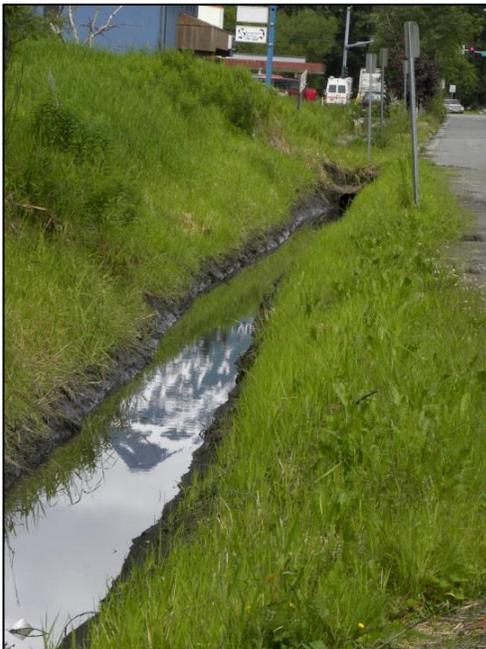
Ditch maintenance activities that remove vegetation and accumulated sediment expose soils to erosion resulting in sediment transport to streams (Figure 32).

- **Avoid removing vegetation from ditches and swales. If ditches must be cleaned, remove the vegetated mat and replace it after excess sediment has been removed, or use check dams to reduce erosion.**

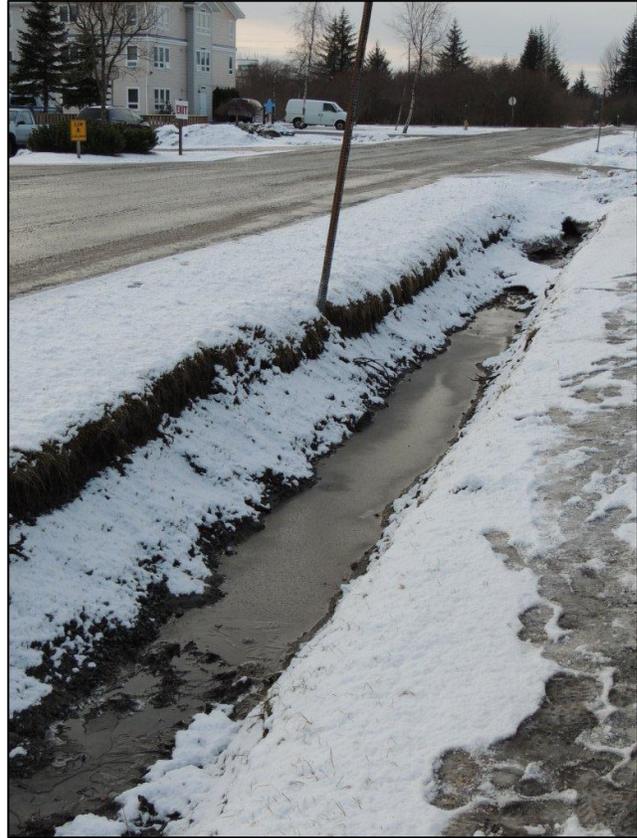
Figure 33. A ditch on the north Side of Teal Street (view looking west from Crest Drive).

- **Replace the ditches with biofiltration swales containing perforated pipe to convey treated runoff to the Crest Drive stormwater system.**
