Wrangell Area Watersheds Assessment

February 2019

Southeast Alaska Watershed Coalition

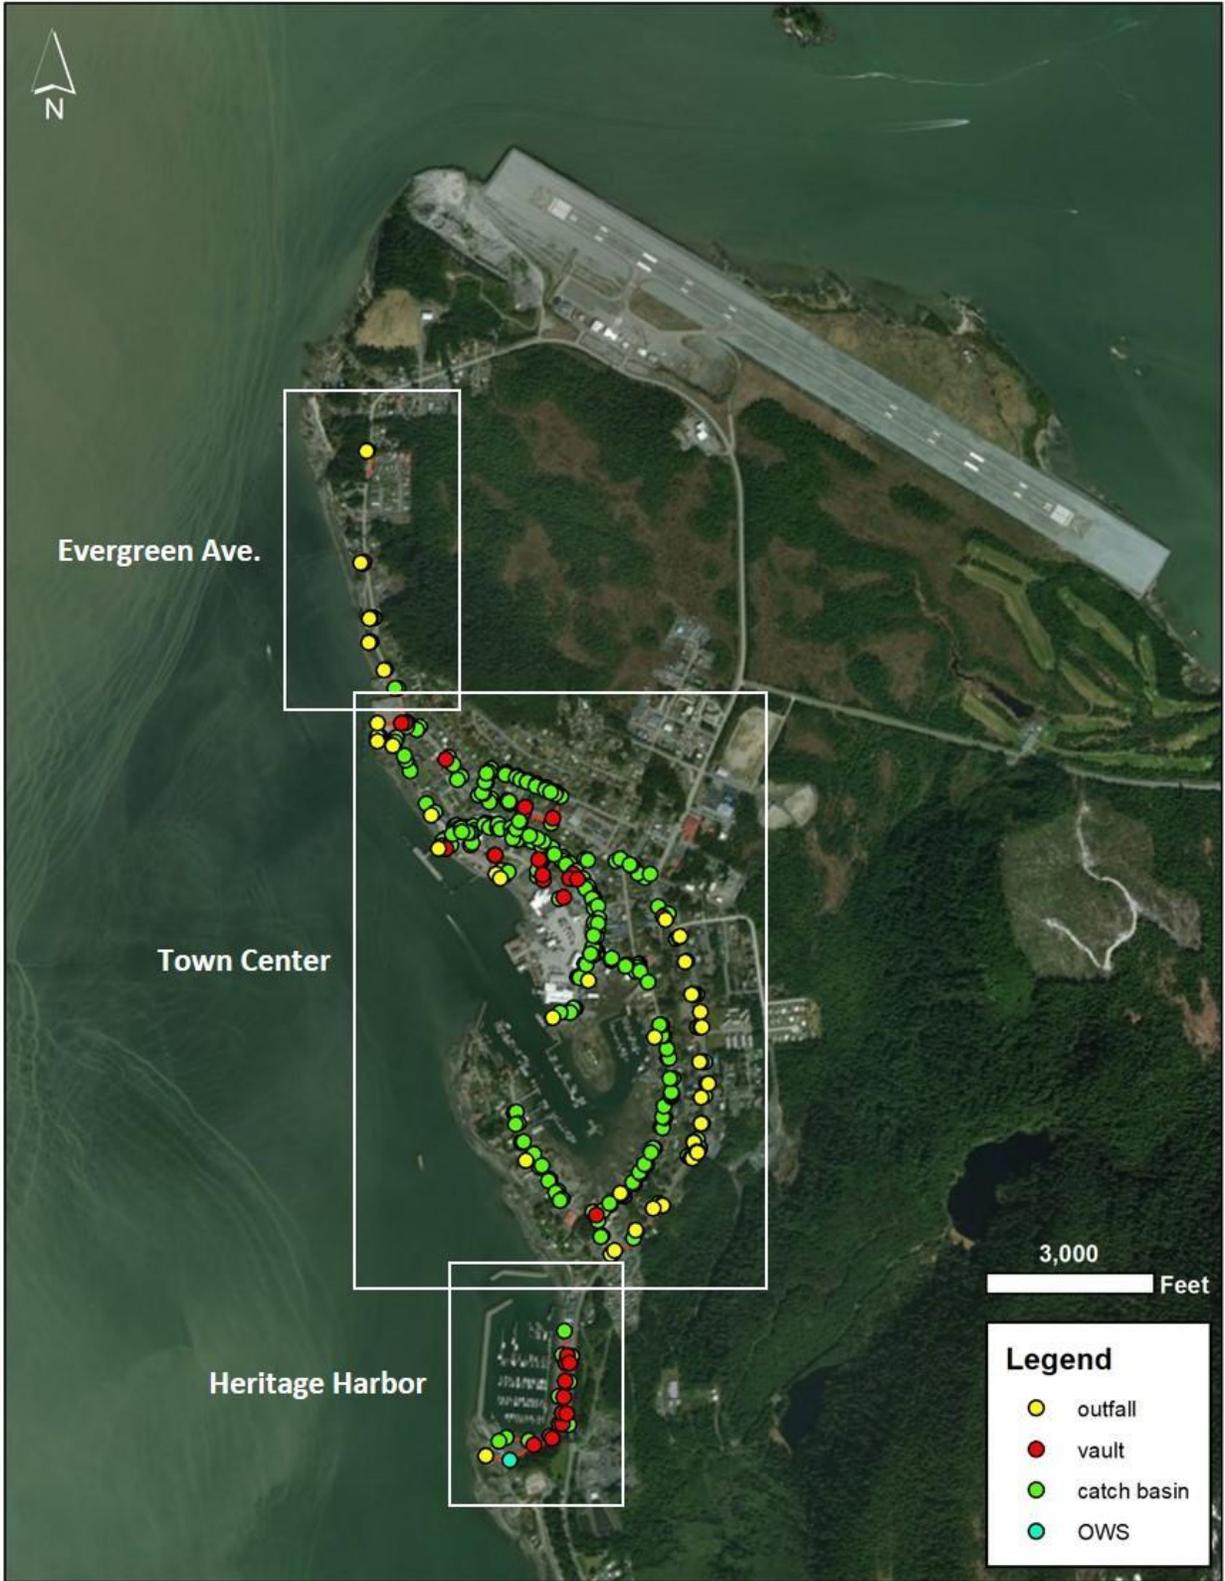
Figure 2. Overview map of stormwater sites assessed. OWS stands for Oil-Water Separator.

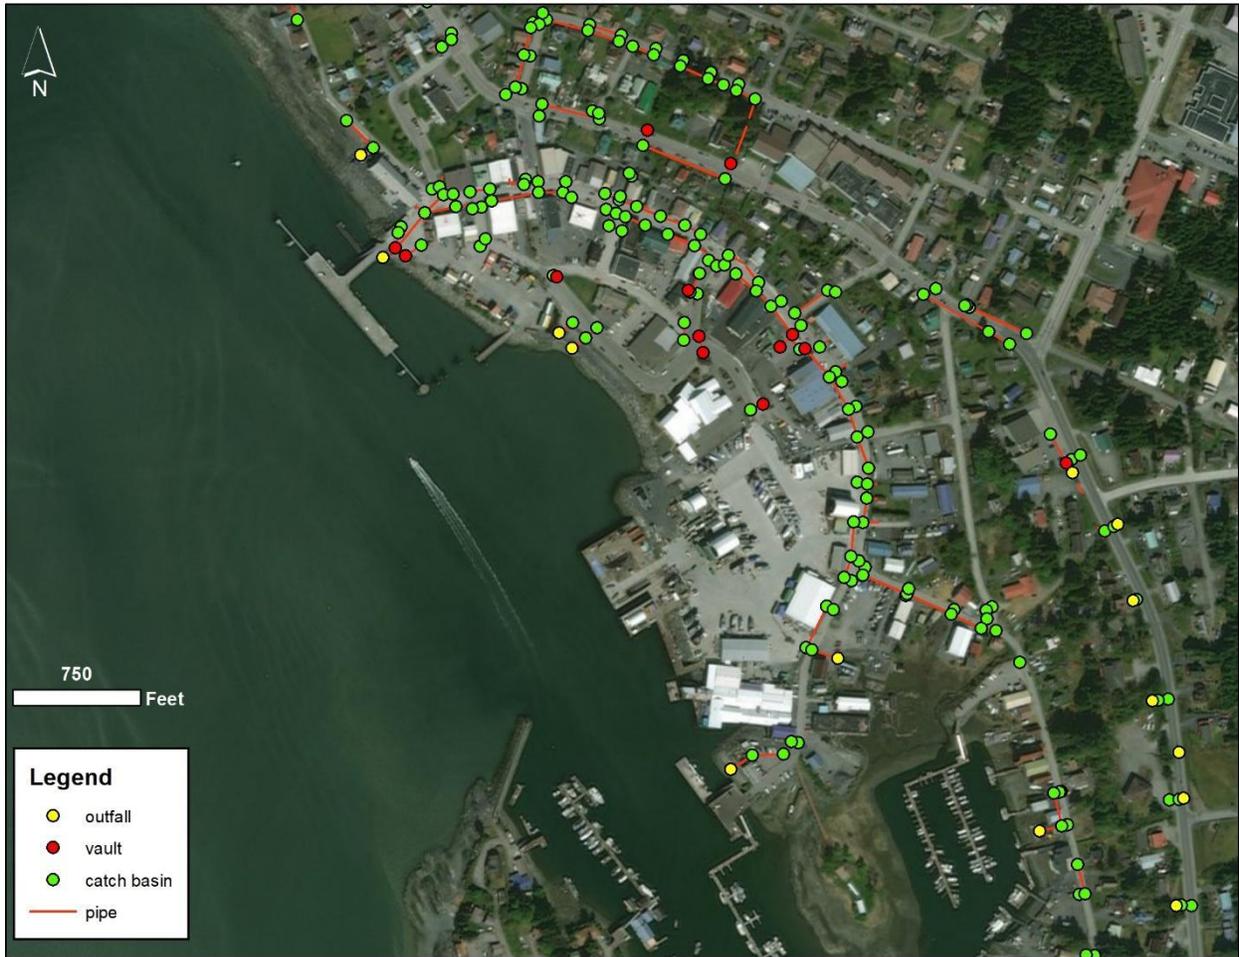
Figure 3. A close-up view of stormwater systems in the downtown area of Wrangell (Note: some systems are incompletely mapped at this time).

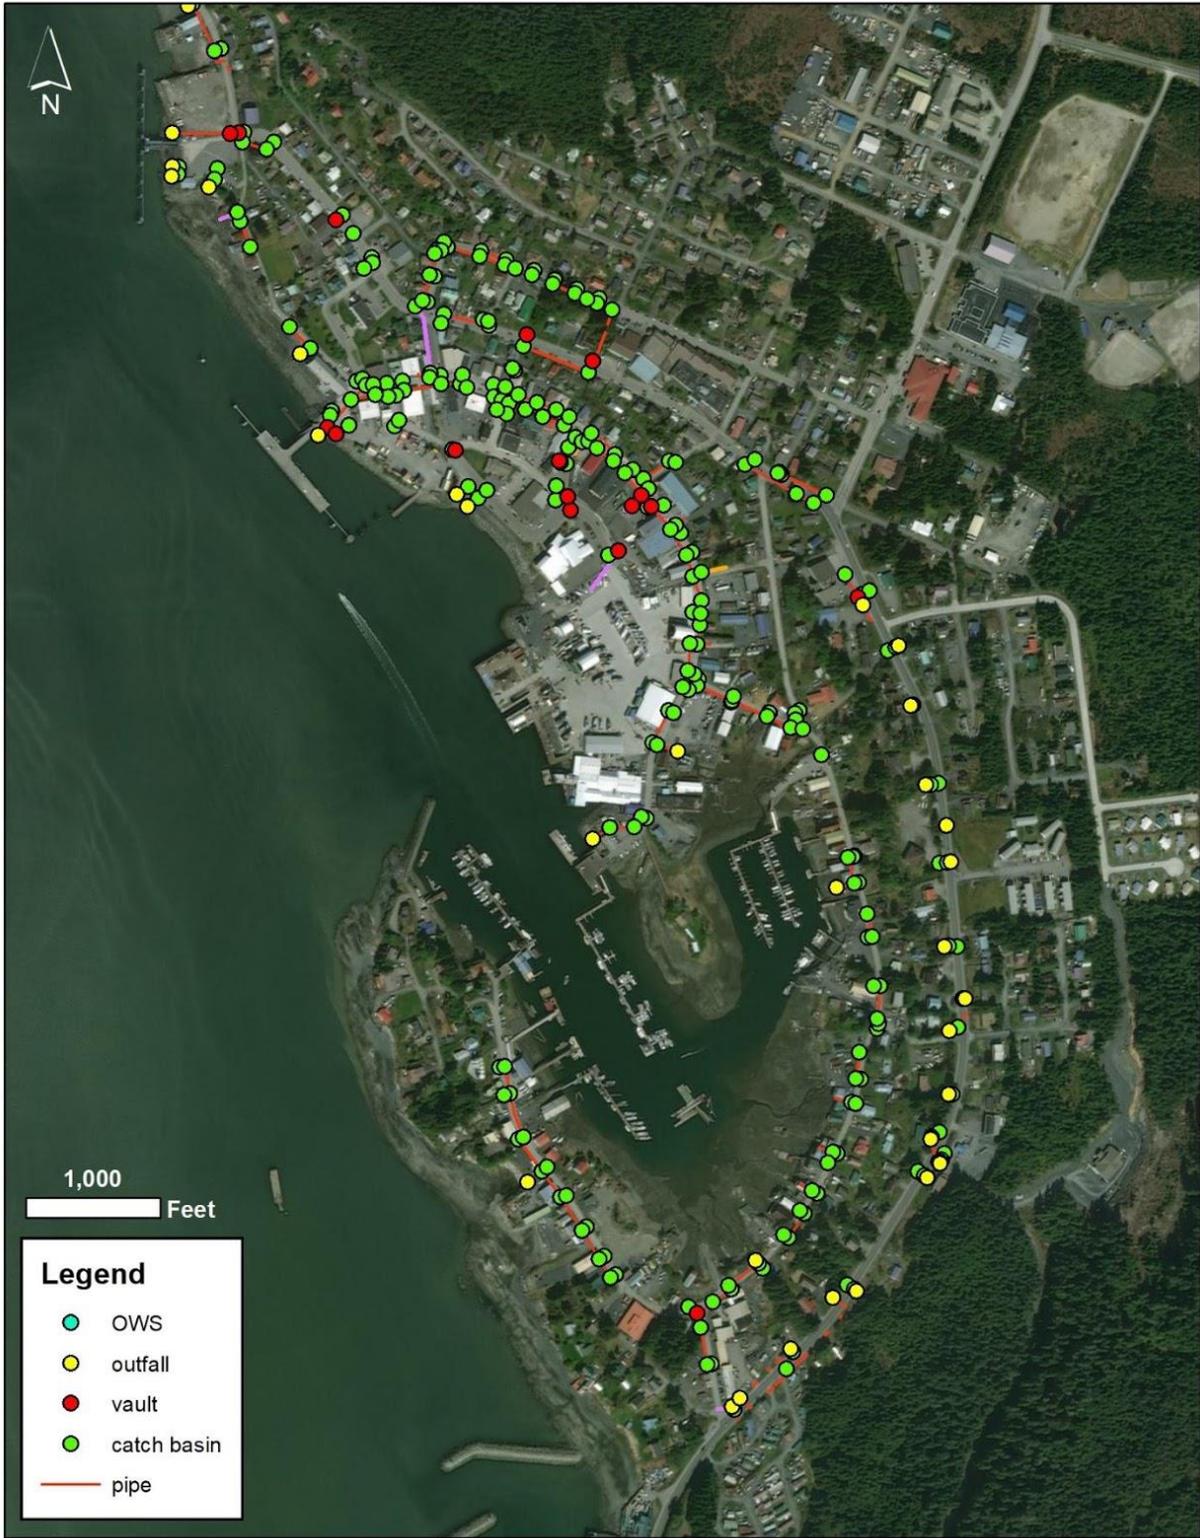
Figure 4. Stormwater systems in town center area of Wrangell. (Note: some systems are incompletely mapped at this time). OWS stands for Oil-Water Separator.

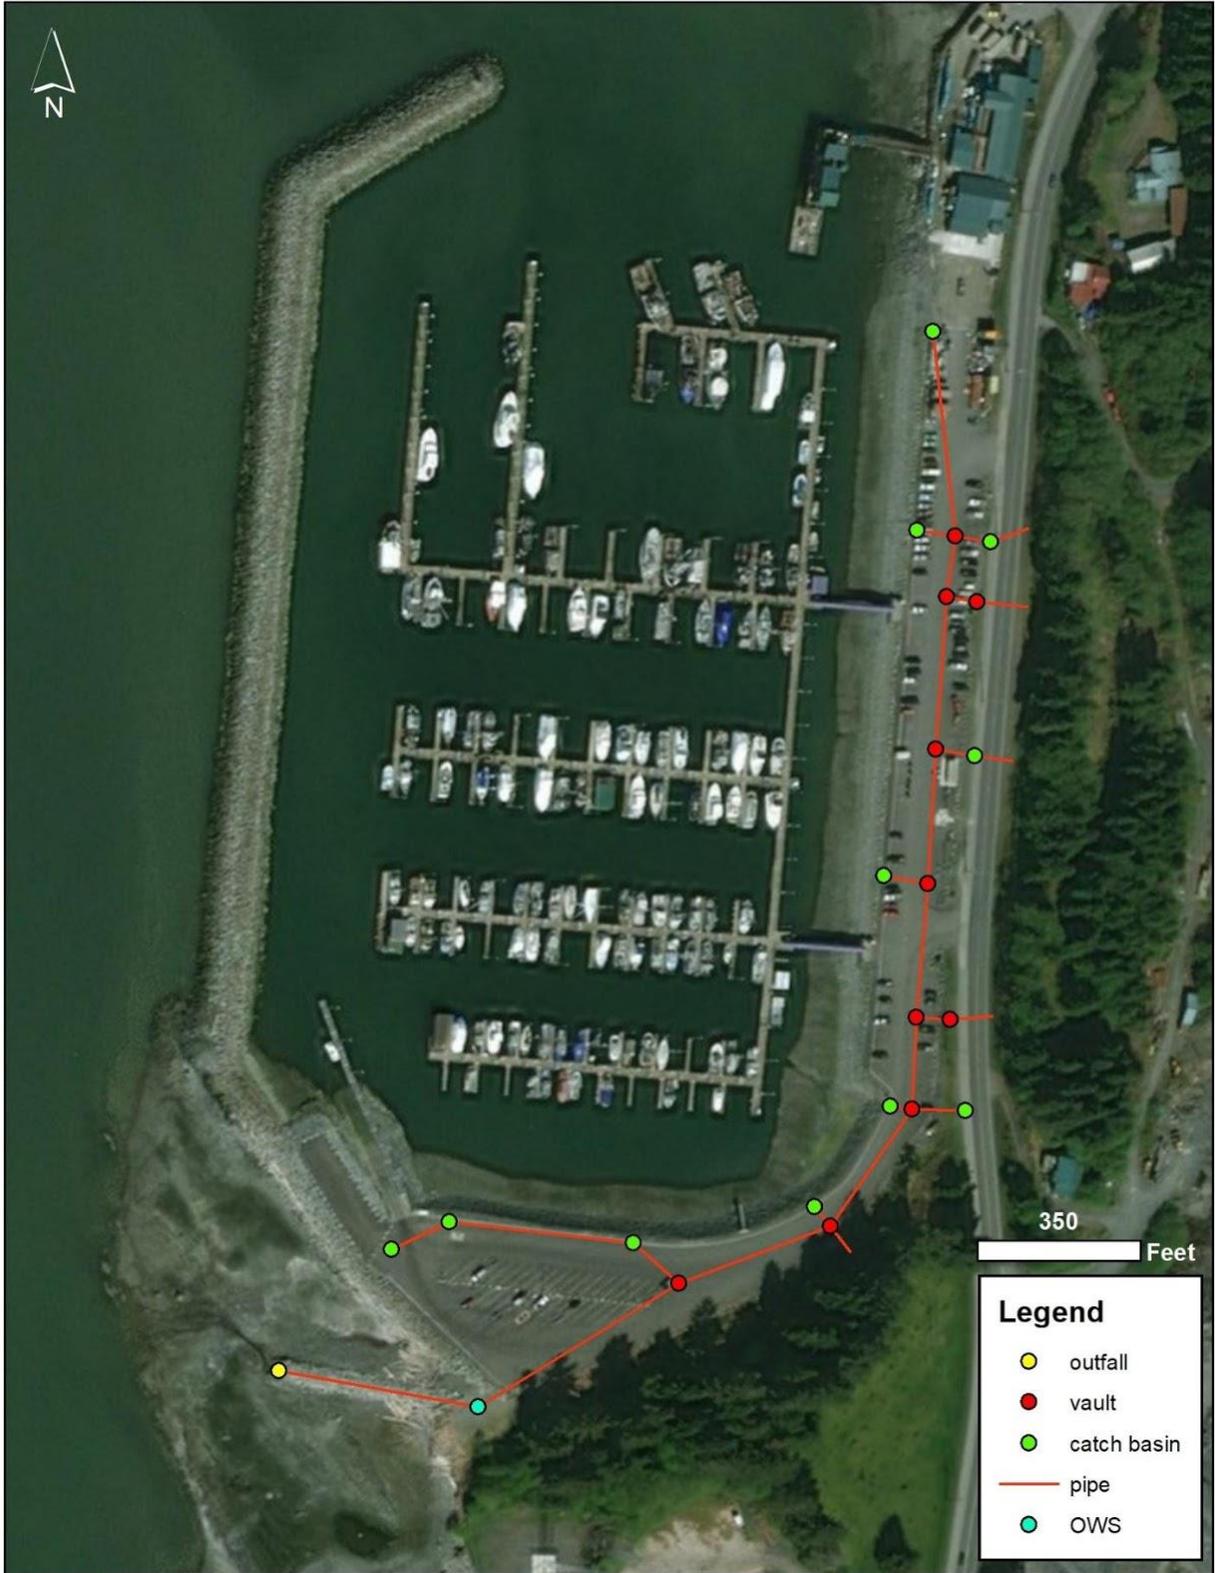
Figure 5. Heritage Harbor stormwater system. OWS stands for Oil-Water Separator.

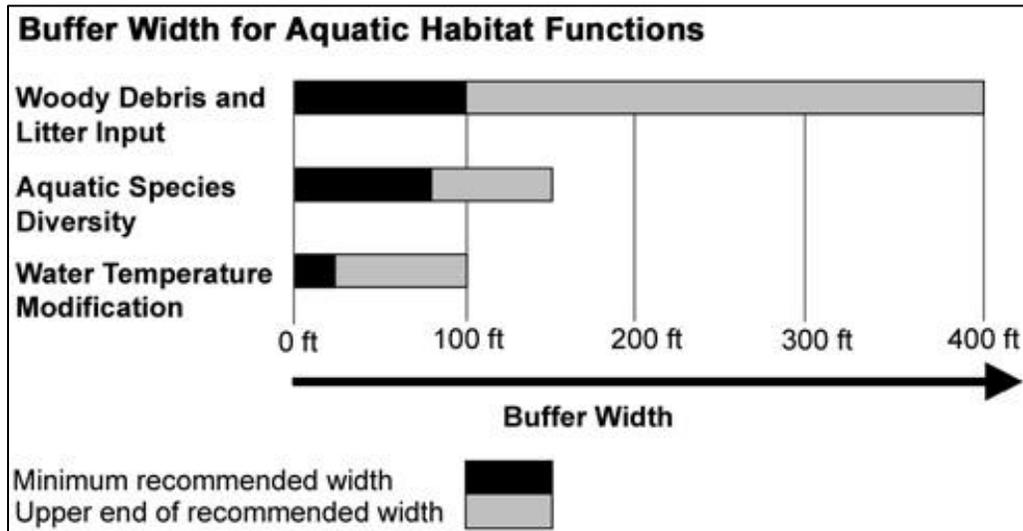
Development that occurs near streams and waterways can cause disruption to streambanks and riparian vegetation. Figure 6 shows examples of different buffer distances recommended for specific riparian functions. Depending on the extent of riparian vegetation removal, many of the ecological benefits that riparian zones provide may be partially or completely lost. For example, Wrangell's Playground Creek has been impacted by development near the stream (Figure 7), and we recommend re-vegetation of the riparian buffer to help intercept stormwater runoff.

Figure 6. [Conservation buffer: design guidelines for buffers, corridors, and greenways](#). From Bentrup, G. 2008, Gen. Tech. Rep. SRS-109. Asheville, NC: USDA Forest Service, Southern Research Station.

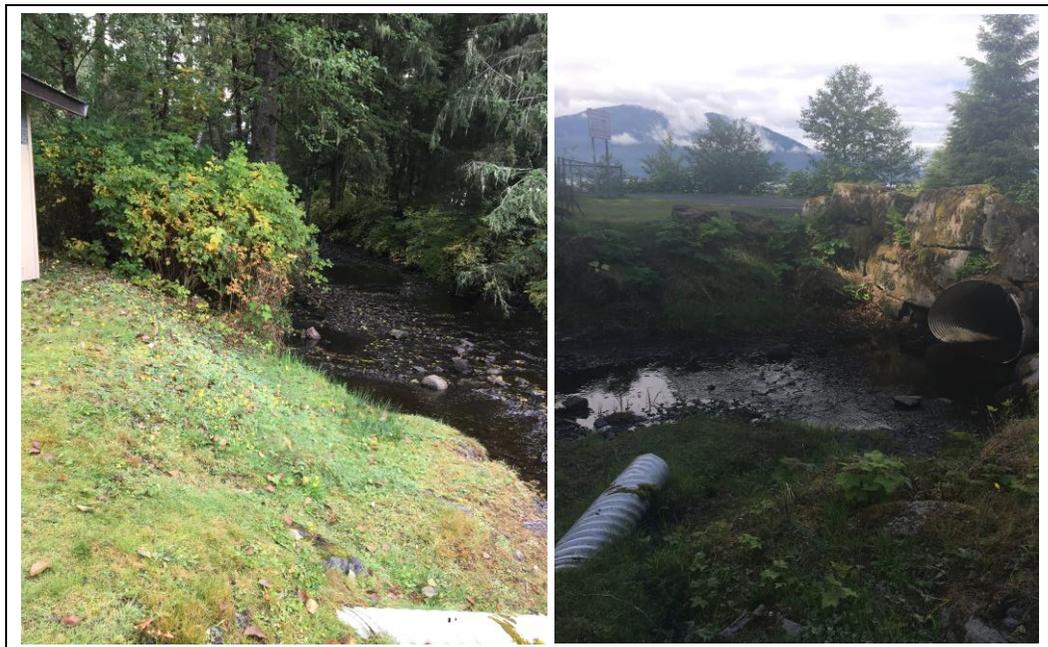
Figure 7. Riparian habitat on Playground Creek has been impacted by development near the stream.

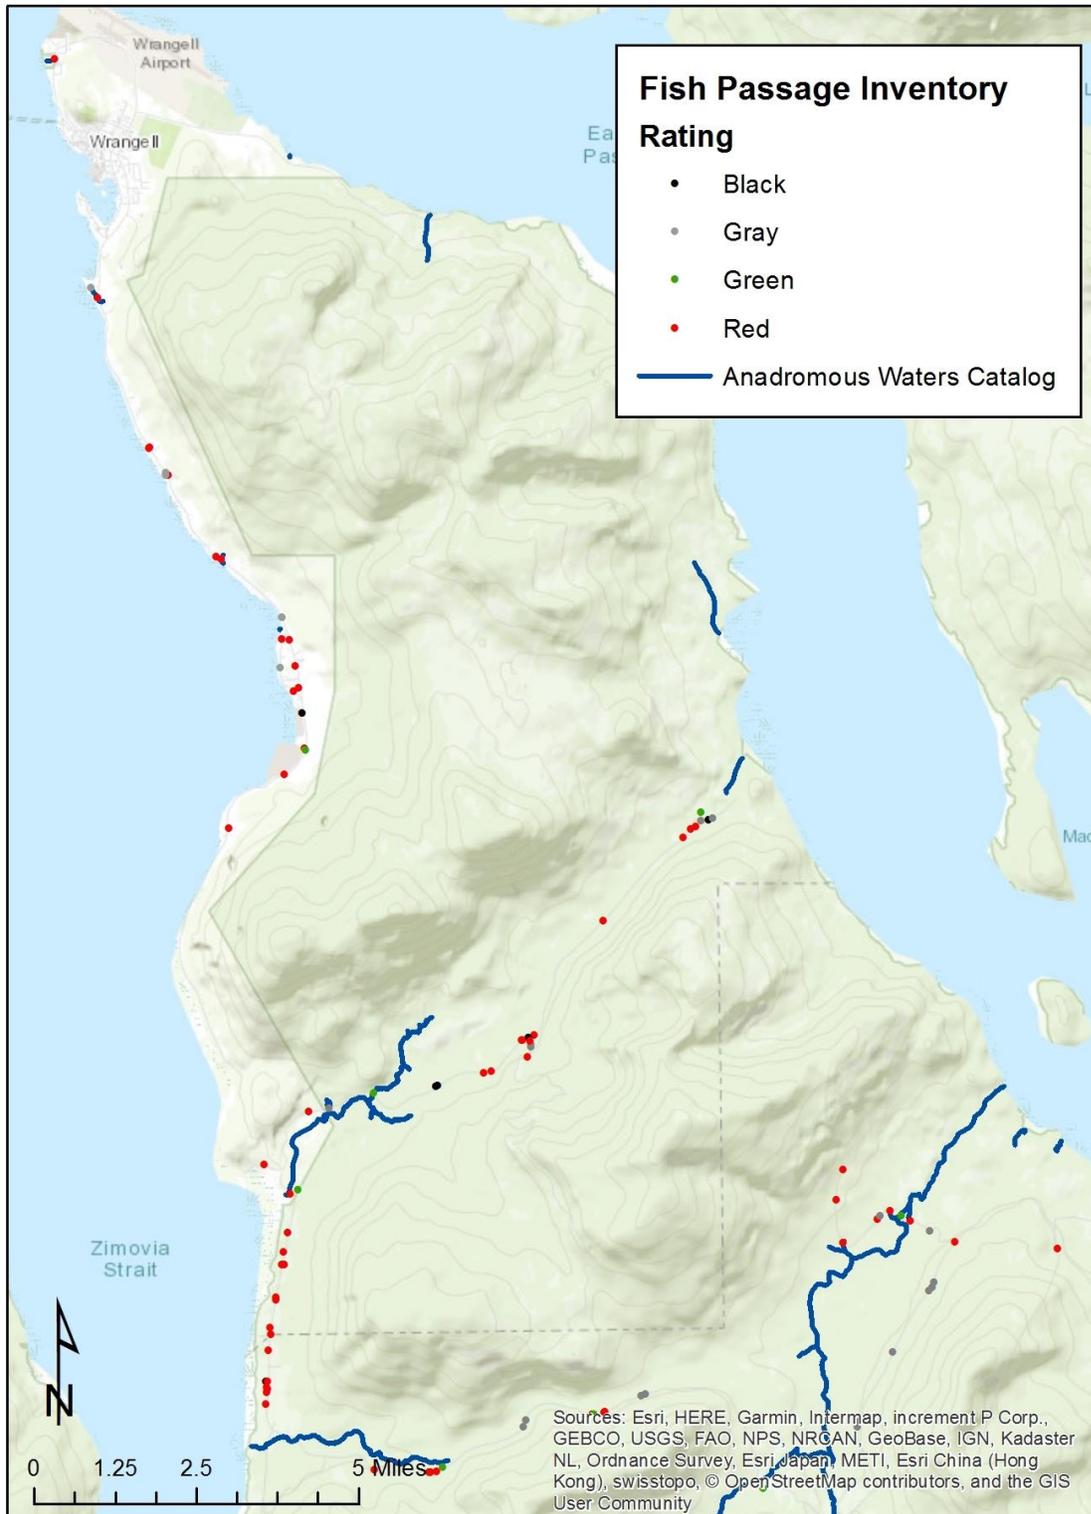
Wrangell's roads have several stream crossings that likely impact fish passage. These 'red pipes' present an opportunity to improve access and connectivity to fish passage through replacement, repair, or modification of impacted culvert and ditch sites. This red pipe distinction warrants additional survey and assessment to determine appropriate solutions to ensure proper fish passage, including these culverts that impact salmon:

Figure 8. Surveyed fish passage structures in the ADFG Fish Passage Inventory (state and city roads) and US Forest Service inventory (US Forest Service roads). Structures are color-coded by rating: Red indicates a fish passage barrier, grey indicates a partial barrier, or a structure at risk of becoming a barrier, green indicates no fish passage problems, and black indicates more data is needed to make a determination.

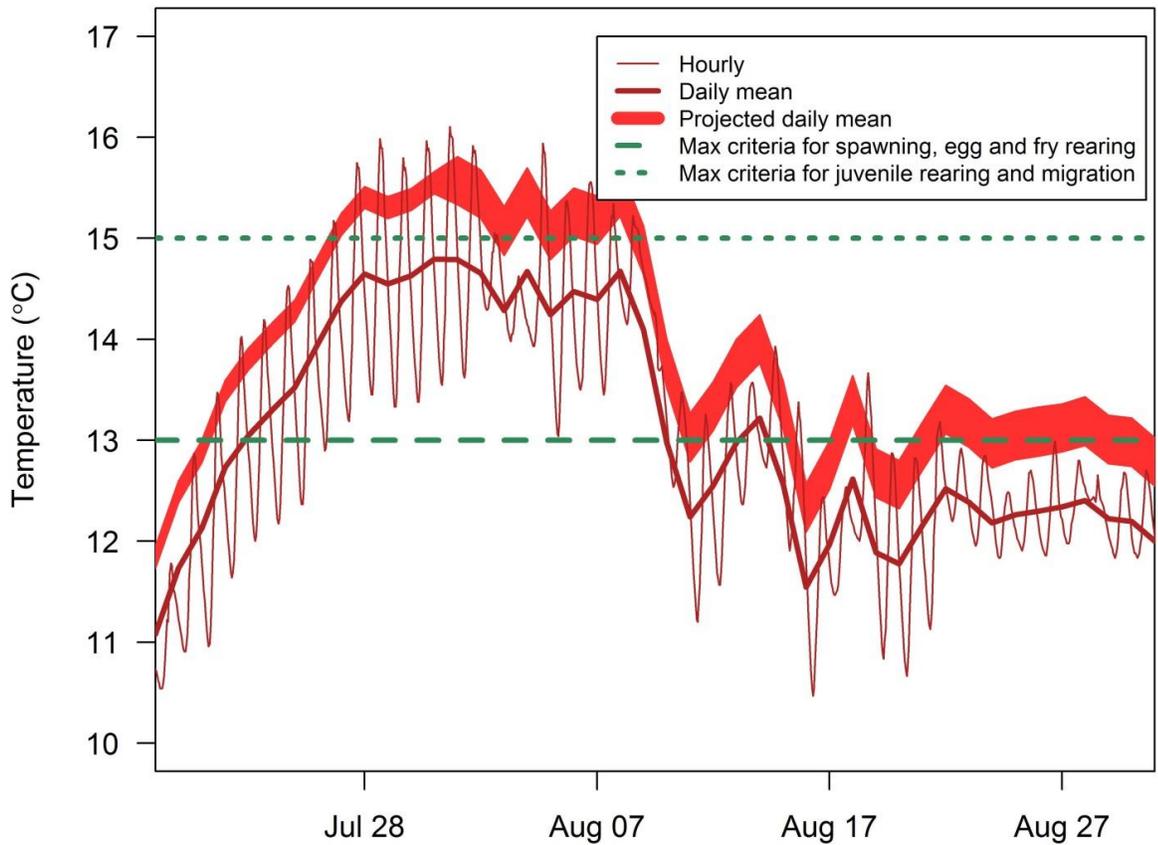
Figure 12: Hourly and mean daily temperatures measured in McCormack Creek, and a range of projected mean daily temperatures based on mid-range and high emissions scenarios. Alaska Department of Environmental Quality water quality criteria for temperature for salmon in various life stages are shown as green dotted lines.

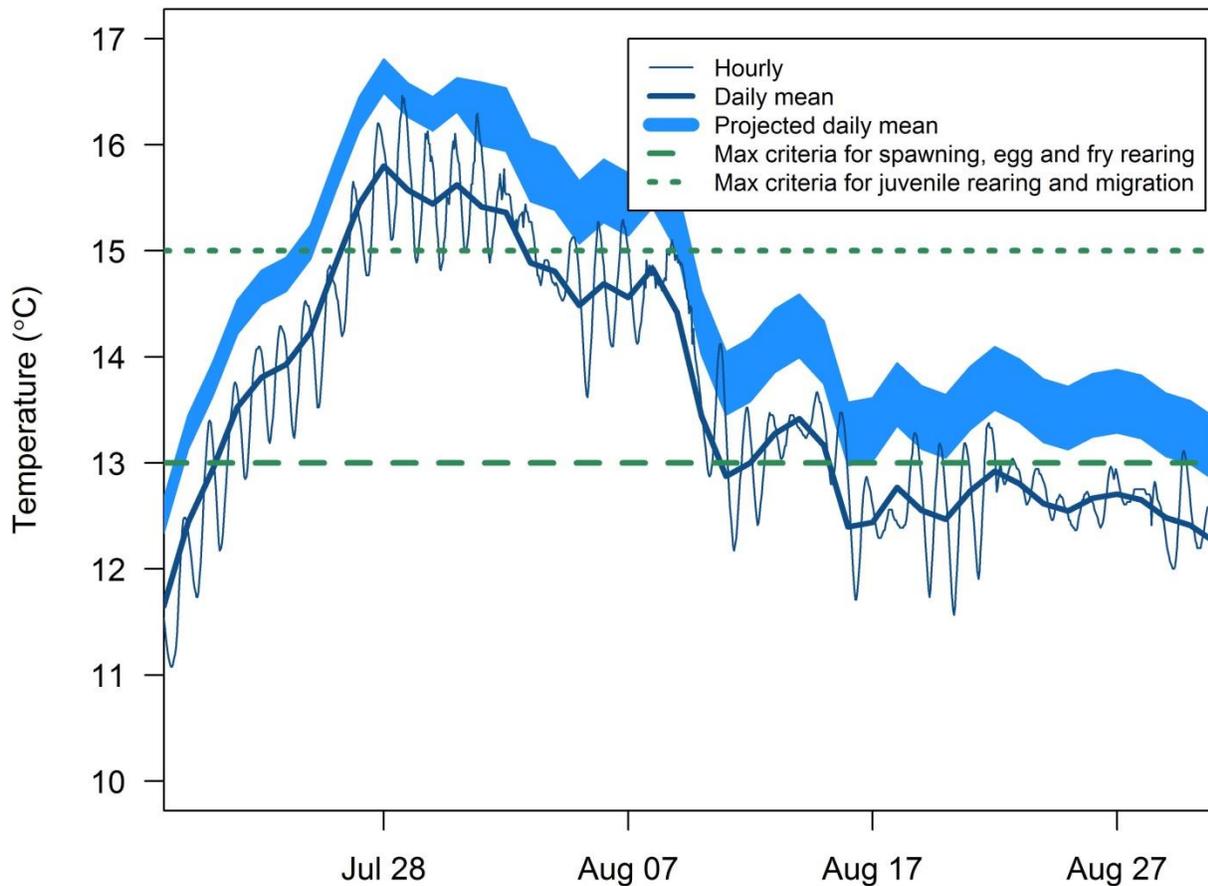
Figure 13. Hourly and mean daily temperatures measured in Pat Creek, and a range of projected mean daily temperatures based on mid-range and high emissions scenarios. Alaska Department of Environmental Quality water quality criteria for temperature for salmon in various life stages are shown as green dotted lines.

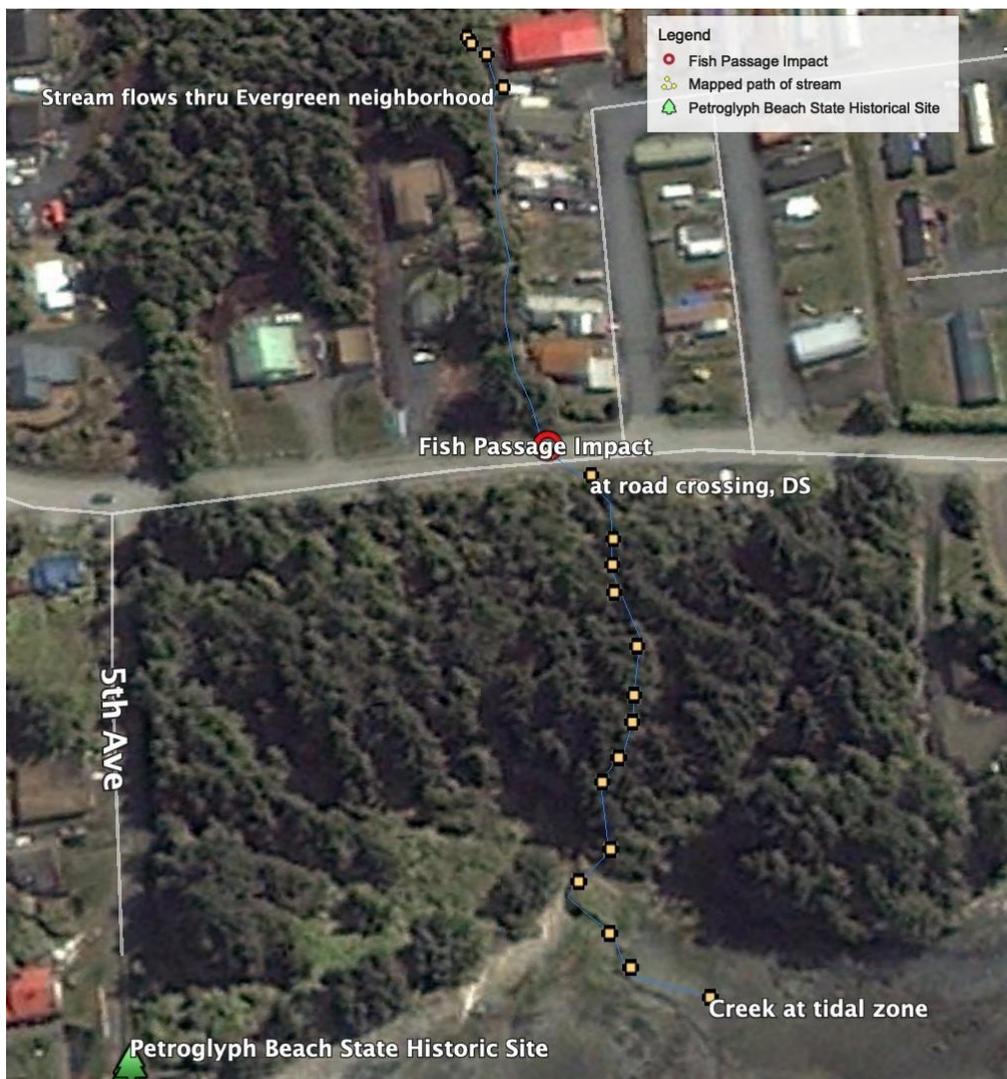
Figure 14. Map of Petroglyph Creek

Petroglyph Creek (previously unnamed) is a small anadromous stream located on the north end of the Wrangell town site and the north tip of Wrangell Island. The stream follows the outer edge of a residential trail court, crosses beneath Evergreen Avenue, and flows through a wooded area before reaching the tidal zone near a park at Petroglyph Beach State Historical Site. SAWC staff conducted a reconnaissance level assessment from the stream outlet to upstream of the residential trailer court (Fig. 14).

Fish passage at the road crossing may be improved through maintenance or replacement of the existing perched culvert. Further survey and design are required for an adequate treatment prescription for this site.

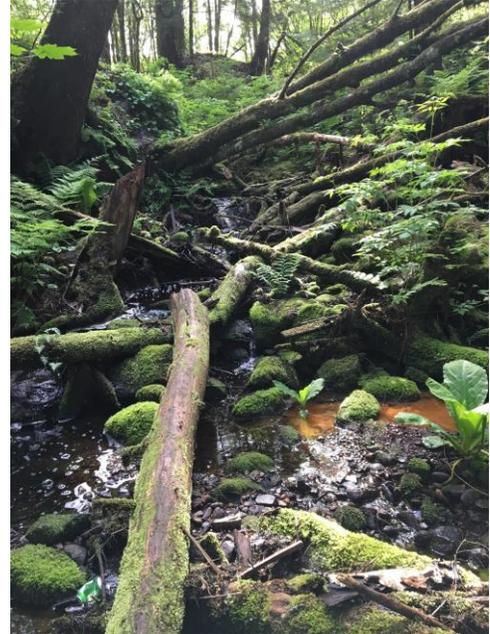
Below the residential area the stream flows beneath Evergreen Ave. through a large culvert. This culvert has been surveyed by the Alaska Department of Fish and Game (ADFG) and entered into the Fish Passage Inventory Database with a red rating, indicating that the culvert likely restricts fish passage. The fish passage survey, completed in 2014, indicates a perched culvert inlet and culvert gradient rating of red.

Figure 15: View of forested reach, looking upstream, below Evergreen Ave.

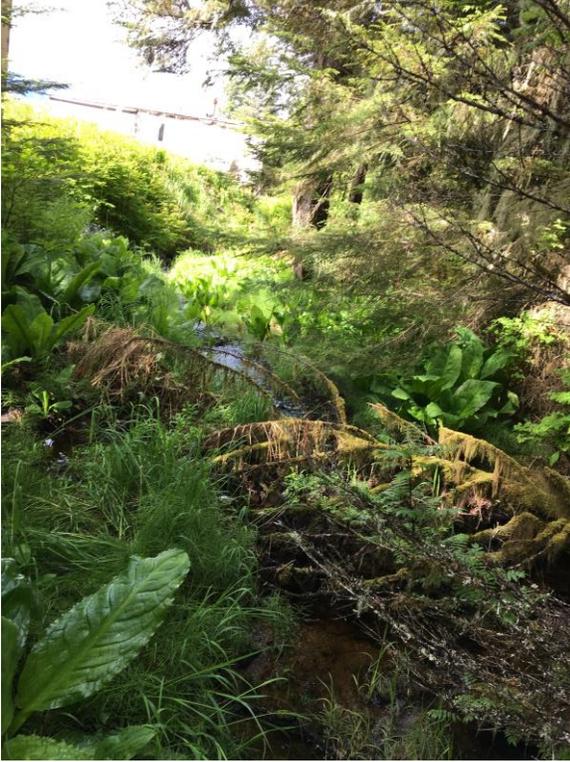
The stream experiences some impacts from its proximity to the residential trailer court. The stream has begun to incise along the reach that borders this residential area, and may experience some inputs of stormwater sediment and pollutants from adjacent parking areas and residential roads. The stream may also receive some stormwater inputs from where it crosses beneath Evergreen Avenue.

Figure 16. The stream flows along the northern border of Evergreen residential trailer court. View looking downstream as left bank becomes steep.

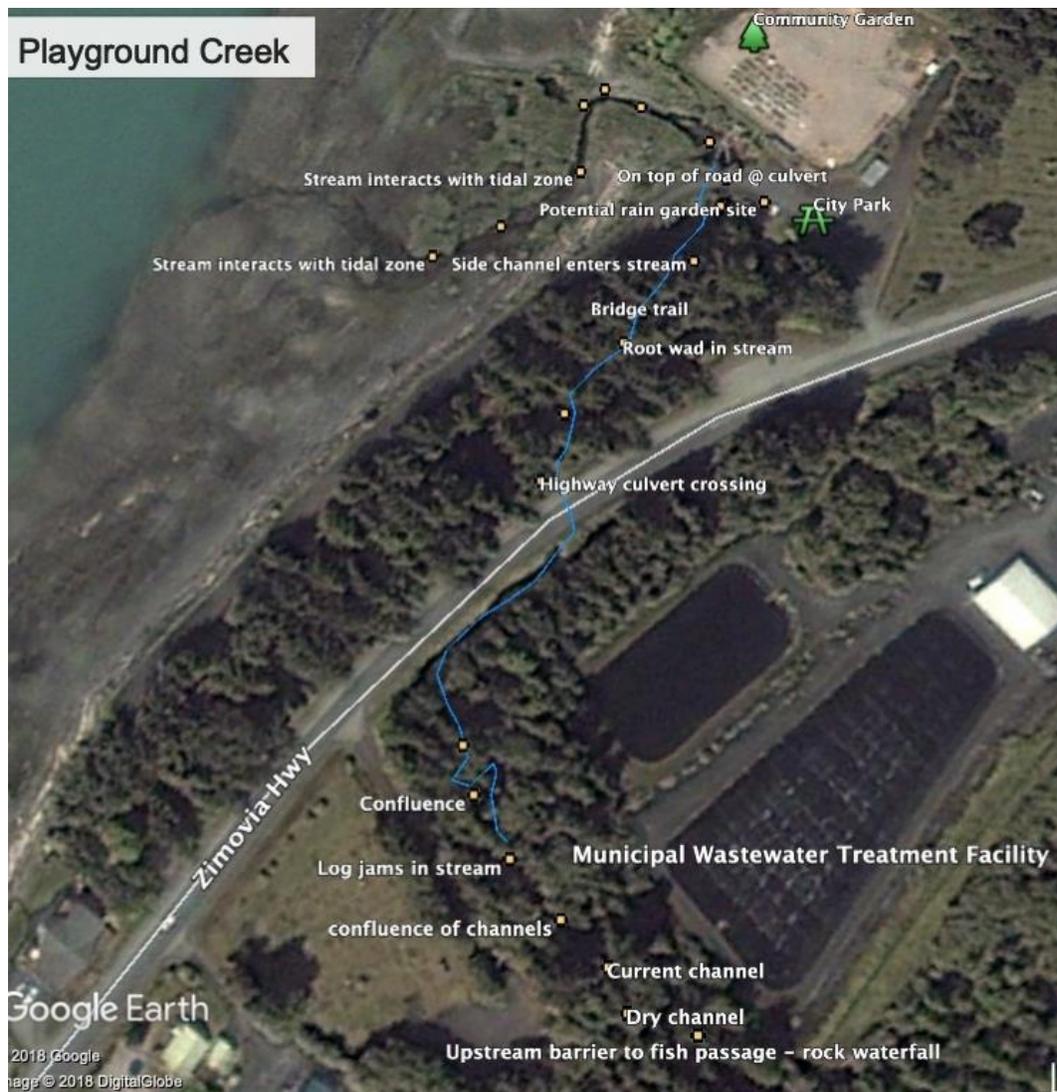
Figure 17. Playground Creek. Blue line indicates Anadromous Waters Catalog layer. Waypoints collected during 2018 SAWC survey.

Playground Creek is a small stream located just south of the Wrangell town site. The stream runs alongside a cemetery, crosses under Zimovia Highway, continues through the widely used local City Park, and crosses beneath the parking area before meandering out over the tidal zone. SAWC staff conducted a reconnaissance level assessment of from the outlet of the stream to the falls above Zimovia Highway in July of 2018 (Fig. 17).

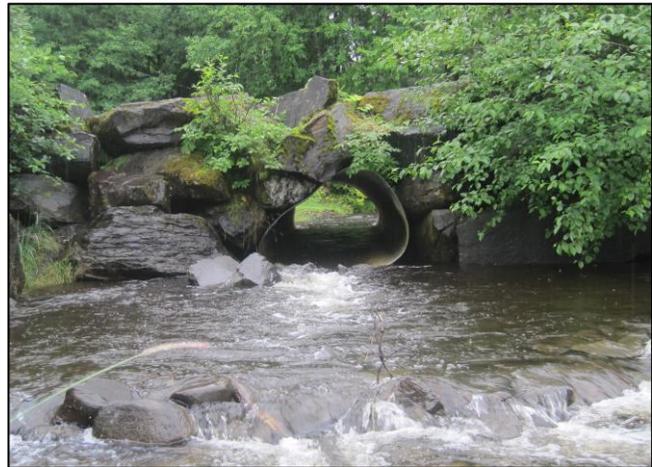
Figure 18. Playground Creek flows through a culvert beneath the entrance to City Park. Culvert outlet pictured.

- Replacement and/or repair of culverts impacting fish passage on Playground Creek may allow for improved habitat condition and improved fish passage.

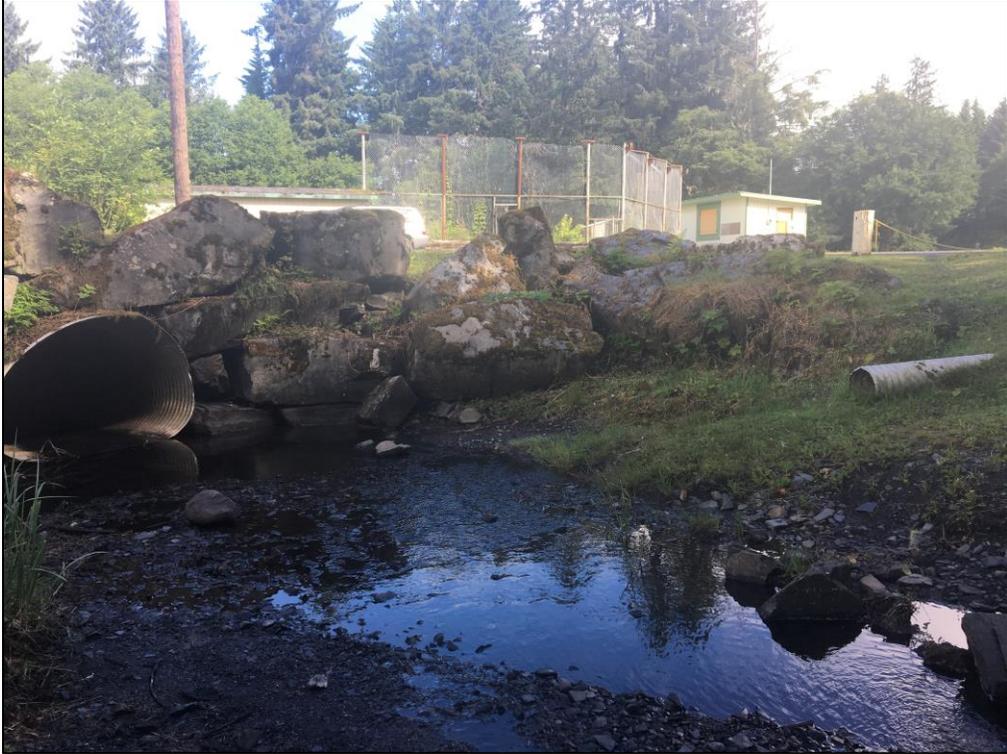
Figure 19. Inlet of the large culvert beneath entrance to City Park. Riparian area has been cleared and mowed. Slope above small drain pipe funnels stormwater directly into stream.

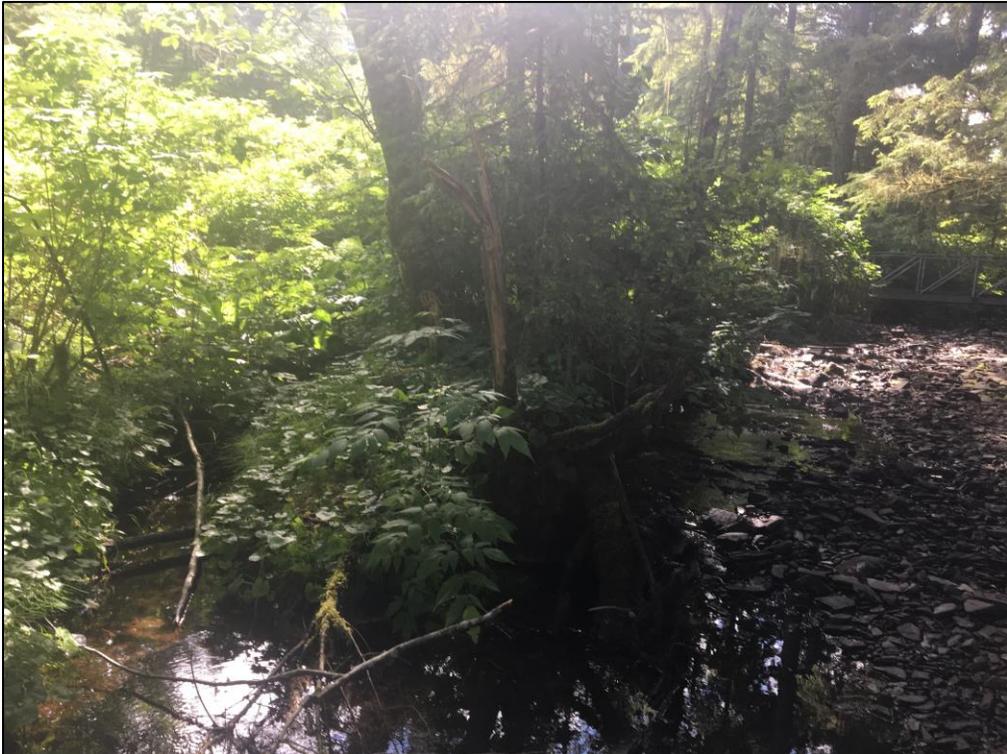
Figure 20. A small tributary enters Playground Creek on the reach that flows through a forested area of City Park. Picture taken at a time of low flow, July 2018.

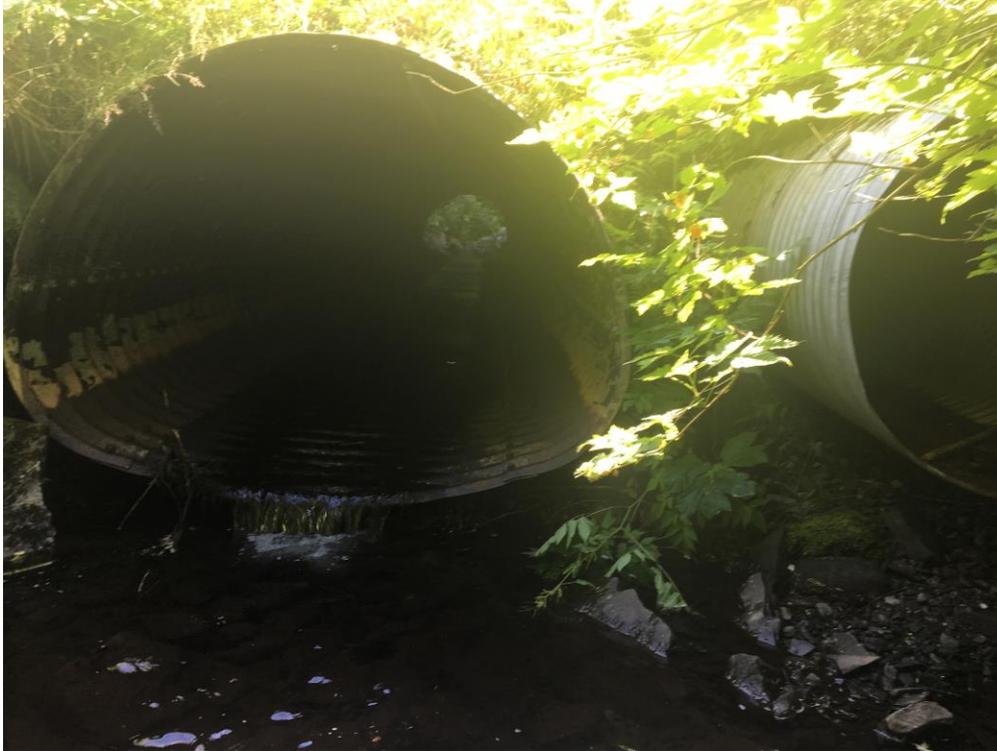
The stream passes under Zimovia Highway via two side-by-side culverts, one of which is activated only at high flows (Fig. 21). These culverts were assessed and inventoried by ADFG as part of the Fish Passage Inventory Database. Both culverts were given a rating of 'red', which indicates that the culverts likely restrict fish passage. Assessment of culvert ID 1 indicates the culvert is poorly aligned, culvert inlet is perched, outfall height and gradient are not adequate, and culvert constriction ratio may limit passage. Assessment of culvert ID 2 indicates similar passage issues.

Figure 21. Culverts 1 (left) & 2 (right) at Zimovia Highway crossing

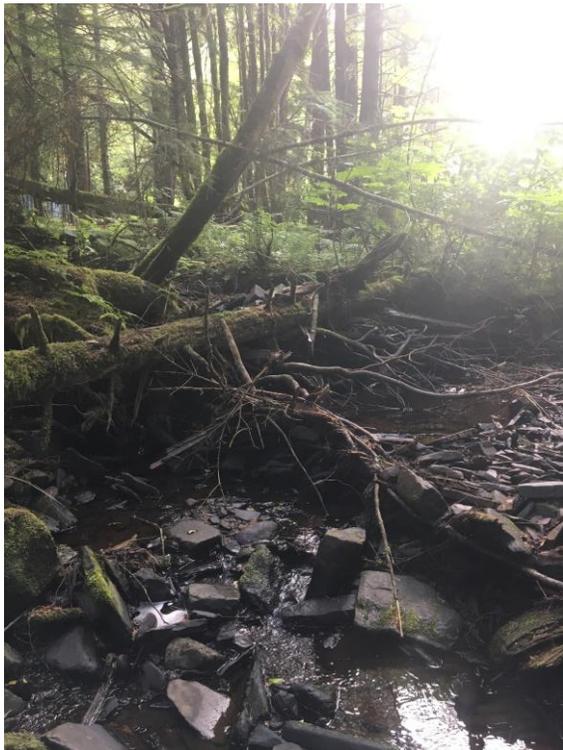
Upstream of the highway the stream follows a roadside ditch before it passes through a forested area at a steep gradient, above which is a naturally occurring rock wall and waterfall that presents a natural barrier to fish passage. A large amount of woody debris is present within the stream and interacts with the stream throughout this reach, and the substrate is composed of large cobbles.

Figure 22. Above Zimovia Hwy. Increased gradient, large cobble substrate, larger alluvial fan floodplain, large wood interacts with stream.

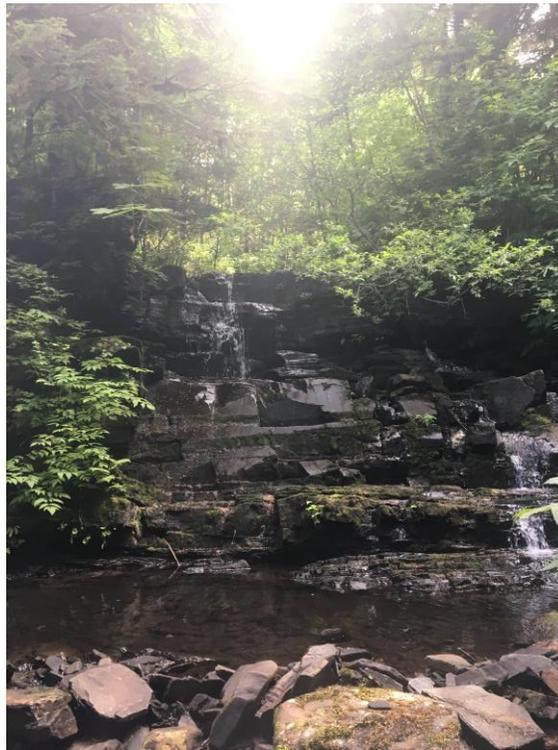
Figure 23. End of survey area. Steep rock waterfall creates a natural barrier to fish passage.

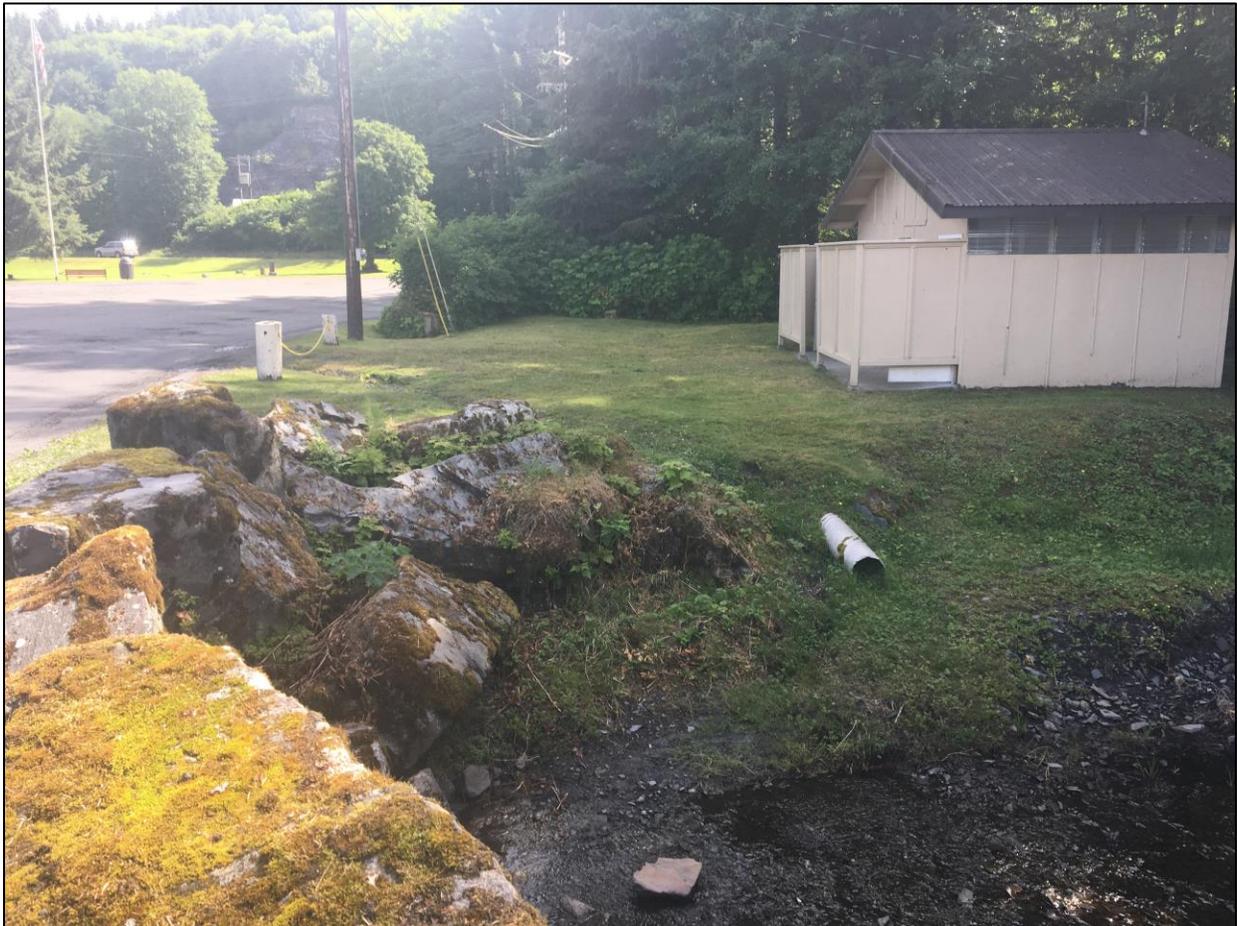
Playground Creek passes through a heavily used section of City Park where the stream experiences some negative impacts from surrounding infrastructure. The topography of the road entrance to City Park allows stormwater runoff from Zimovia Highway to flow along the driveway entrance, picking up sediment and pollutants before depositing directly into the stream, posing a threat to water quality. A bathhouse for the park equipped with flushing toilets is situated near the stream at the point of stormwater entry and the ground surrounding this bathhouse have been cleared and are regularly mowed, stripping vegetation from the stream's riparian area in this section (Figs. 19, 24-25). Stormwater and sediment deposition also pose a threat to water quality where the stream crosses beneath Zimovia Highway.

Figure 24. Entrance to City Park from Zimovia Highway. Bathhouse is located near Playground Creek riparian area. Stormwater runs from highway, through park entrance, across lawn pictured, and into stream.

- Re-vegetation of riparian areas that have been degraded. Streambanks near the park's bathhouse facility, and near the proposed site of a Green Infrastructure BMP, could be easily planted with native vegetation (Figs. 24-25) such as willow, alder, or salmonberry to provide streambank stabilization, shade, and habitat complexity along this reach of stream.

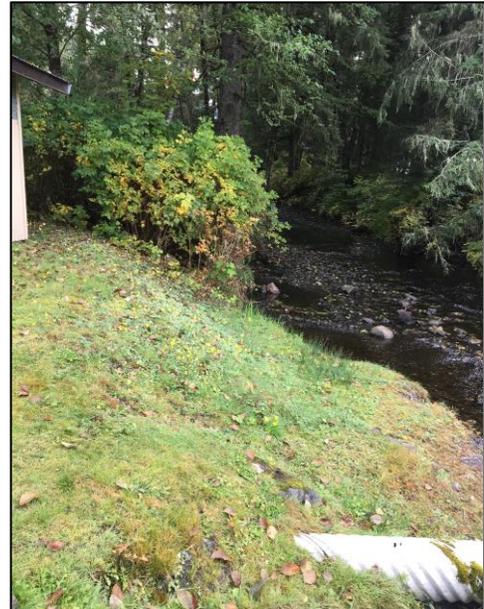
Figure 25. Riparian area near City Park bath house
