Wrangell Area Watersheds Assessment

February 2019

Southeast Alaska Watershed Coalition

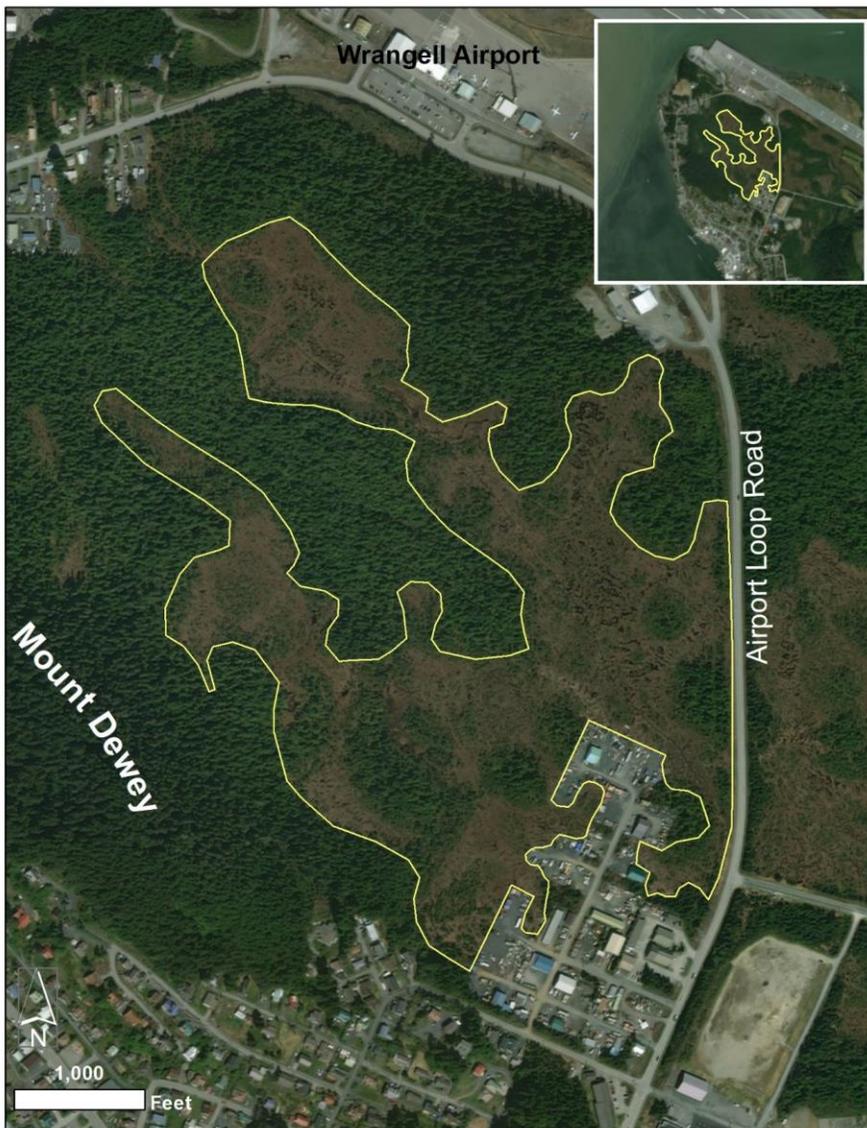
Figure 26: Dewey Bog Assessment Area

John Hudson and Angie Flickinger of the Southeast Alaska Watershed Coalition conducted a function and value assessment (Wetland Ecosystem Services Protocol for Southeast Alaska, WESTPAK-SE) of Dewey Bog in Wrangell, Alaska on October 8, 2018. Dewey Bog (so-named for this assessment) is located on the north end of Wrangell Island in southeastern Alaska. The wetland is part of a larger wetland complex bisected by Airport Loop Road. The assessment area (AA) consisted of a 76-acre forested peatland located on the west side of Airport Loop Road (Fig. 26). This wetland is bordered by the Wrangell Airport to the north, Mount Dewey to the west, and the Wrangell town site to the south. The wetland is owned by the City of Wrangell.

The AA is relatively flat in its eastern half and gently sloping to the west in its western half. Stands of cedar and hemlock border the AA, which consists of peatland containing widely scattered shore pine. There are several ponds of varying sizes in the AA; some of the ponds are connected by flowing surface water.

The Dewey Bog AA had an overall rating of 'lower', largely because it does not directly contribute to fish habitat. It had "moderate" functional ratings for habitat for songbirds, raptors, mammals, pollinators, amphibians, and aquatic invertebrates, and "moderate" and "high" value ratings associated with public use and subsistence and provisioning services, respectively. The WESPAK-se methodology results can be found [here](#).

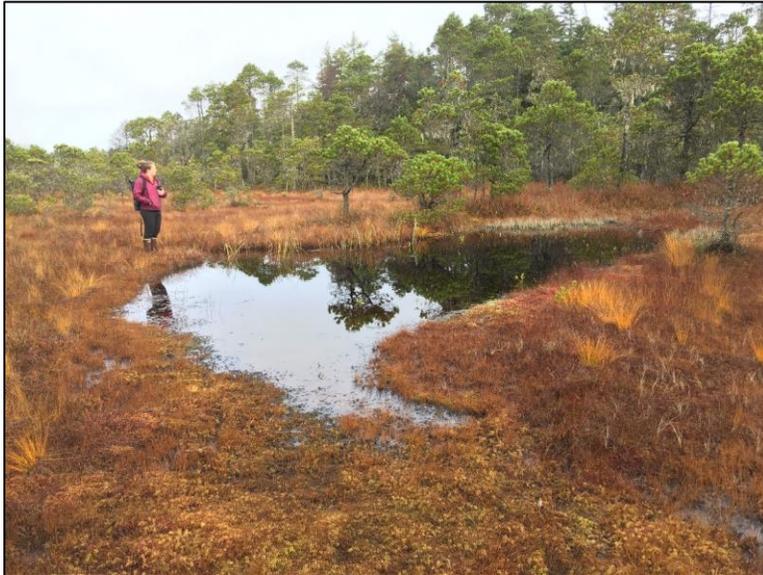
Figure 27. Pond in northwestern quadrant of the AA. View looking west.

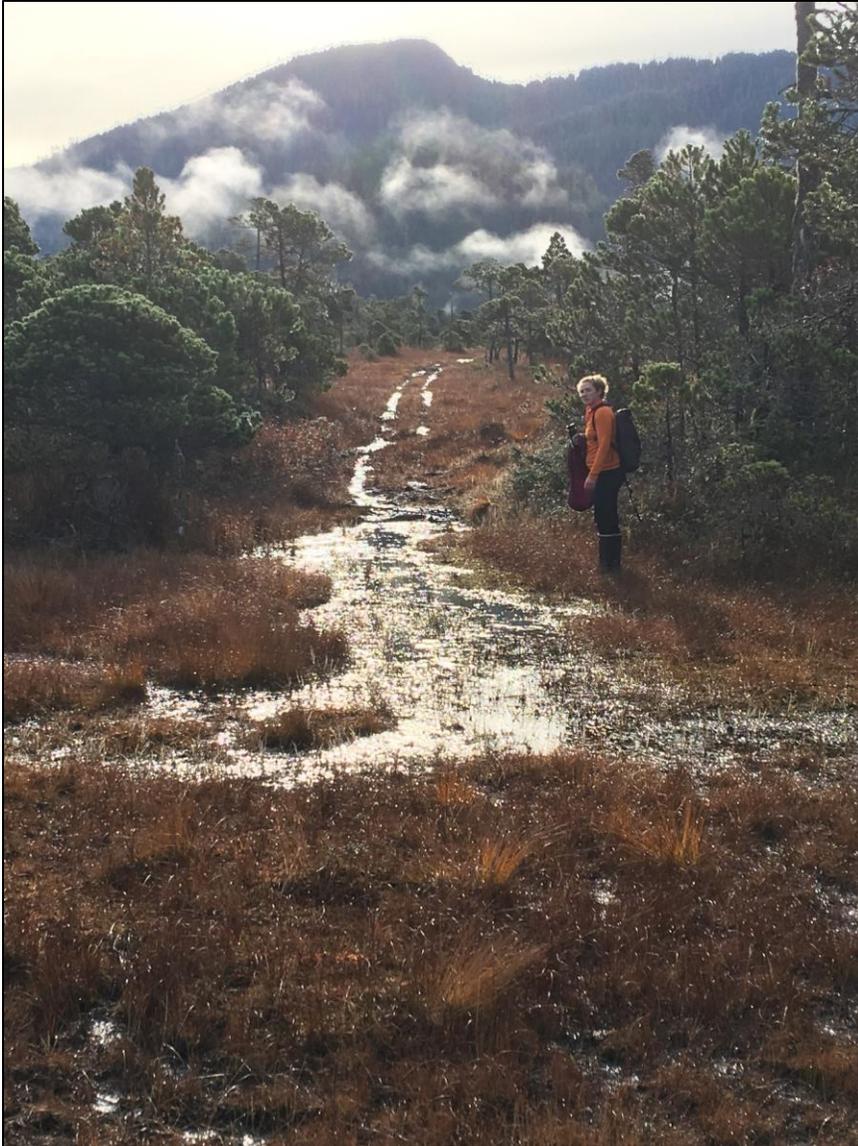
Several off-road vehicle trails traversing the AA have damaged plants and soil (Figs. 28-29), which has altered local hydrology by converting groundwater into surface flows of water.

Figure 28. Off-road vehicle trail in northern half of AA. View looking southeast.

Restricting access of off-road vehicles to sensitive wetlands habitat would prevent additional impacts and allow trails to re-vegetate.

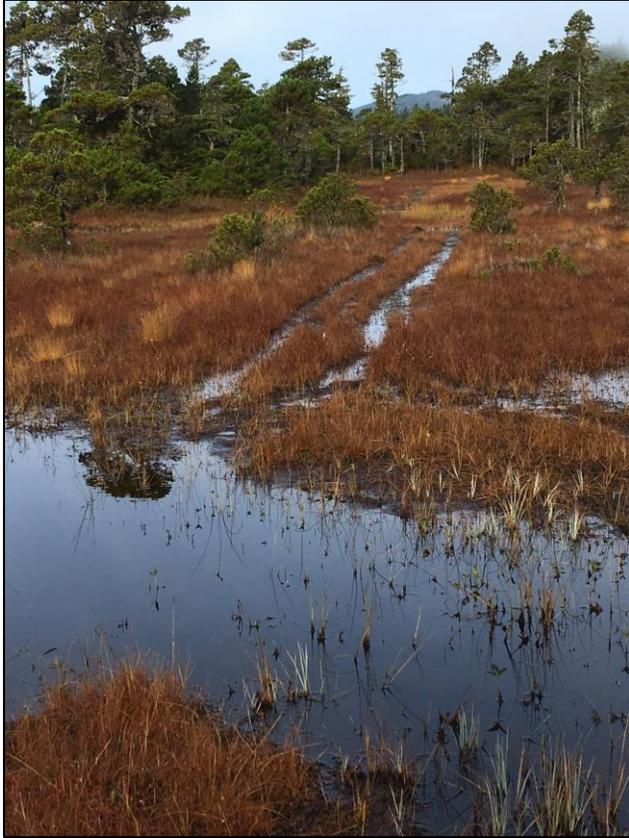
Figure 29. Pond and off-road vehicle trail in northern half of the AA. View looking northwest.

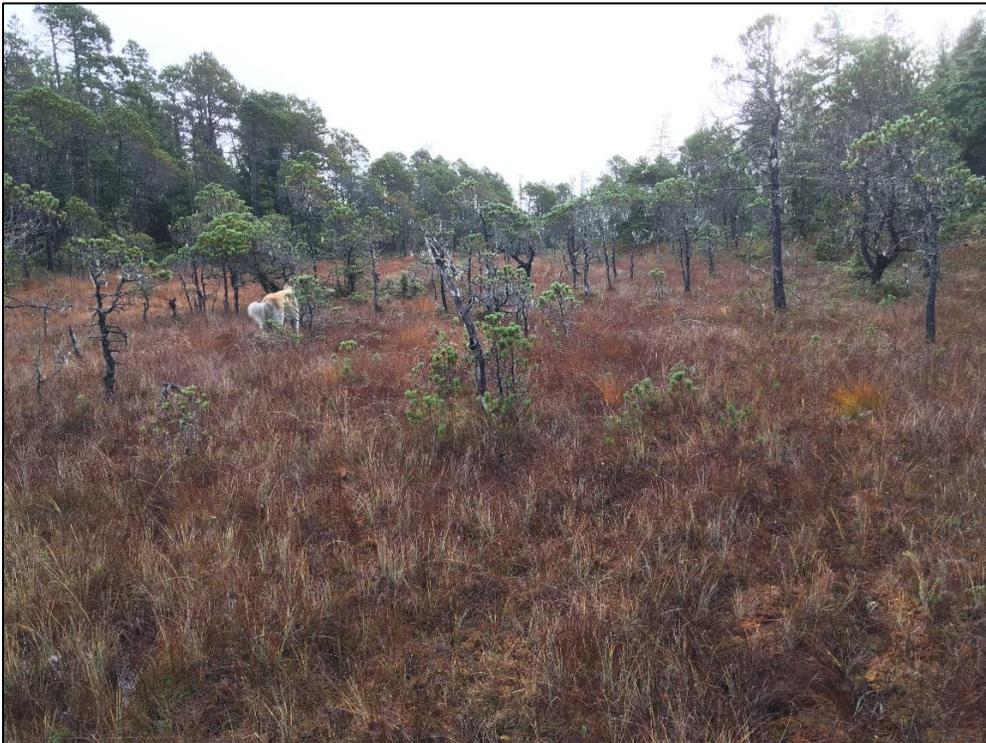
Figure 30. Northwestern quadrant of the AA. View looking east.

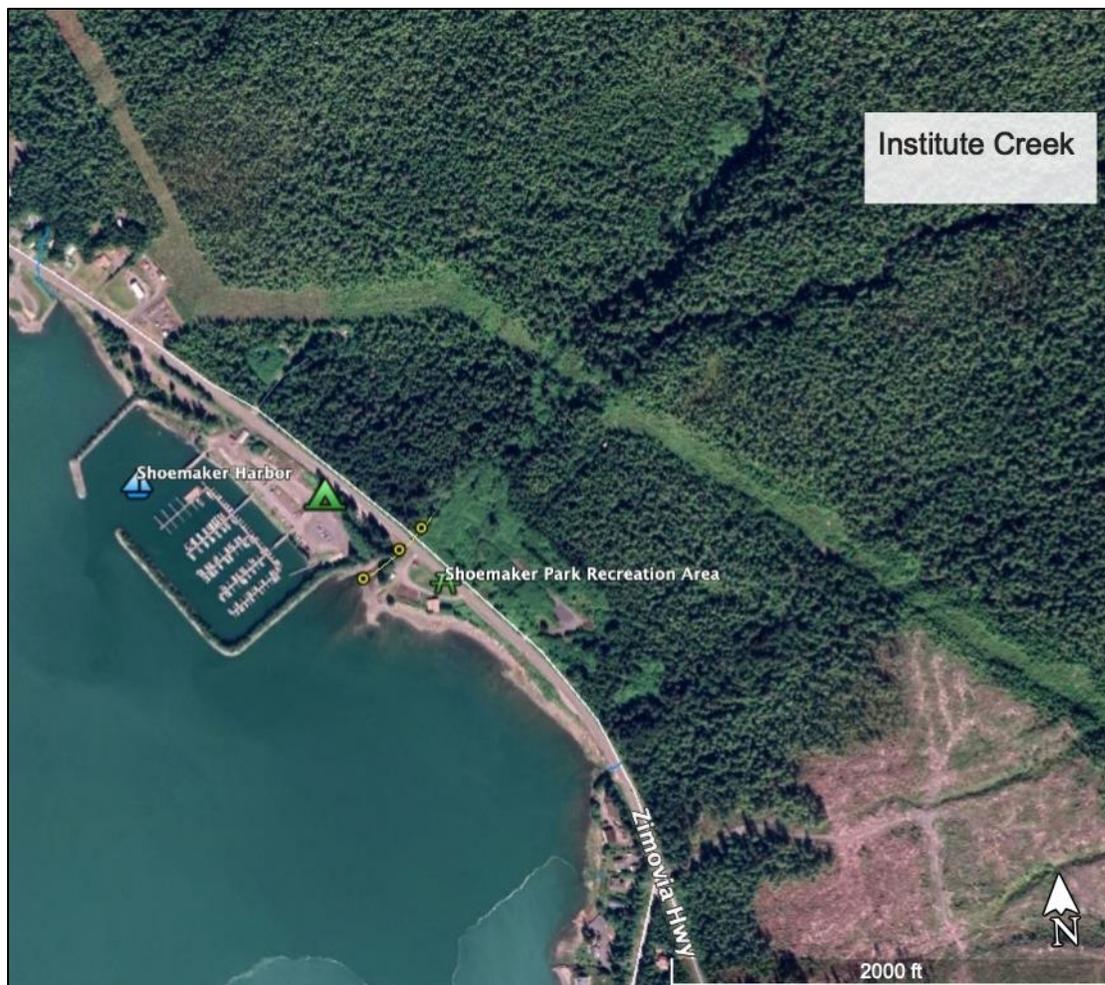
Figure 31. Map of surveyed area of Institute Creek.

Institute Creek is a steep, fast moving stream that flows off of a mountain about 5 miles from the Wrangell town site, crosses beneath Zimovia Highway, and meets the tidal zone between the Shoemaker boat harbor and Shoemaker Park recreation area. Where the stream flows through US Forest Service land, a recreational boardwalk trail crosses the stream several times. SAWC staff conducted a reconnaissance level assessment of accessible reaches of Institute Creek (Fig. 31).

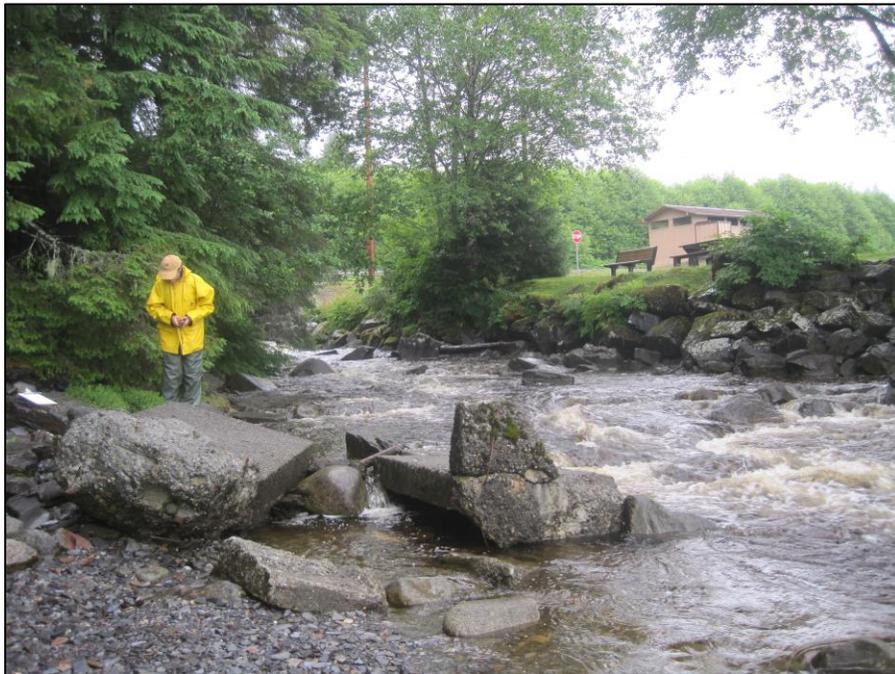
Institute Creek is a steep gradient, fast flowing stream. Substrate is dominated by large cobbles and boulders (Fig. 32). The reach of stream that flows beneath Zimovia Highway and through Shoemaker Park features little riparian habitat, with large riprap fill and minimal vegetation. Above the highway the riparian area is densely forested with willow, alder, and conifer species (Fig. 33).

Figure 32. Rebecca Bellmore takes a waypoint on the lower reach of Institute Creek. Shoemaker Park bathhouse is pictured in the background.

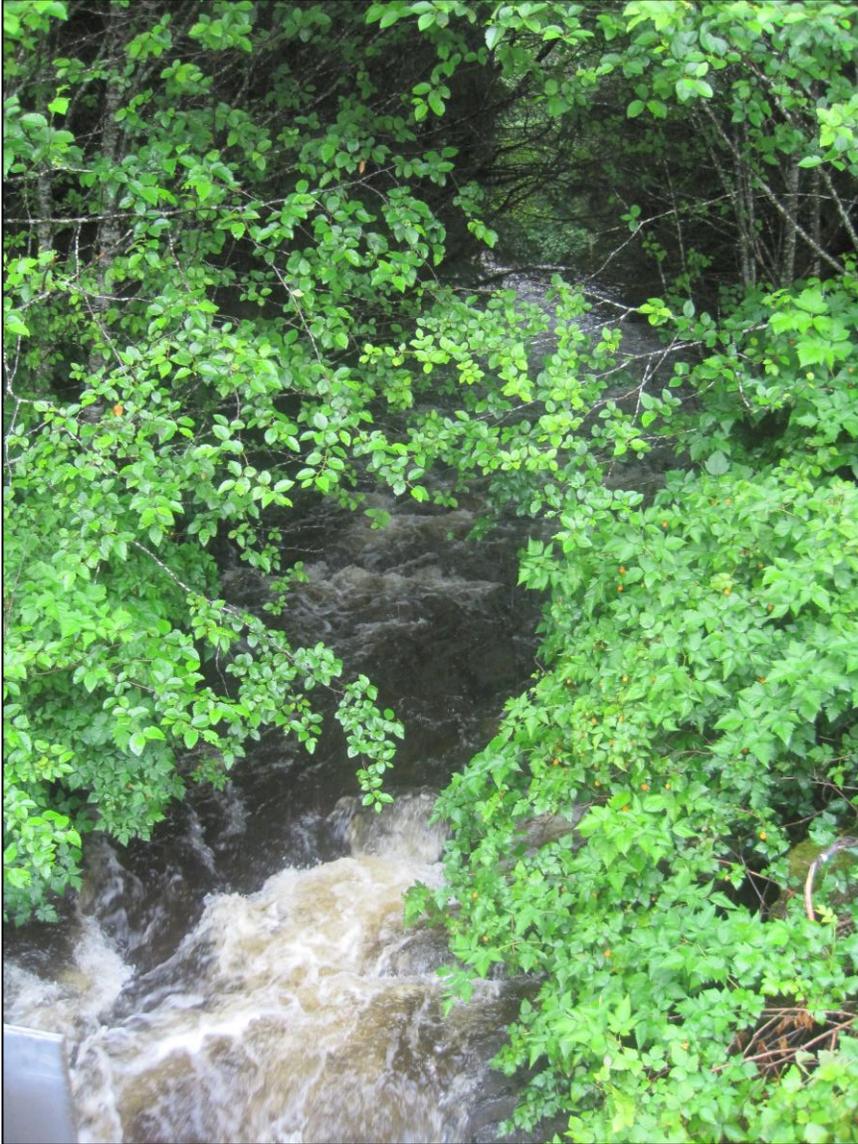
Figure 33. Institute Creek above Zimovia Highway.

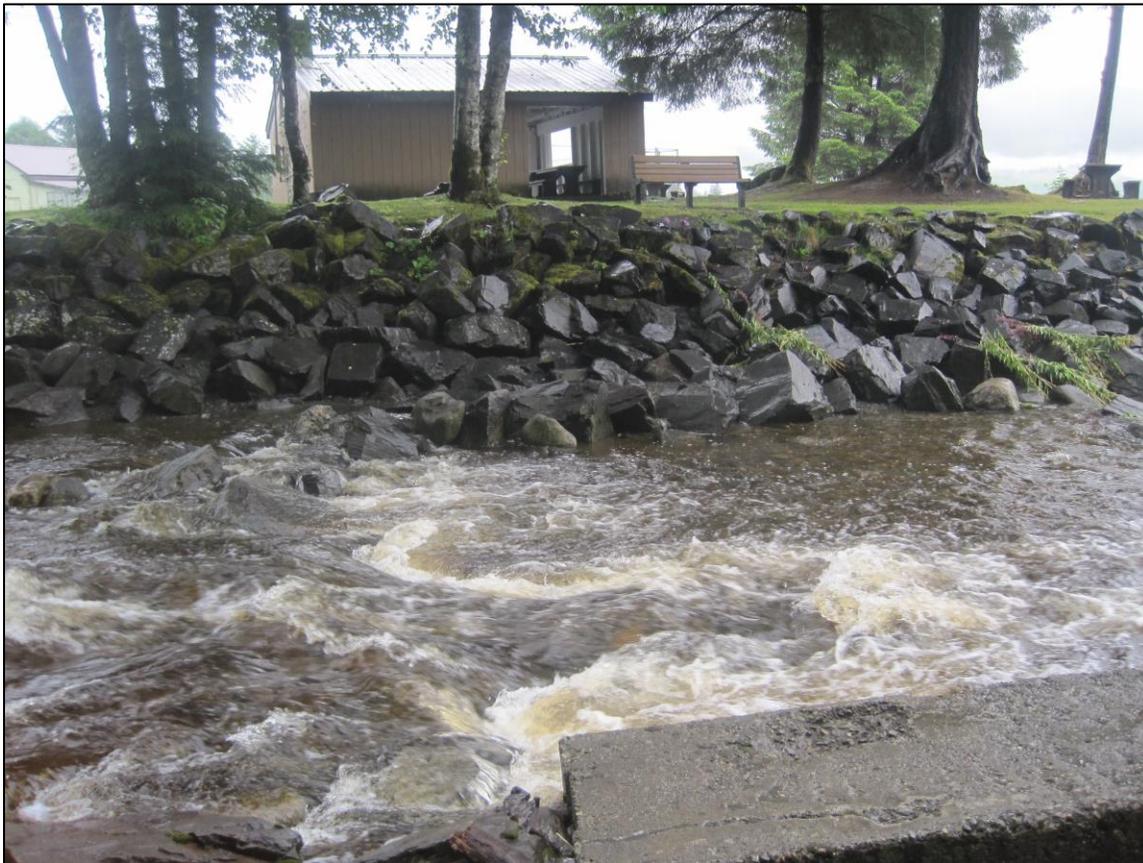
Figure 34. Riprap streambank as the stream crosses between Shoemaker Harbor and Shoemaker Park

Bare riprap in the lower reach's riparian area could be planted with native species such as willow or salmonberry to create aquatic insect habitat and provide a buffer for stormwater management (Fig. 34).

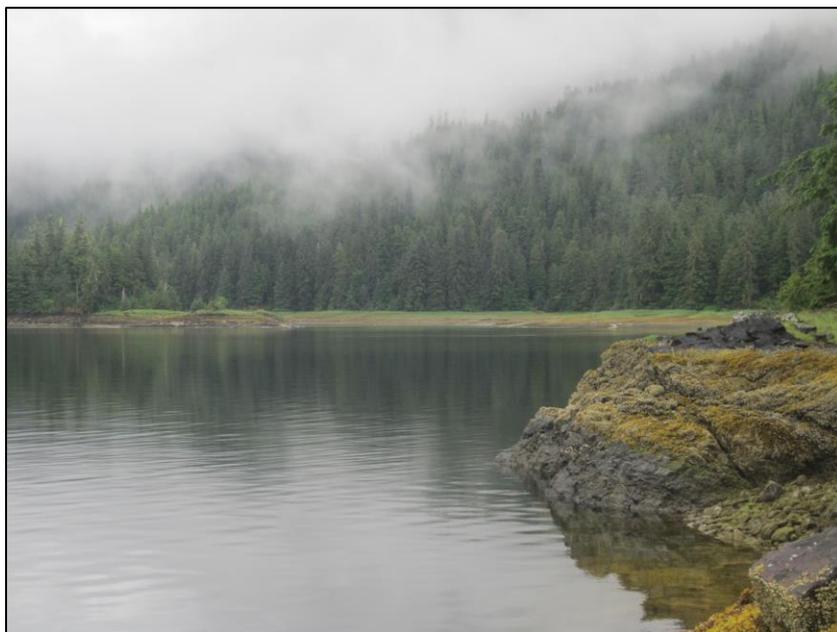
Figure 35: Earl West Cove

The City and Borough of Wrangell recently acquired a parcel of land at Earl West Cove on the east side of Wrangell Island (Fig. 35). The Southeast Alaska Watershed Coalition conducted a reconnaissance level assessment of this area and previously mapped streams (Fig. 36).

The shoreline along the city's newly acquired parcel by Earl West Cove is in fairly undisturbed condition, except for the log transfer facility at the end of the road. The biological community along the beach and intertidal area includes dunegrass, barnacles, rockweed, green and red algae, blue mussels, and soft brown kelp. Earl West Cove itself is a physically protected estuary with tidal flats that may be used as rearing area by Coho from Earl West Creek and five other nearby anadromous streams, which have all been documented as having rearing Coho.

Any future developments in this area should consider proximity to streams, especially those mapped within the anadromous waters catalog known to provide habitat for salmon species. Implementation of a stream buffer or setback requirement would help to protect salmon spawning, rearing, and overwintering habitat in streams near Earl West Cove.

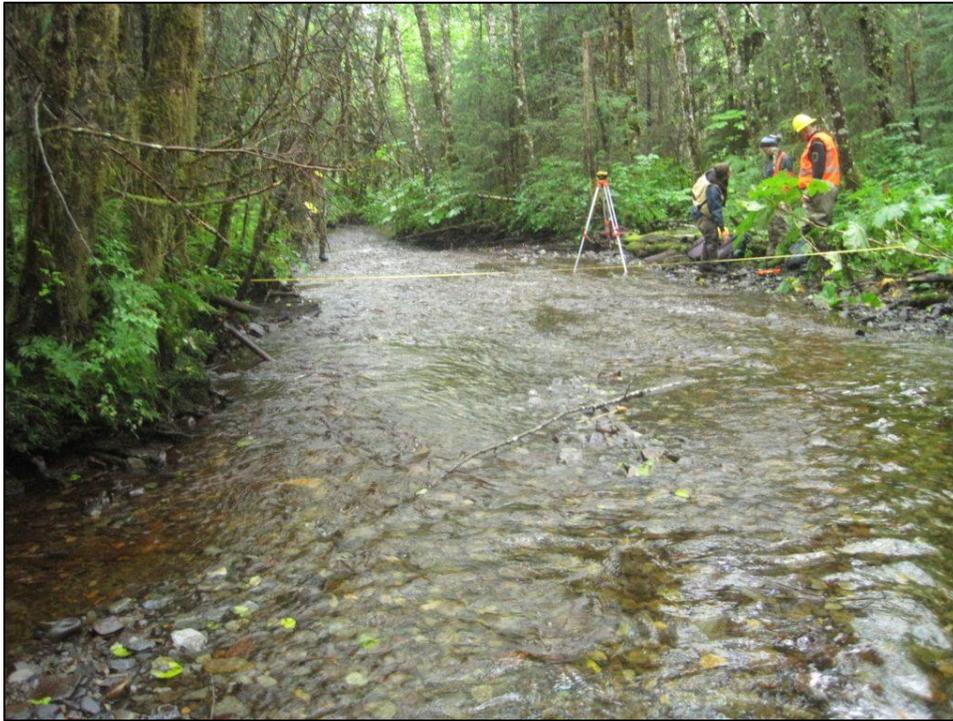
Figure 38. SAWC & USFS crew assess fish habitat condition on Pat Creek.

Tier II stream habitat surveys conducted on the lower West and East Forks of Pat Creek indicated that the size and frequency of woody debris (an important component of high quality fish habitat) was lower in harvested reaches surveyed than in unharvested streams of similar channel type and size. The surveys also indicated a potential restriction on floodplain connectivity within the watershed, possibly due to relic logging roads within the floodplain. A comprehensive report from this watershed assessment is available for review at:

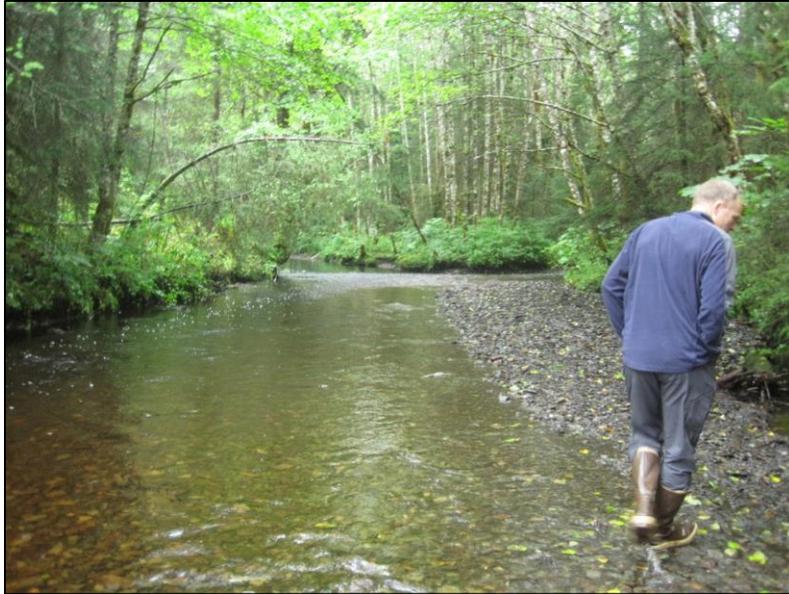
As a result of these reconnaissance-level survey indications, with support from the US Fish and Wildlife Service, SAWC contracted the services of Inter-Fluve, a firm specializing in investigations, design, and restoration of rivers, lakes and wetlands, to complete a more comprehensive site assessment and develop a conceptual design to restore fish habitat on impacted reaches of the East & West forks of Pat Creek watershed. In the spring of 2018, Inter-Fluve completed [final site surveys for design](#) of an in-stream habitat restoration project on Pat Creek. A full technical memorandum outlining project concepts developed by SAWC and Inter-Fluve in detail is available [here](#).

Figure 39: SAWC staff survey riparian areas on the main stem of Pat Creek

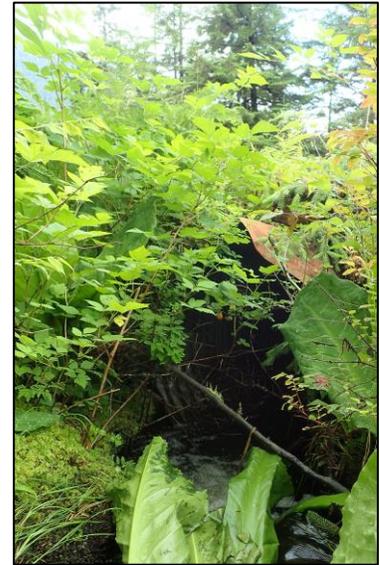
Figure 45. Tributary B of Hermit Creek. Culvert outlet.

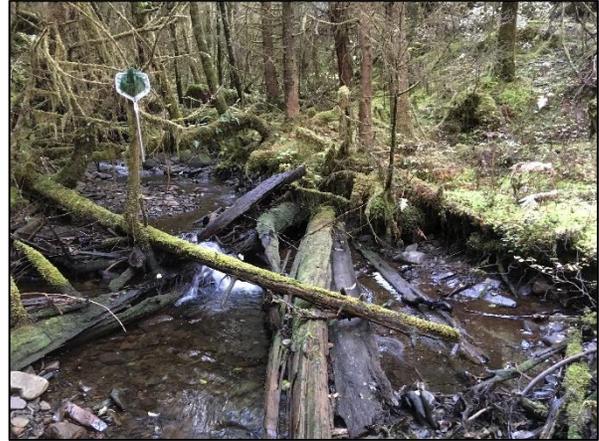
Figure 48. Tributary A of McCormack Creek in the new-growth reach. Net width is 9.5 inches.

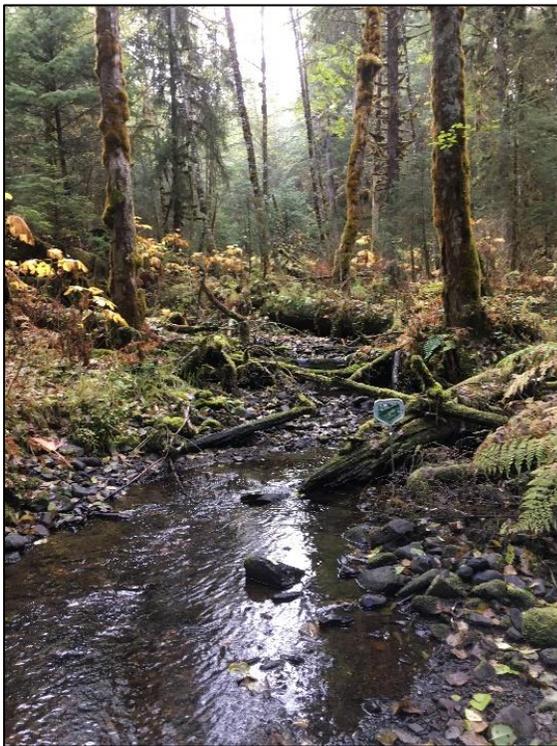
McCormack Creek is an anadromous stream on the west side of Wrangell Island that flows into Zimovia Strait (Fig. 47). A potential restoration reach in a tributary (Trib A) on the north side of the main stem was visited on October 10, 2018. About 2,500 feet of channel, including an upstream new-growth reach (Fig. 48) and a downstream old-growth reach (Fig. 49), was evaluated and mapped.

Figure 49. Tributary A of McCormack Creek in the old-growth reach. Net width is 9.5 inches.

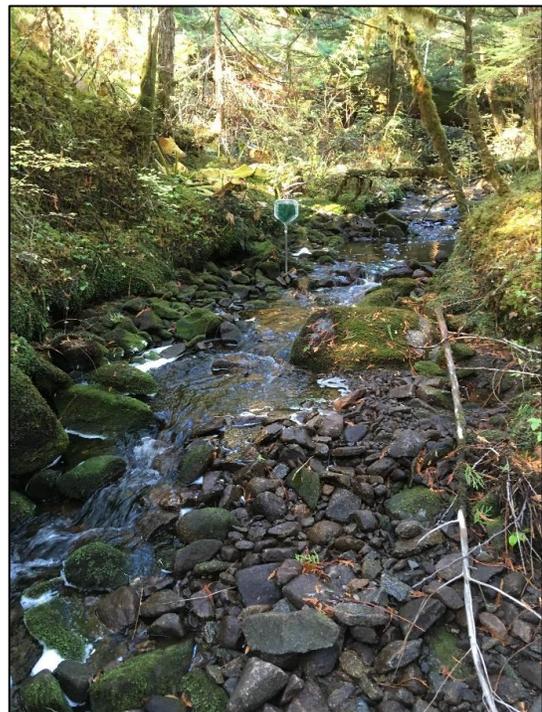
Trib A is a high gradient contained (HCL) channel as determined by SWCA consultants in 2010 (Fig. 52). The stream reach has a bed width of about 6 feet and cobbles are the dominant substrate. The stream runs parallel to the edge of a harvest unit. Most of the old-growth trees within 25 feet of the channel were not cut. Large wood debris does not appear to play a role in pool formation due to the high gradient/incised nature of the channel and large size of the substrate.

Figure 52. Tributary A in the Thoms Creek watershed.

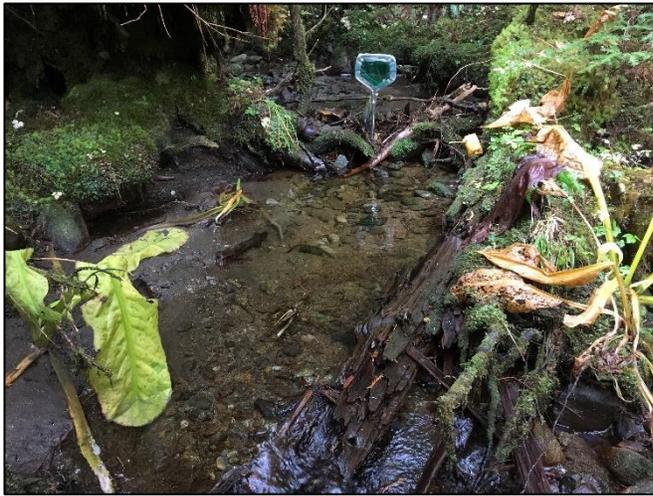
Figure 53. Tributary B in the Thoms Creek watershed.

Trib B is a small floodplain channel with a bed width of about 4 feet (Fig. 53). Substrate is dominated by sand and silt. The riparian forest consists of numerous species of understory shrubs and a thinned stand of Sitka spruce up to 16" diameter at breast height (dbh). A juvenile Dolly Varden char was collected in this reach. The USFS has documented cutthroat trout, Dolly Varden char, and coho salmon in the stream. A 30 m long reach of this stream was surveyed using the SAWC Stream Credit Debit Methodology results can be obtained upon request. This stream reach deserves further

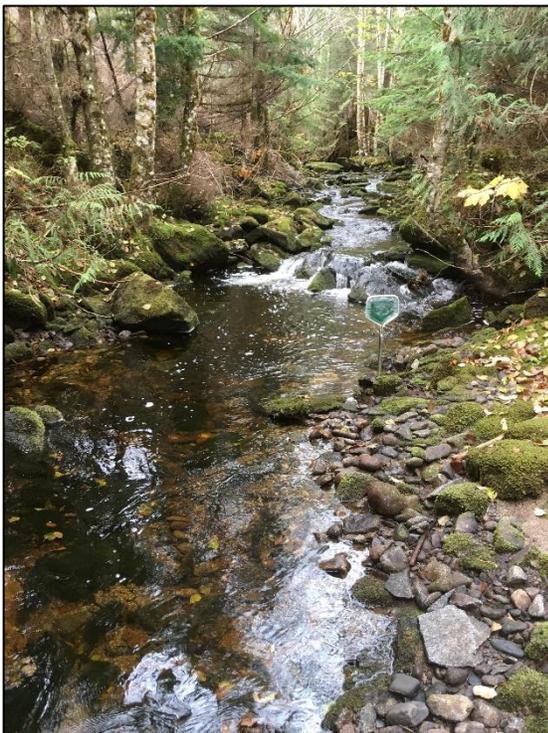
Figure 54. Tributary C in the Thoms Creek watershed.

Trib C is a Class I stream in the upper Thoms Creek watershed (Fig. 54). The channel bed width is about 13 feet and the streambed is dominated by cobbles and boulders. The stream has a moderate gradient and step-pool channel morphology. Riparian vegetation consists of red alder and young-growth conifer which was thinned recently. Very little large wood was observed in the channel within the harvest unit. Due to the large substrate that dominates the stream bed, wood likely does not play an important role in habitat creation and sediment dynamics in this channel.

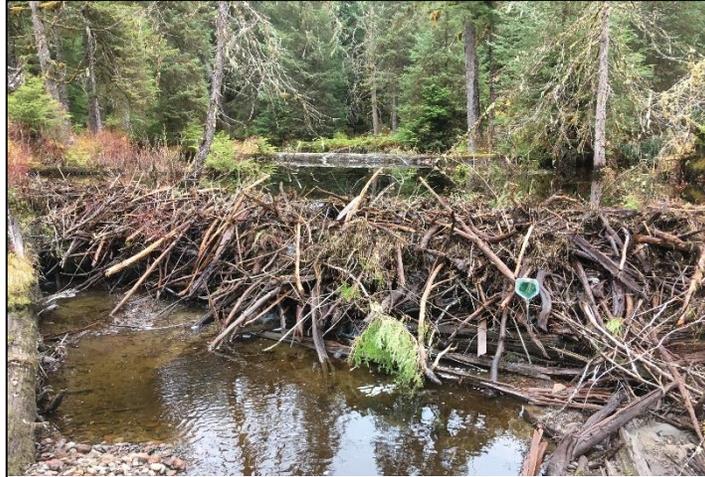
Figure 55. A beaver dam in the upper Thoms Creek main channel at the Mainstem B site.

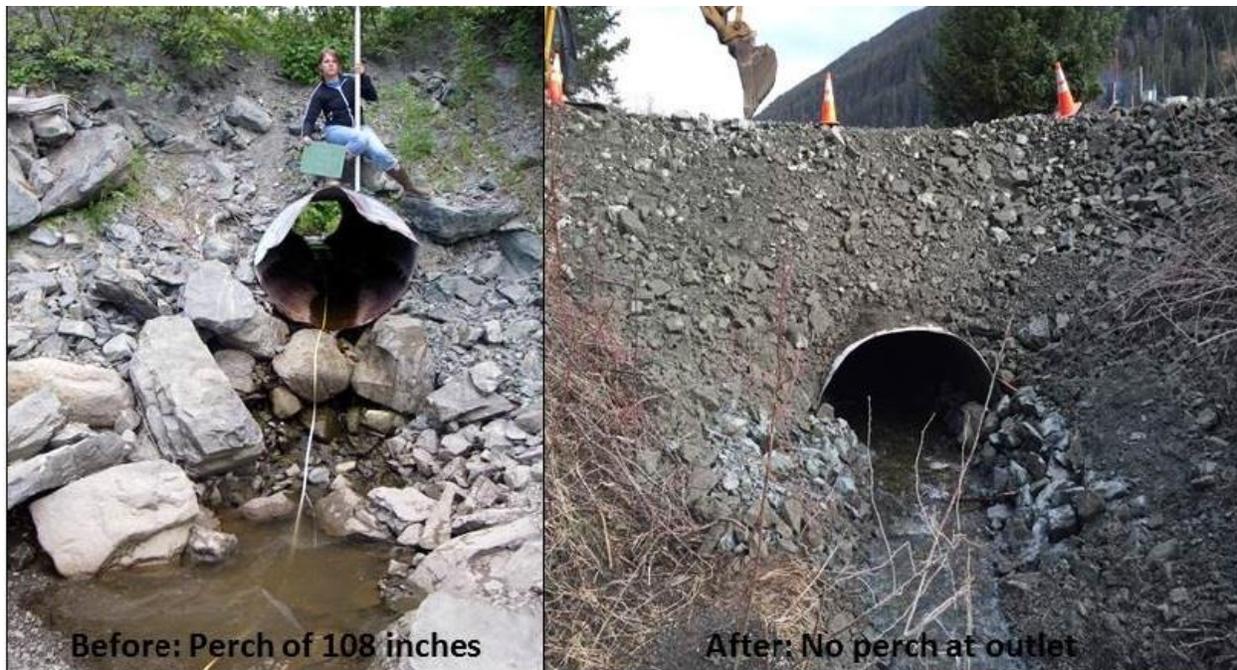
Figure 9. The failing culvert was replaced with a 95" x 67", 60' long rolled aluminum pipe arch culvert. The culvert placement was lowered to allow for unimpeded fish passage. Photo courtesy of Takshanuk Watershed Council.

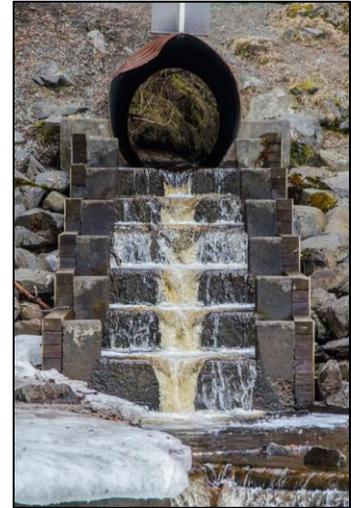
Figure 10. The outlet of Picnic Creek near Juneau before

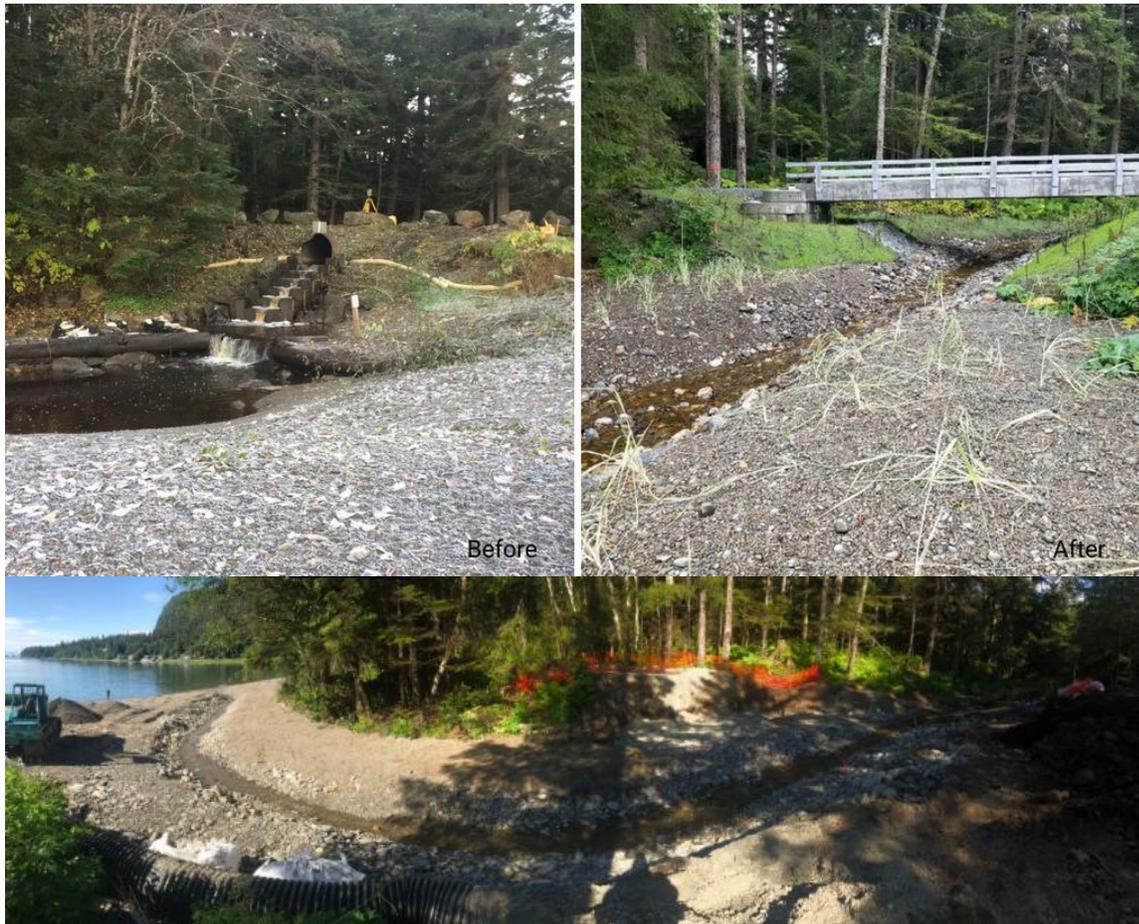
Figure 11. Picnic Creek fish passage before construction, during and after construction of fish passage improvements. The culvert and fish ladder are removed, and a wider footbridge is installed to allow for natural stream flow and fish passage. Image from SEALASKA (<https://www.sealaska.com/news/item/2018-08-28/sealaska-restores-lena-beach-recreation-area-while-improving-juneau-salmon-run>)
