Mendenhall Wetlands Restoration Opportunity Assessment 2019

Southeast Alaska Watershed Coalition

December 2019

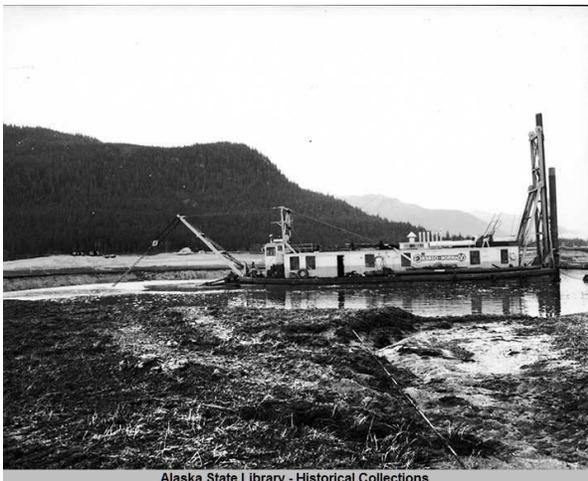
Dredging in the wetlands during expansion of the Juneau Airport in 1953.

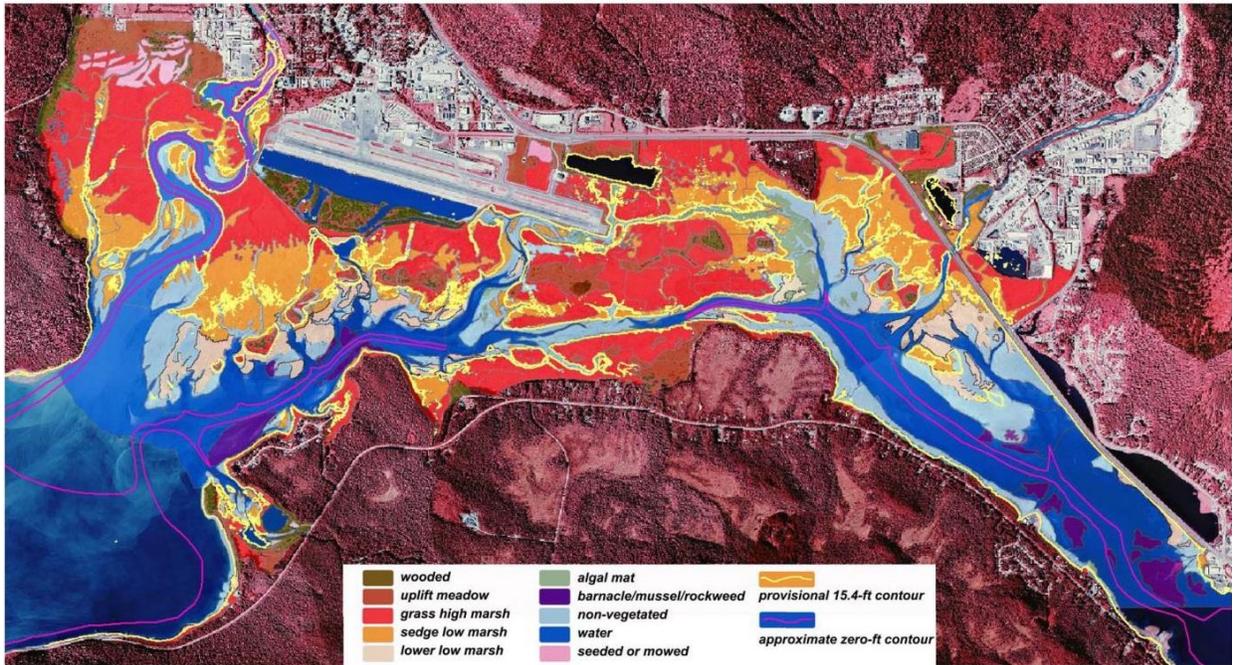
Figure 1. Map of Mendenhall Wetland complex. (Discovery Southeast, 2004)

Appendix C Vegetation 2003, and contours: Mean High Water (15.4 foot, provisional, LIDAR-generated) and Mean Lower Low Water (from photography on zero-foot tide)

The Mendenhall Wetlands area covers 1,500 acres of Gastineau Channel between the Juneau mainland to the north and Douglas Island to the south (Figure 1). This dynamic area includes upland meadows, high marsh, low marsh, non-vegetated mudflats and stream channels. The wetlands support a wide variety of fish, including all five species of Pacific salmon and several species of flatfish, and the area is a globally recognized Important Bird Area, providing critical habitat for multiple resident and migratory bird species ([Armstrong et al. 2009](#)). Most of the wetlands are encompassed by the Mendenhall Wetlands State Game Refuge, which was established to protect wildlife and be a place for recreation. Areas surrounding the refuge are in local, state, federal, and private ownership with varying land use priorities.

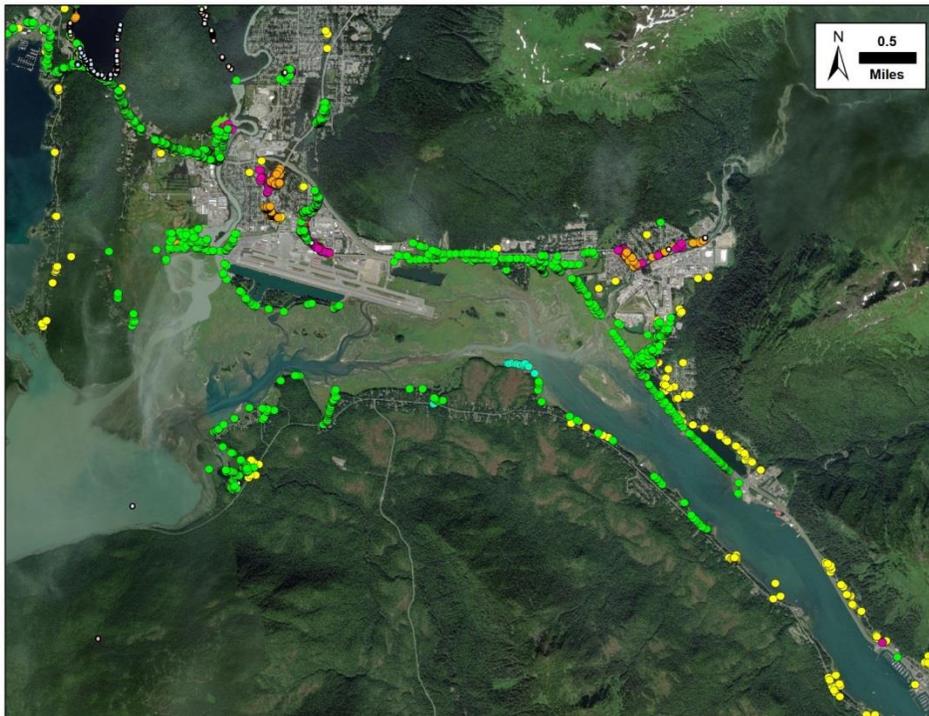
Invasive plant infestations near the Mendenhall Wetlands and surrounding areas. High-priority species for management include Bohemian knotweed (yellow), European bird cherry (pink), reed canarygrass (green), European mountain ash (orange), and perennial sowthistle (blue). Some of these infestations have been eradicated.

Native plants are highly valued by humans and provide numerous ecological functions. These important values and functions are threatened by non-native invasive plants that can outcompete and displace native plants and plant communities. Invasive plants surveys have been conducted in the Mendenhall Wetlands, the upland fringe bordering the wetlands, and along several of the urban stream corridors that connect to the wetlands (Hudson et al. undated). Invasive plant records from these surveys are maintained by the Southeast Alaska Watershed Coalition (SAWC) and are updated as new records are obtained. SAWC is actively managing several invasive plant species in the Mendenhall Wetlands area, including perennial sowthistle (*Sonchus arvensis*), reed canarygrass (*Phalaris arundinacea*), Bohemian knotweed (*Fallopia x bohemica*), European bird cherry (*Prunus padus*), and European mountain ash (*Sorbus aucuparia*). These invasive plants are targeted because of their high invasiveness rank, relative ease of control, risk of spreading, and/or threat to important habitats. SAWC recently received a grant from the Alaska Sustainable Salmon Fund to manage Bohemian knotweed and reed canarygrass in the wetlands and several tributaries from 2020 to 2022.

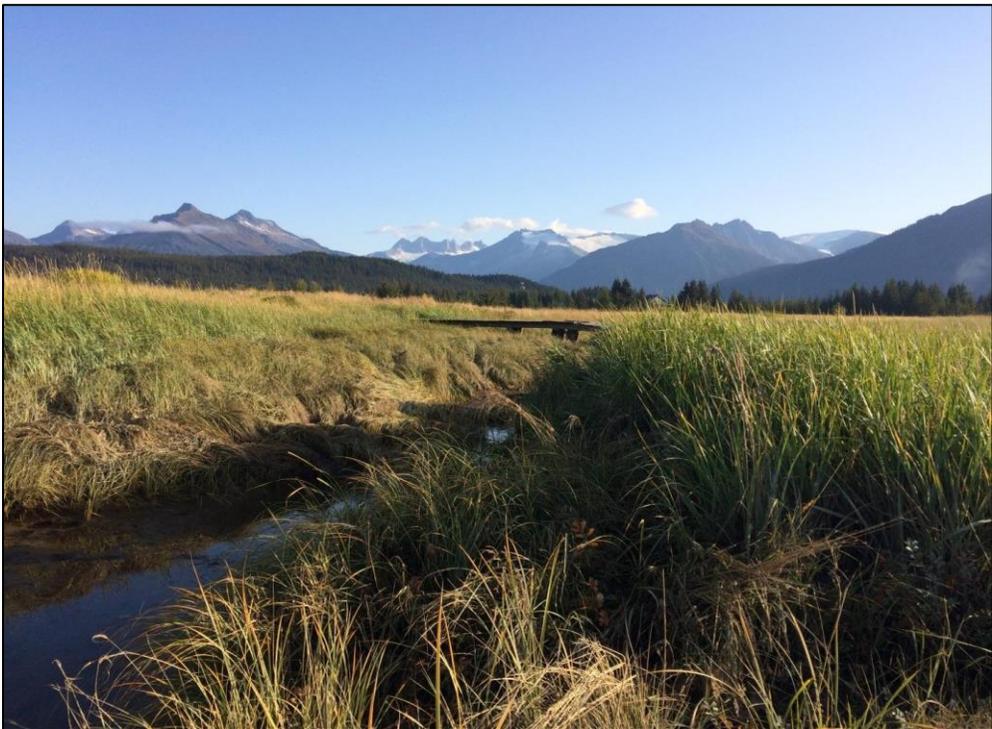
Casa del Sol Creek (aka Pederson Hill Creek) riparian area (Sep 10, 2019; view looking northeast).

2. Plant native shrubs along the riparian area to limit erosion, shade out reed canarygrass, and cool the water.
3. Acquire a conservation easement on unused land or the whole parcel if/when the owners no longer want to run a golf course.

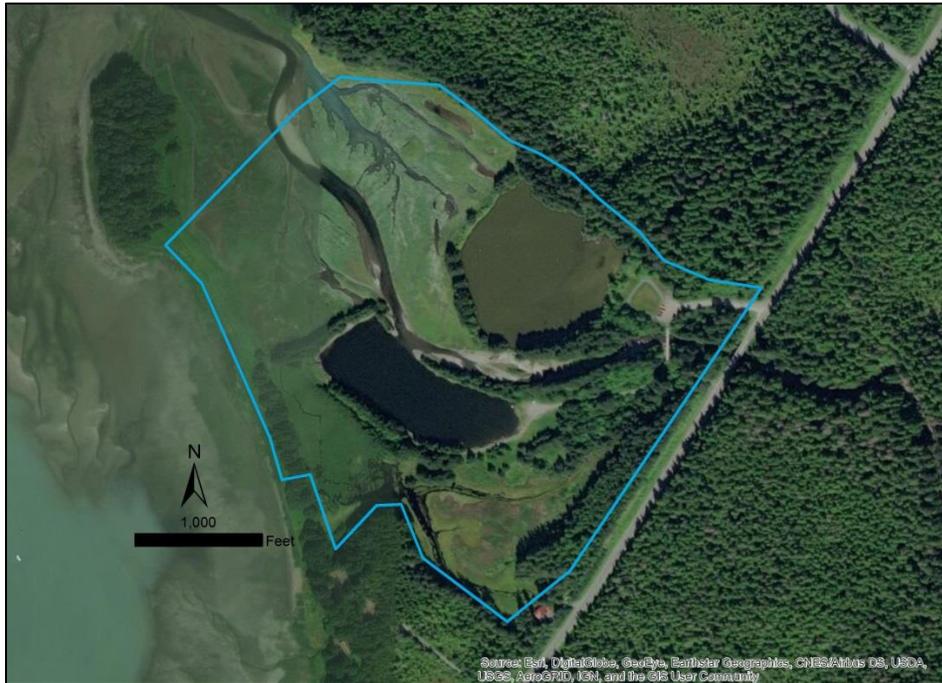
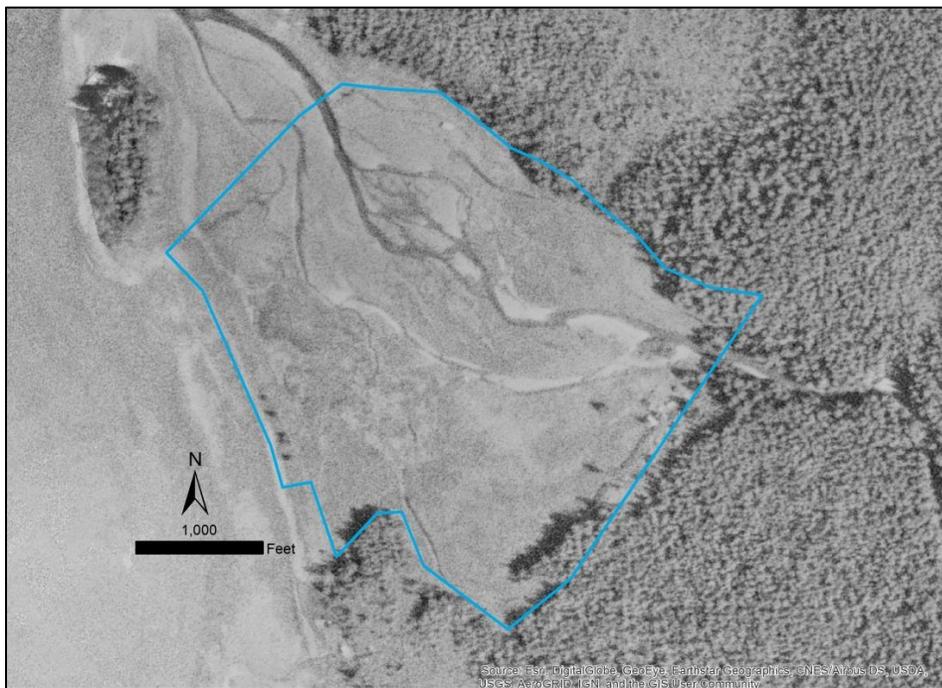
Fish Creek estuary aerial view. Current conditions (top) and pre-dredge ponds in 1949 (bottom).

The alluvial fan was mined for gravel in the 1960's and 1970's forming two borrow ponds separated from the tidelands and stream by dikes. The west pond's dike was breached during a 1984 flood, and the pond is now tidally influenced. It is used as a King salmon release site by Douglas Island Pink and Chum hatchery, and is an important recreational and sport fishing site for locals. The east pond remains hydrologically disconnected from tidal influence, but a small channel at the head of the pond is assumed to provide an ephemeral connection to Fish Creek during high flows. The east pond is a locally important breeding and rearing habitat for western toads. Small infestations of Bohemian knotweed have been eradicated near the parking lot and east pond and numerous reed canarygrass infestations are being treated with herbicide. The park receives moderate to heavy use, depending on the time of year, and is appreciated by dog walkers, bird watchers, waterfowl hunters, and anglers.

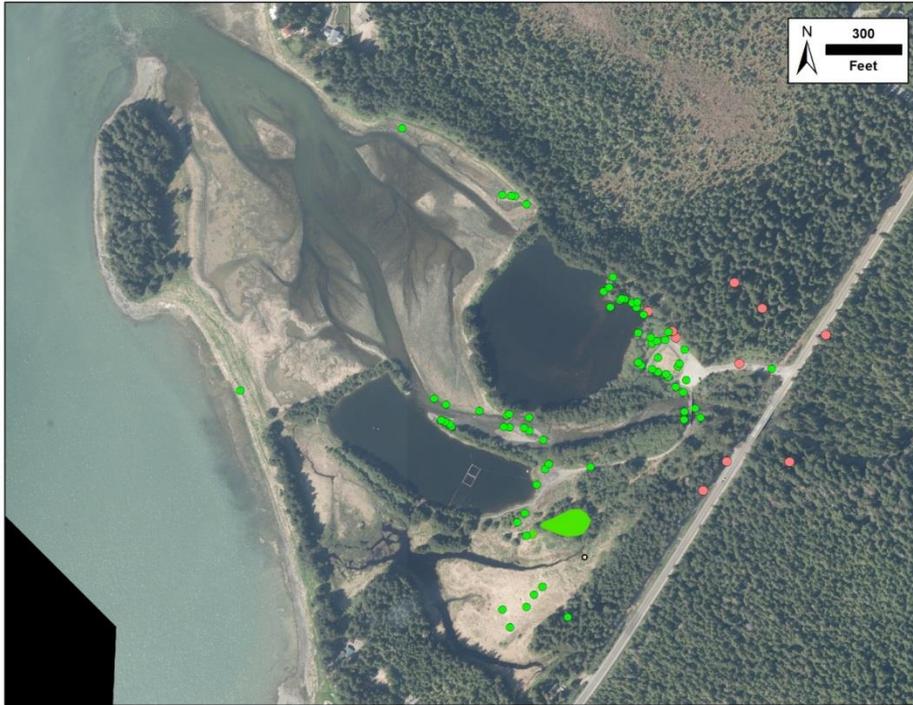
Reed canarygrass infestations (green polygons and symbols) in the Fish Creek estuary area.

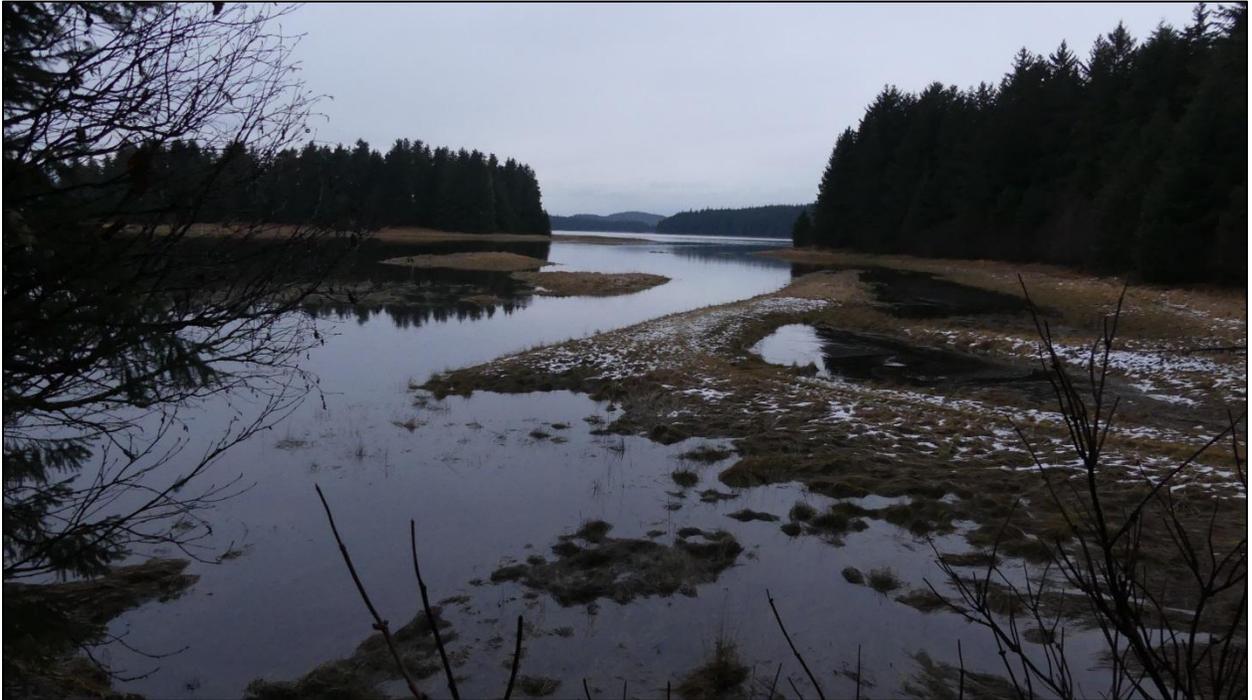
Intertidal area beyond the east pond, at high tide. (Dec 18, 2018; view looking northwest)

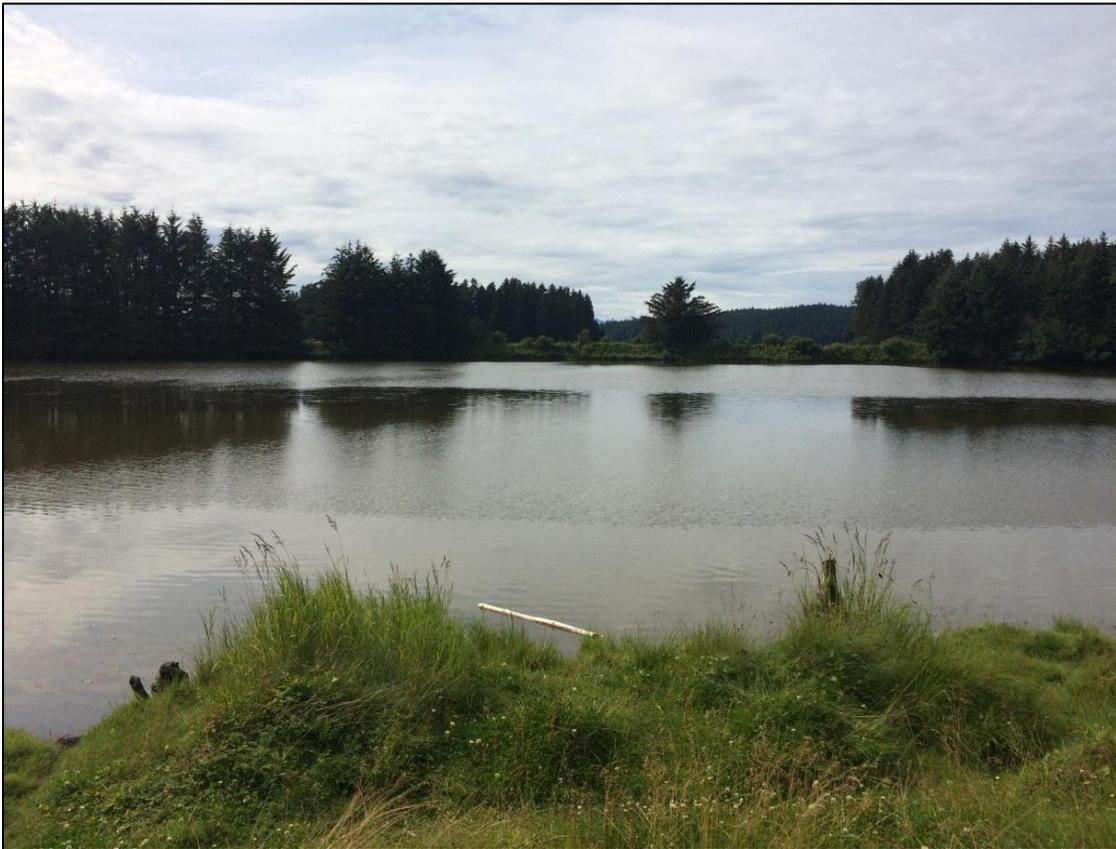
View of the East Pond from the parking lot area. (July 17, 2019; view looking northwest)

1. Breach the east pond and allow tidal influence.
2. Create more shallow water habitat in the east pond for macrophytes and invertebrate and juvenile fish habitat.
3. Thin new-growth stands of Sitka spruce to enhance structural and biological diversity by promoting understory growth.

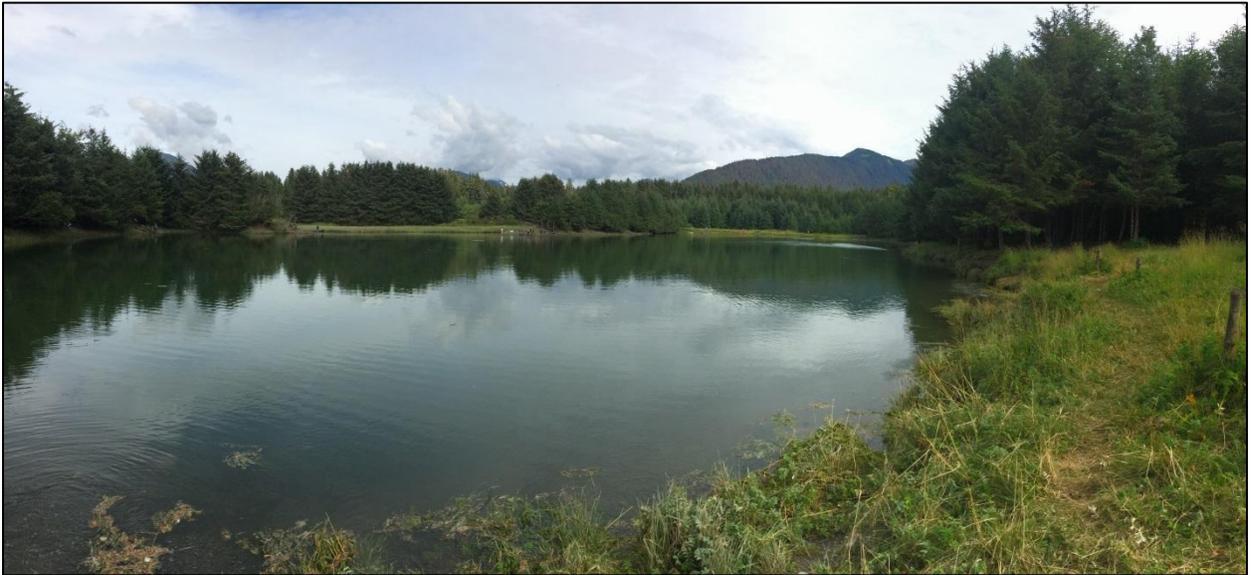
Panoramic view of the west pond from the east end. (July 17, 2019)

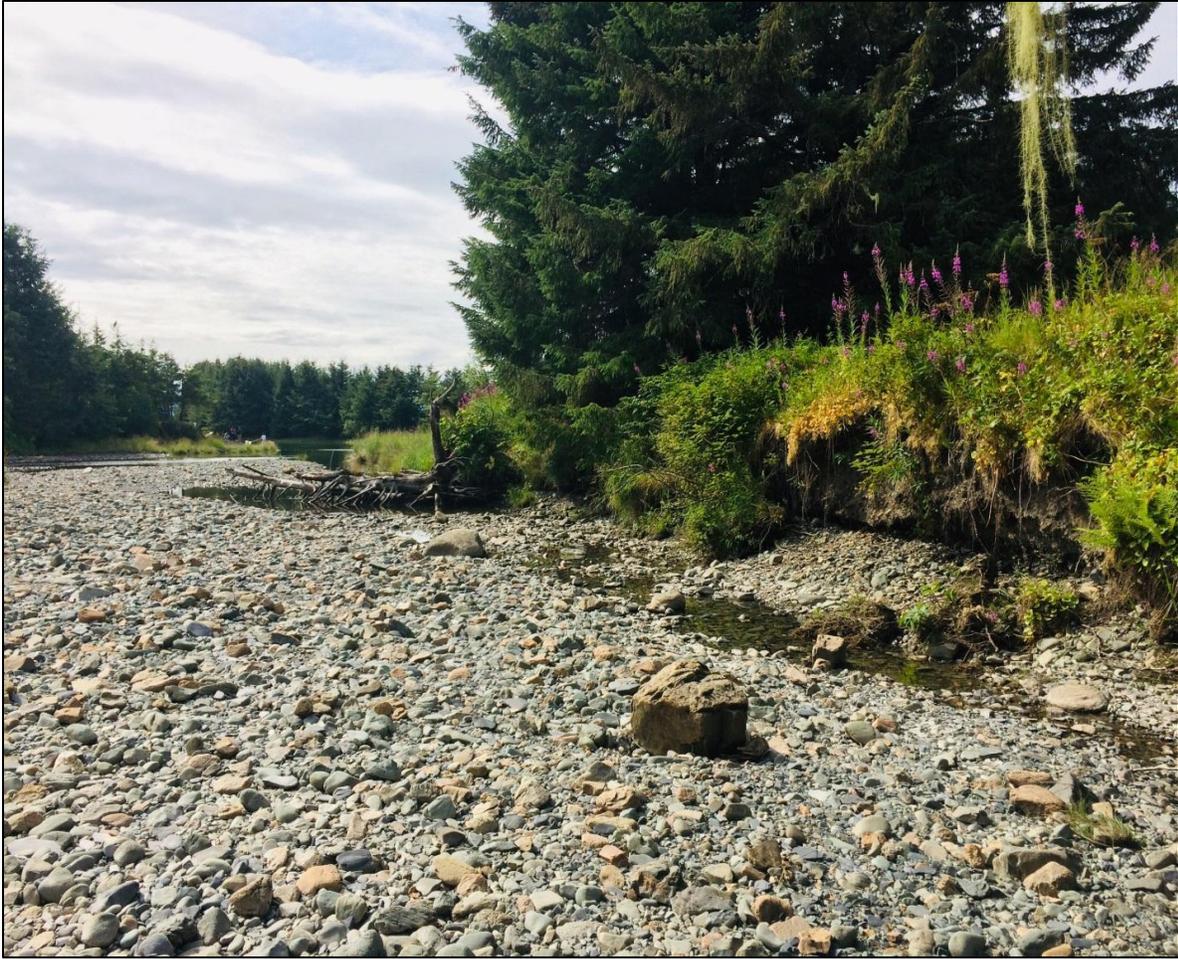
Eroding east pond dike along Fish Creek (July 17, 2019; view looking downstream).

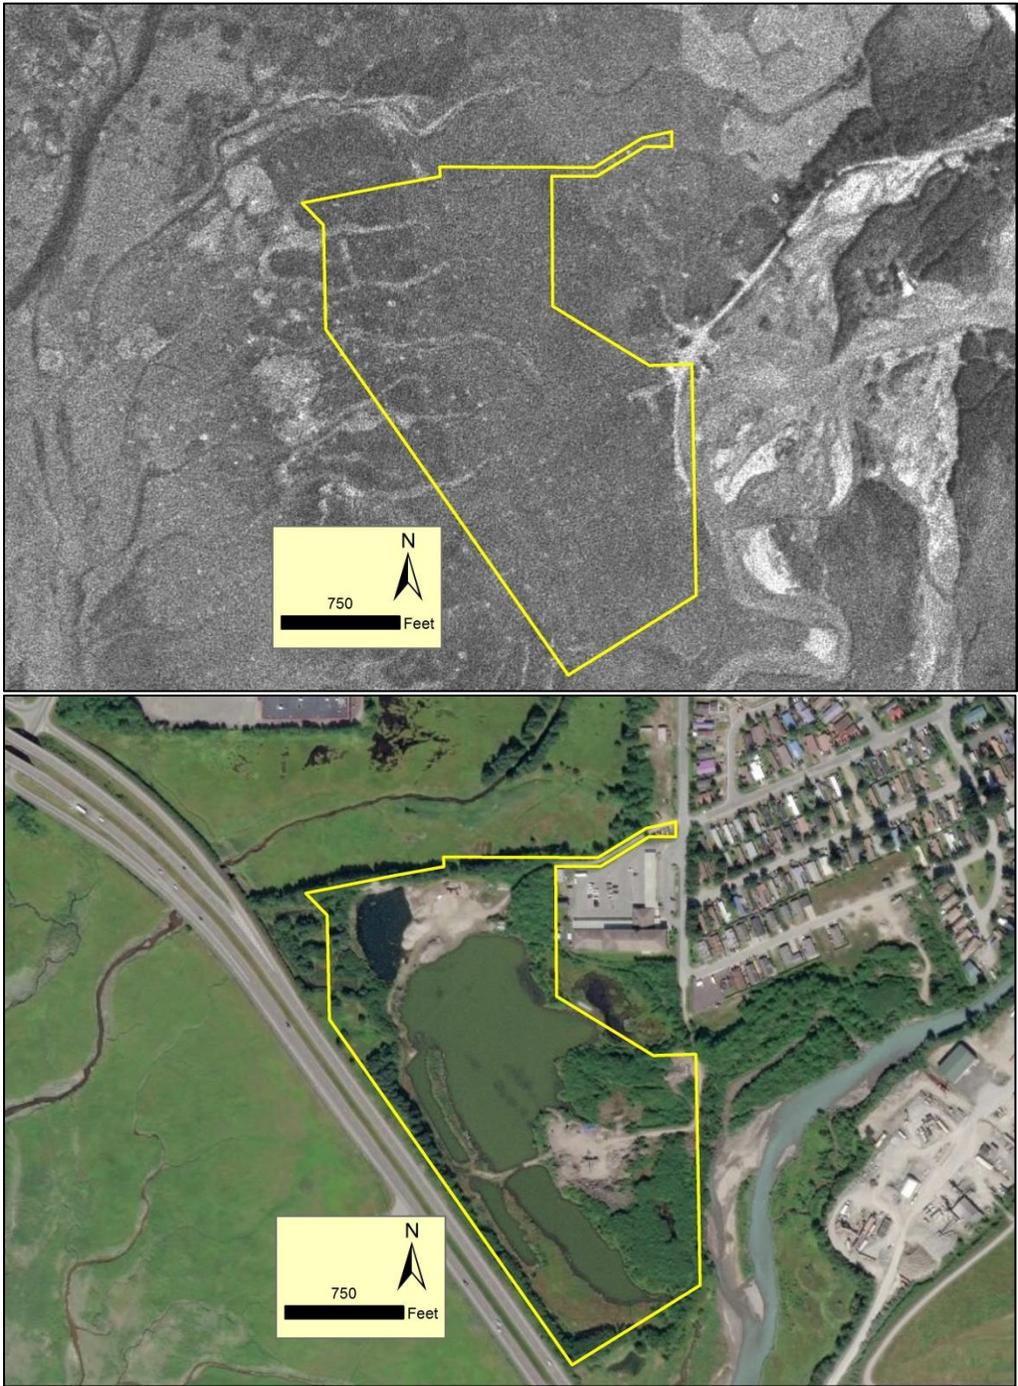
Duran Pond property boundary; current conditions (top) and 1949 (bottom).

1. Fill the pond and convert it to emergent tidally influenced wetlands.
2. Remove the dikes separating the area from the Switzer and Lemon Creek floodplains.
3. Reconnect the area to the Mendenhall wetlands via two existing culverts under Egan Drive, and to Lemon Creek, and/or Switzer Creek.
4. Manage the area for fish and wildlife habitat in conjunction with the neighboring Kingfisher pond and ADNR lands.

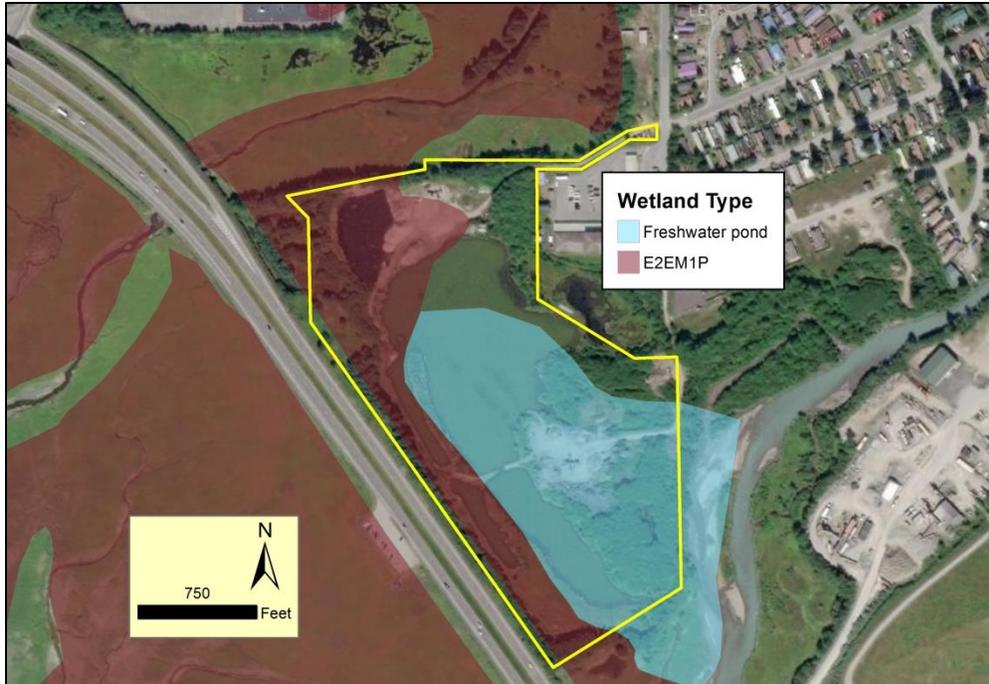
Duran pond property boundaries with National Wetland Inventory wetland types. The “Freshwater Pond” wetland area was mis-identified as E1UBLh (Estuarine, Subtidal). E2EM1P = Estuarine, Intertidal, Emergent, Persistent, Irregularly Flooded.

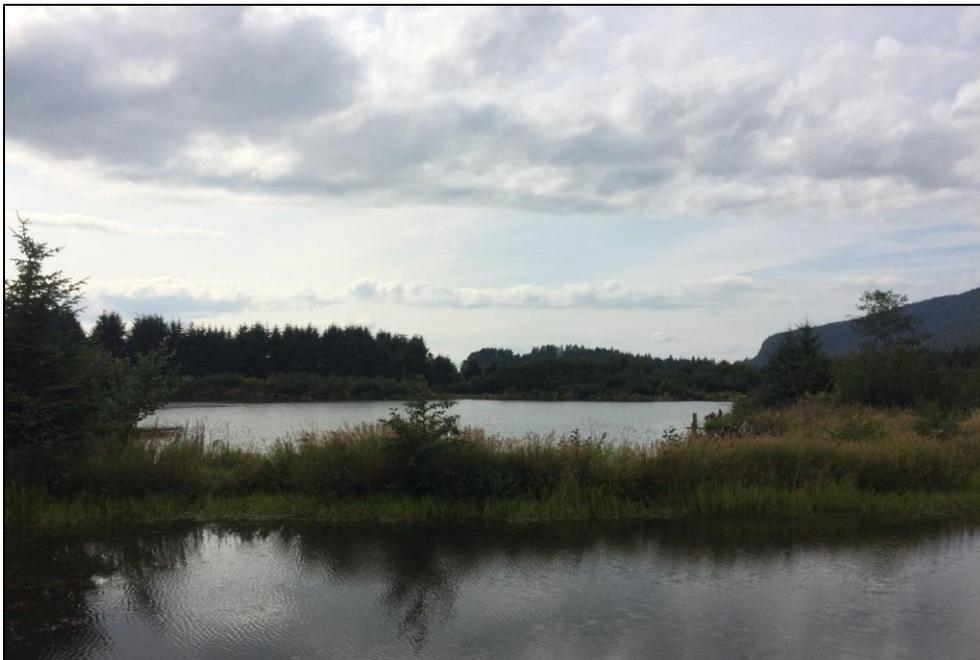
View of the Duran pond (background) from Kingfisher pond on CBJ property (foreground). (Aug 13, 2019; view looking west)

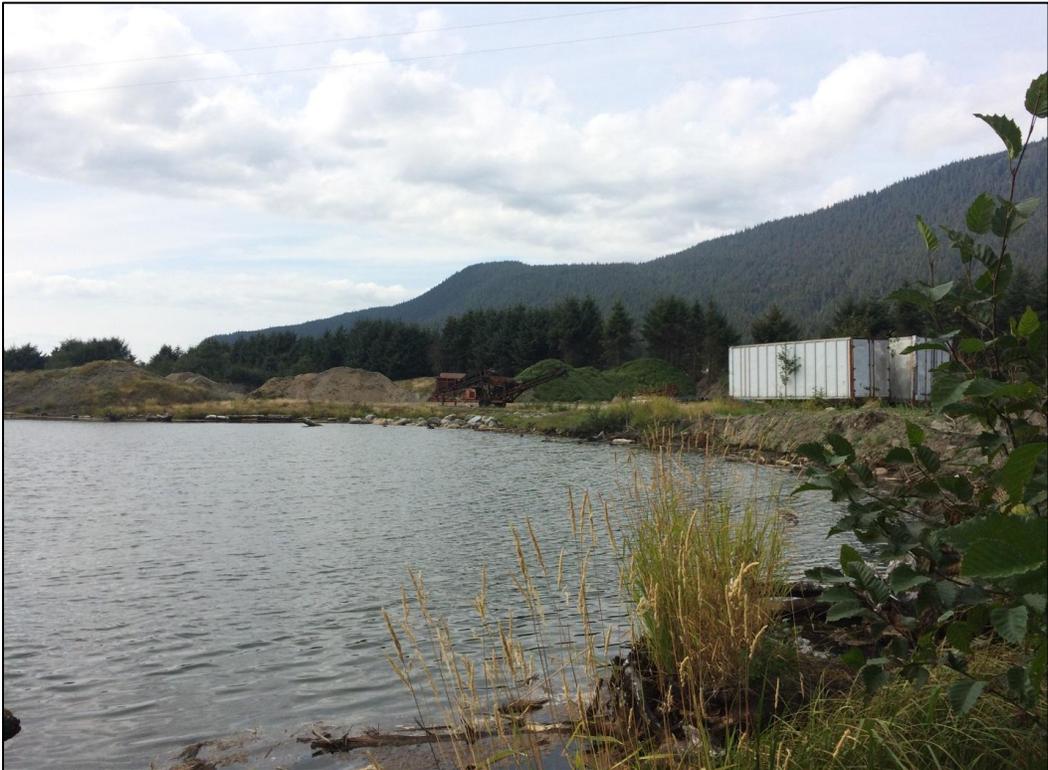
Infrastructure on the north side of the Duran pond as viewed from CBJ property. (Aug 13, 2019)

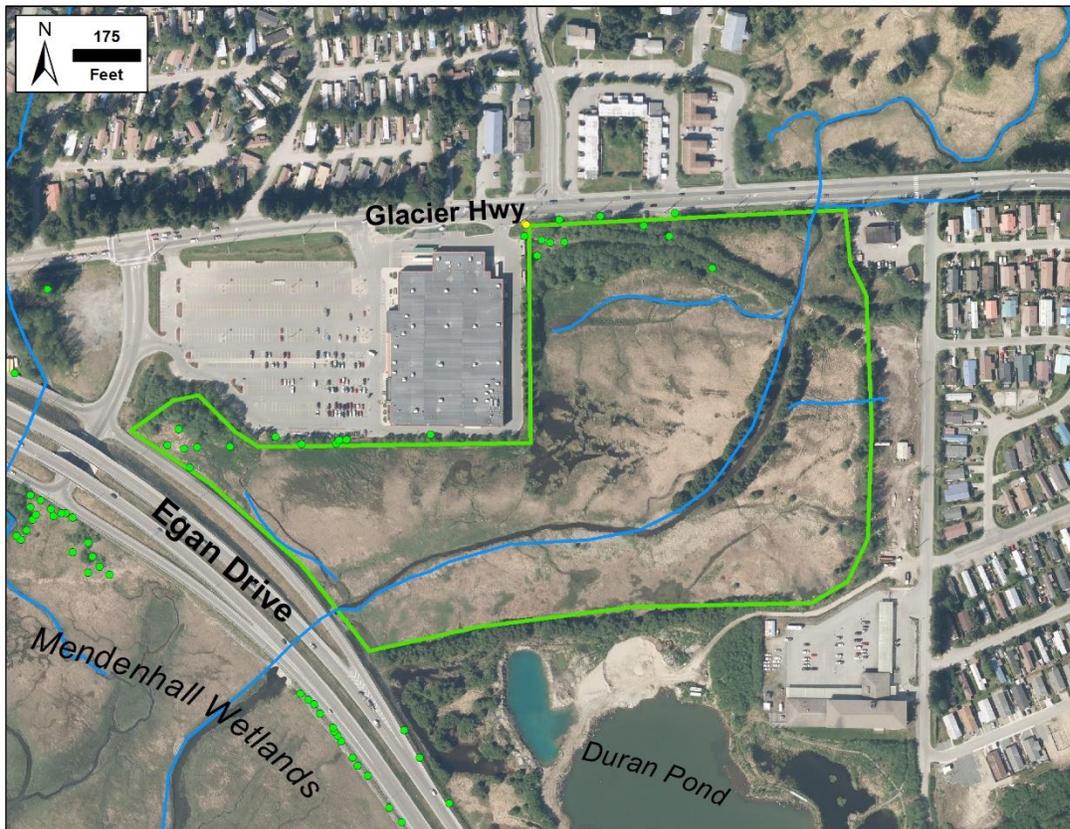
Lower Switzer Creek wetlands between Glacier Highway and Egan Drive. The abandoned road is visible as a tree-lined feature arcing through the northern portion of the area.

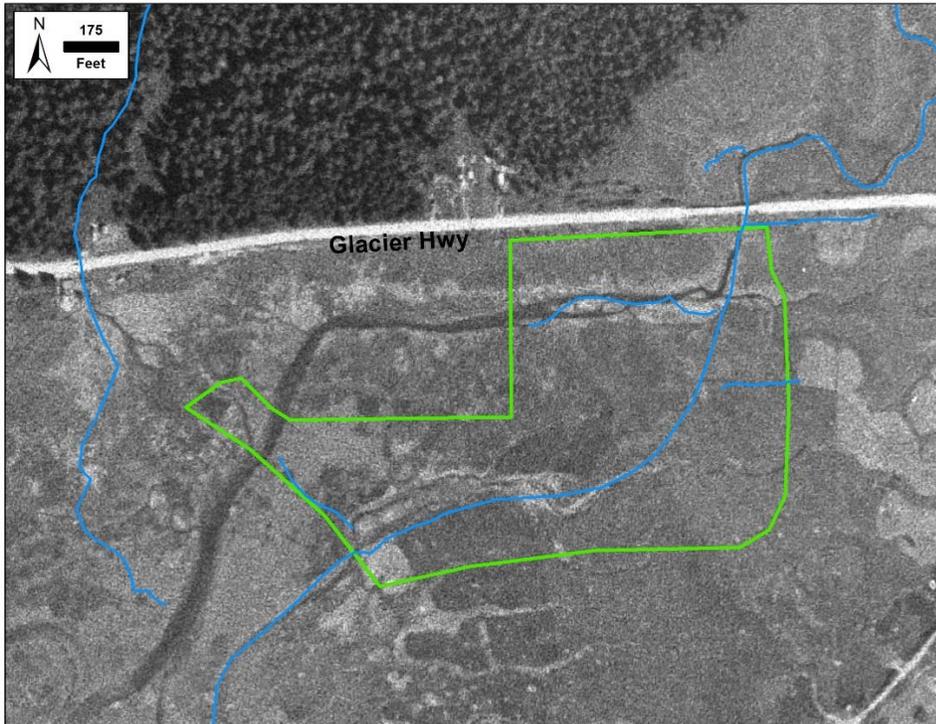
Site boundary and existing anadromous stream channels overlain on 1949 imagery of the area. The elongated dark feature is the original Switzer Creek channel.

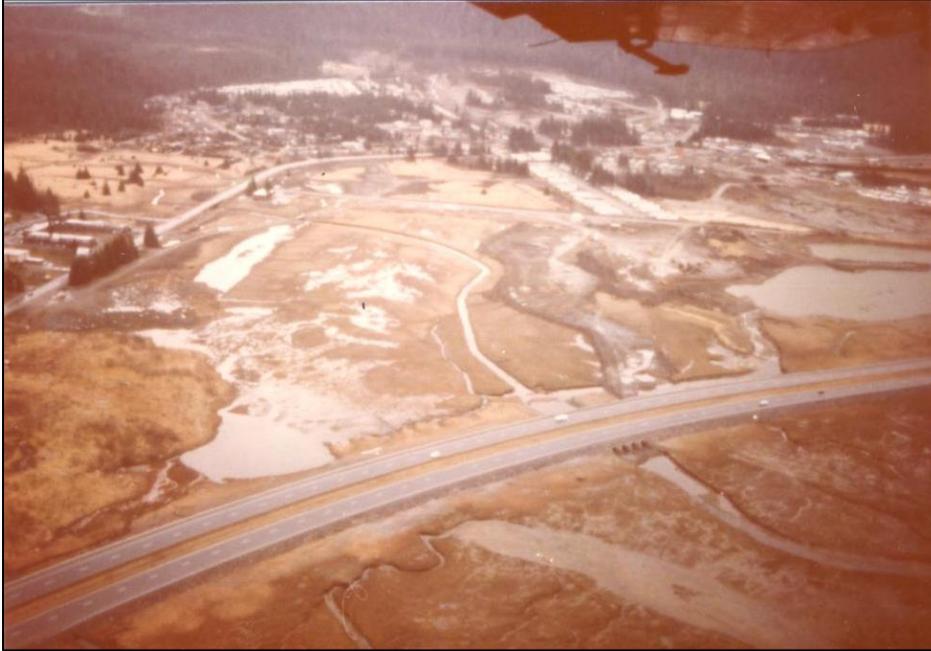
Aerial view of site looking northeast on April 14, 1981, after the Switzer Creek channel was relocated. Egan Drive is visible in foreground, Glacier Hwy. in mid-ground left, and fill pad in lower left.

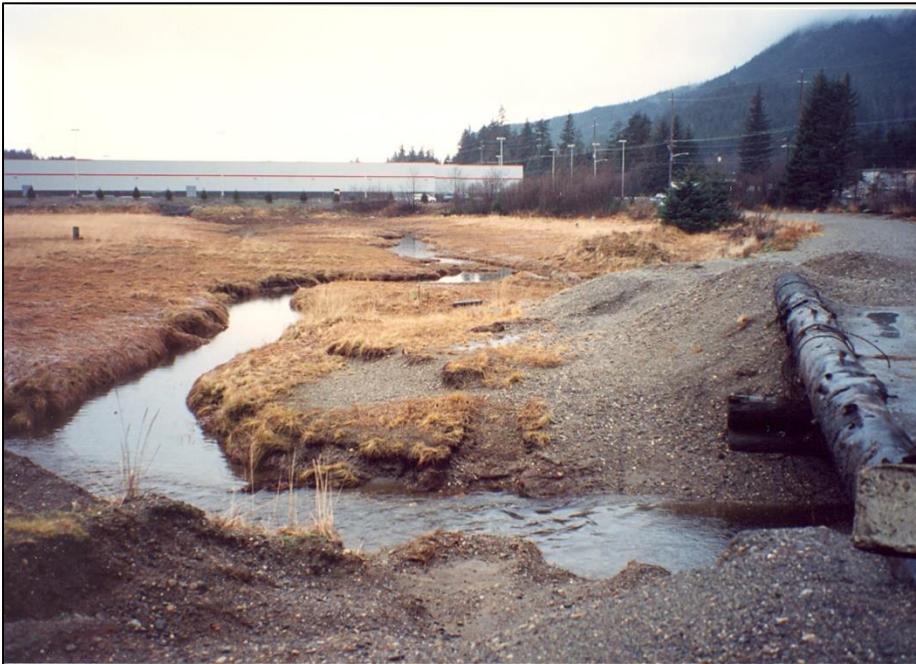
Switzer Creek downstream of Glacier Highway looking west towards the K-Mart building in 1993. The relocated channel is at bottom of photo and flows from right to left. The abandoned channel is the slough extending towards K-Mart. The abandoned road is on photo right.

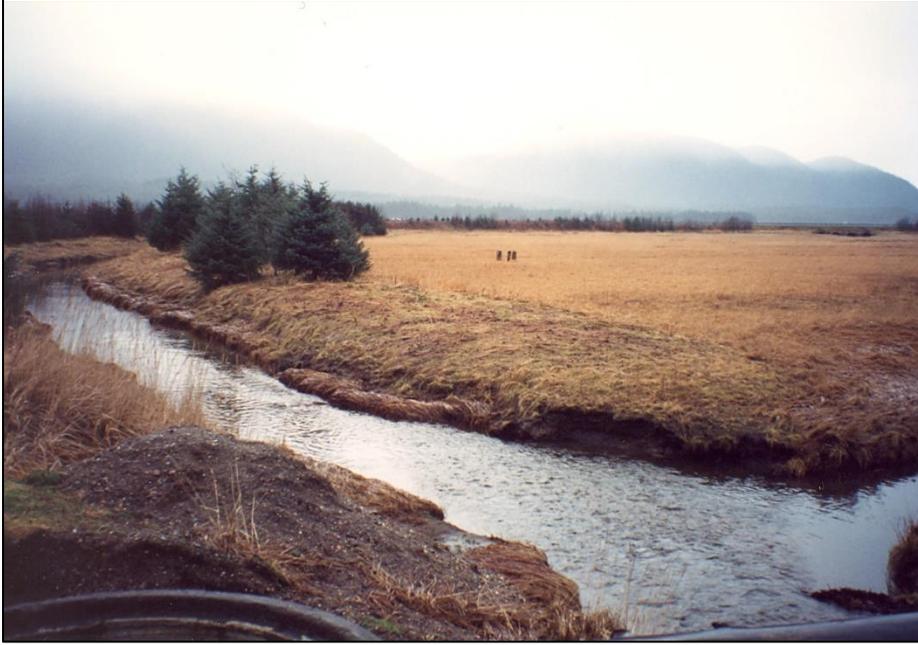
The relocated Switzer Creek channel looking downstream from the abandoned road in 1993. Sitka spruce trees in the foreground are growing on a spoil berm apparently left behind after the new channel was dredged. Mountains on Douglas Island are visible in the distance.

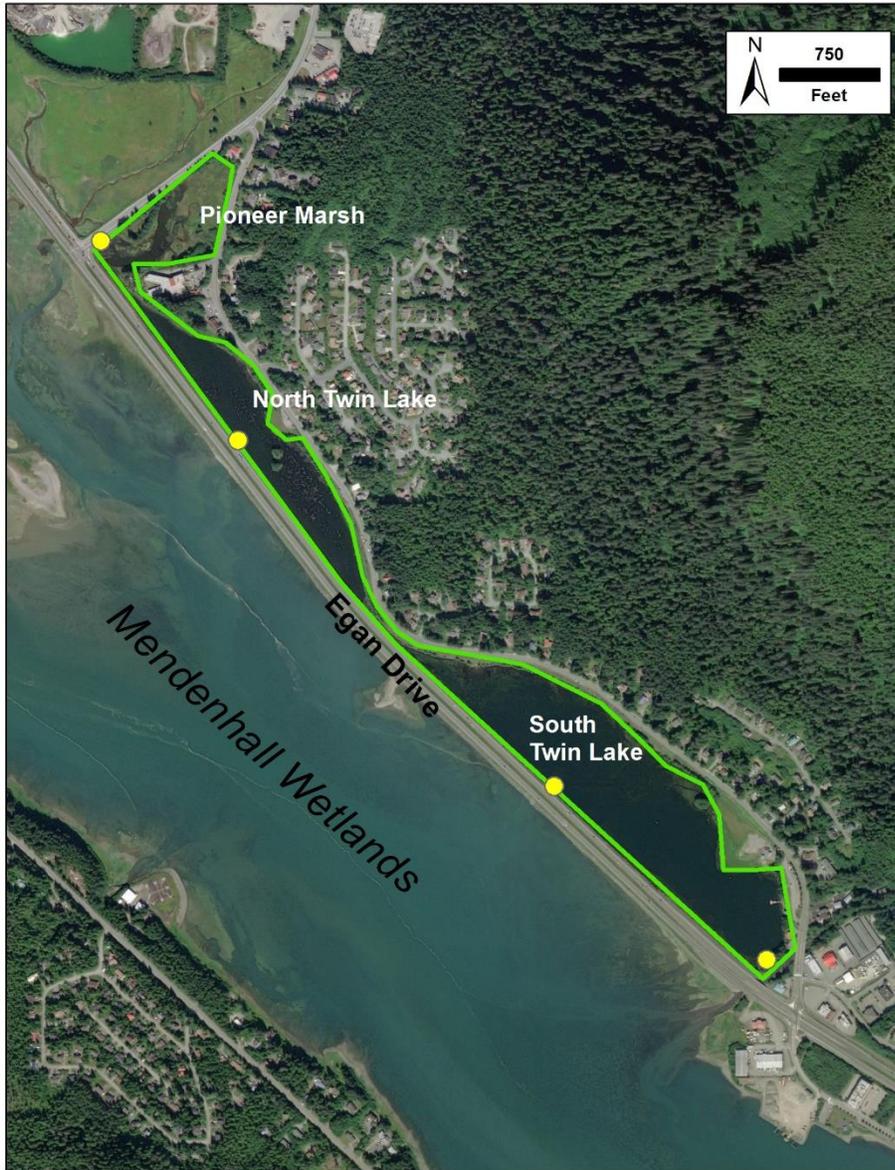
Twin Lakes and Pioneer Marsh. Yellow symbols indicate water control structures described in text.

Stakeholders and landowners should be engaged to further define goals at this site, as there are a range of options for this site. For example, the degree of tidal influence to the system can be manipulated to match desired conditions. Water levels can be controlled by the log weir/flap gates, and use of the log weir and/or excavation of deeper water areas could ensure permanent water that could be quality juvenile salmon rearing habitat. This habitat is currently unavailable to salmon because of the gate structures. Alternatively, the gate system could be fully opened and the area would naturally become an intertidal wetland. An intertidal wetland at Norway Point (just north of Juneau Yacht Club) provides an ideal reference wetland for this prescription. It is bisected by Egan Drive but is connected to Gastineau Channel through a culvert.

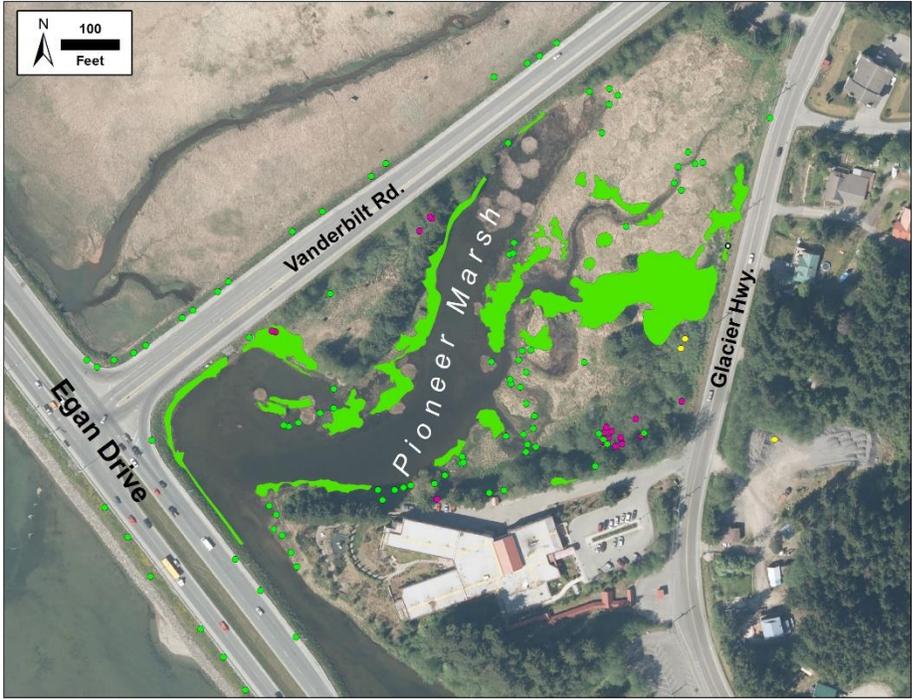
Invasive plant infestations in the Pioneer Marsh area: reed canarygrass (green), European mountain ash (magenta), Bohemian knotweed (yellow).

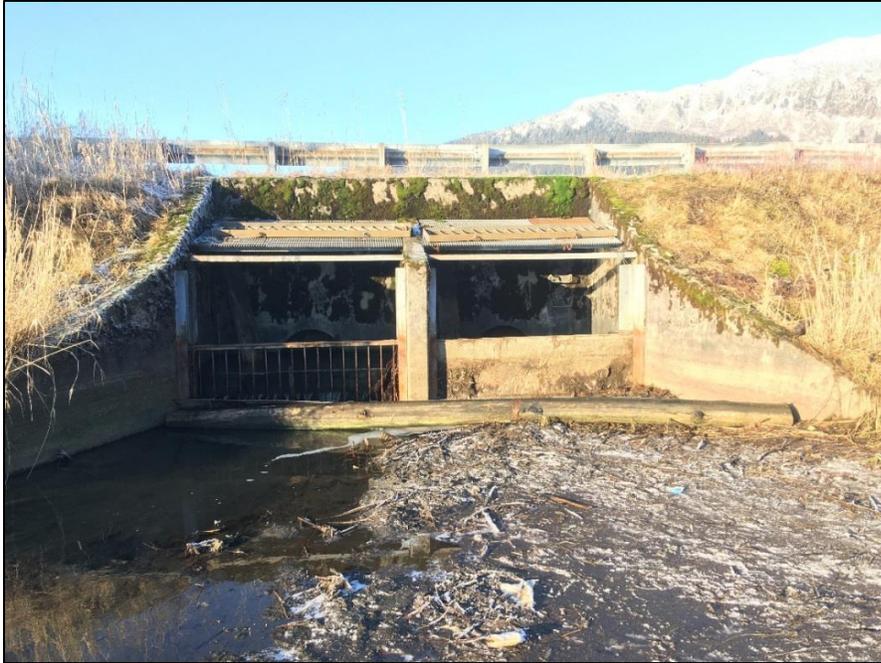
A water-level control structure near the Egan Drive/Vanderbilt Road intersection at Pioneer Marsh. (Nov 27, 2019)

Potential Barriers to Project Success: North Twin Lakes is a relatively high use area, and it may take some outreach to allay resident concerns and resistance to changing the pond to an intertidal wetland. If overall public response is negative or the desired ecological outcome is not achieved, the original conditions could be easily restored using the water control structures.

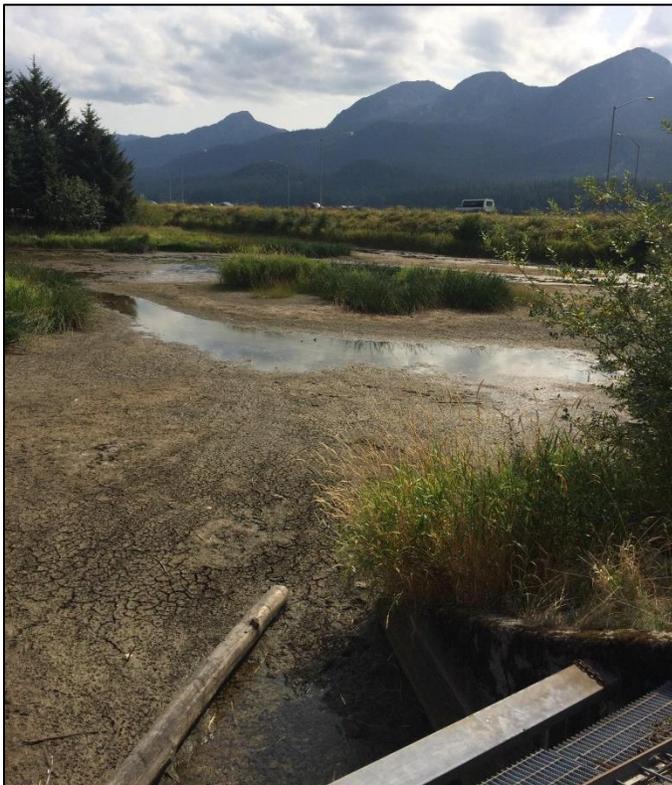
The south end of Pioneer Marsh looking south from the water-level control structure under Vanderbilt Road. View looking southeast. Conditions were very dry. (Aug 13, 2019)

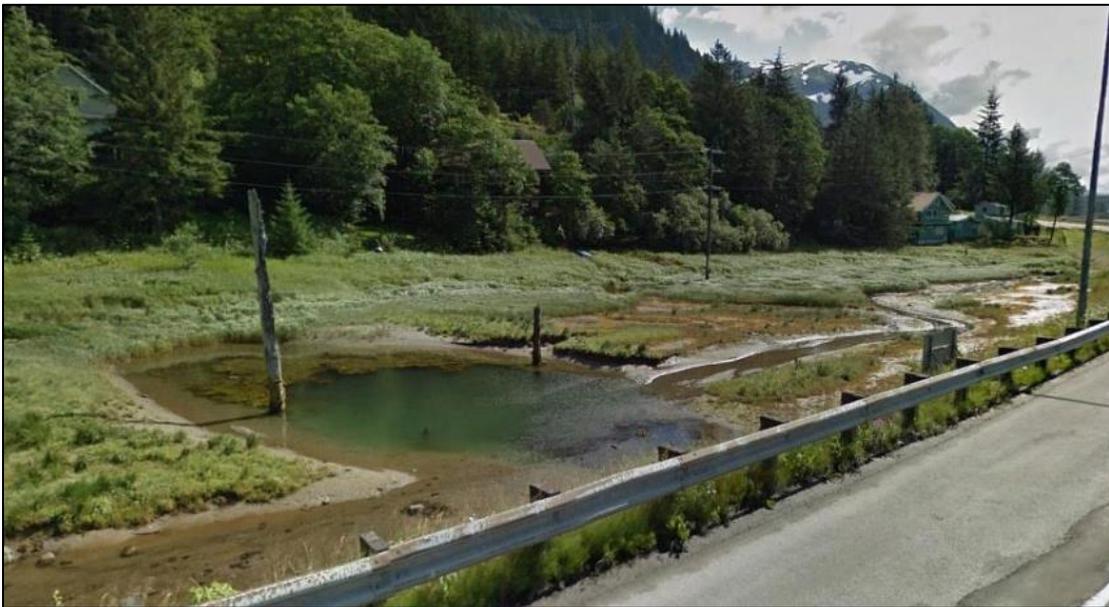
An example of an intertidal wetland that is bisected by Egan Drive but hydrologically connected to Gastineau Channel through a culvert. Located at Norway Point, just north of Juneau Yacht Club.

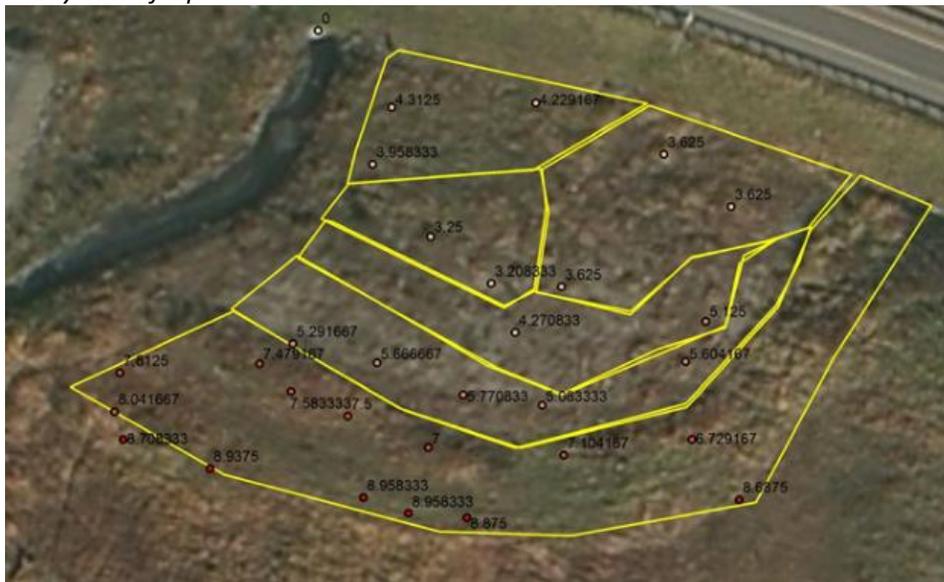
Spot elevations with a laser level and GIS were used to estimate the volume of material in the fill pad, approximately 2,910 (+/- 20%) cubic yards.

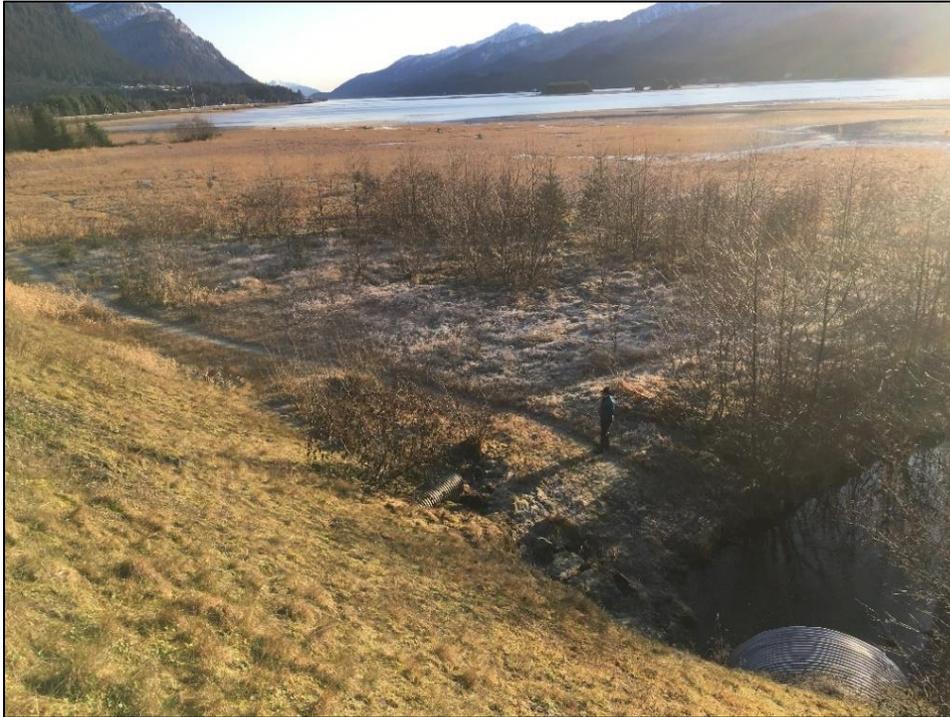
View of fill pad and West Creek looking southeast from the Sunny Point interchange on November 26, 2019.
