Mendenhall Wetlands Restoration Opportunity Assessment 2019

Southeast Alaska Watershed Coalition

December 2019

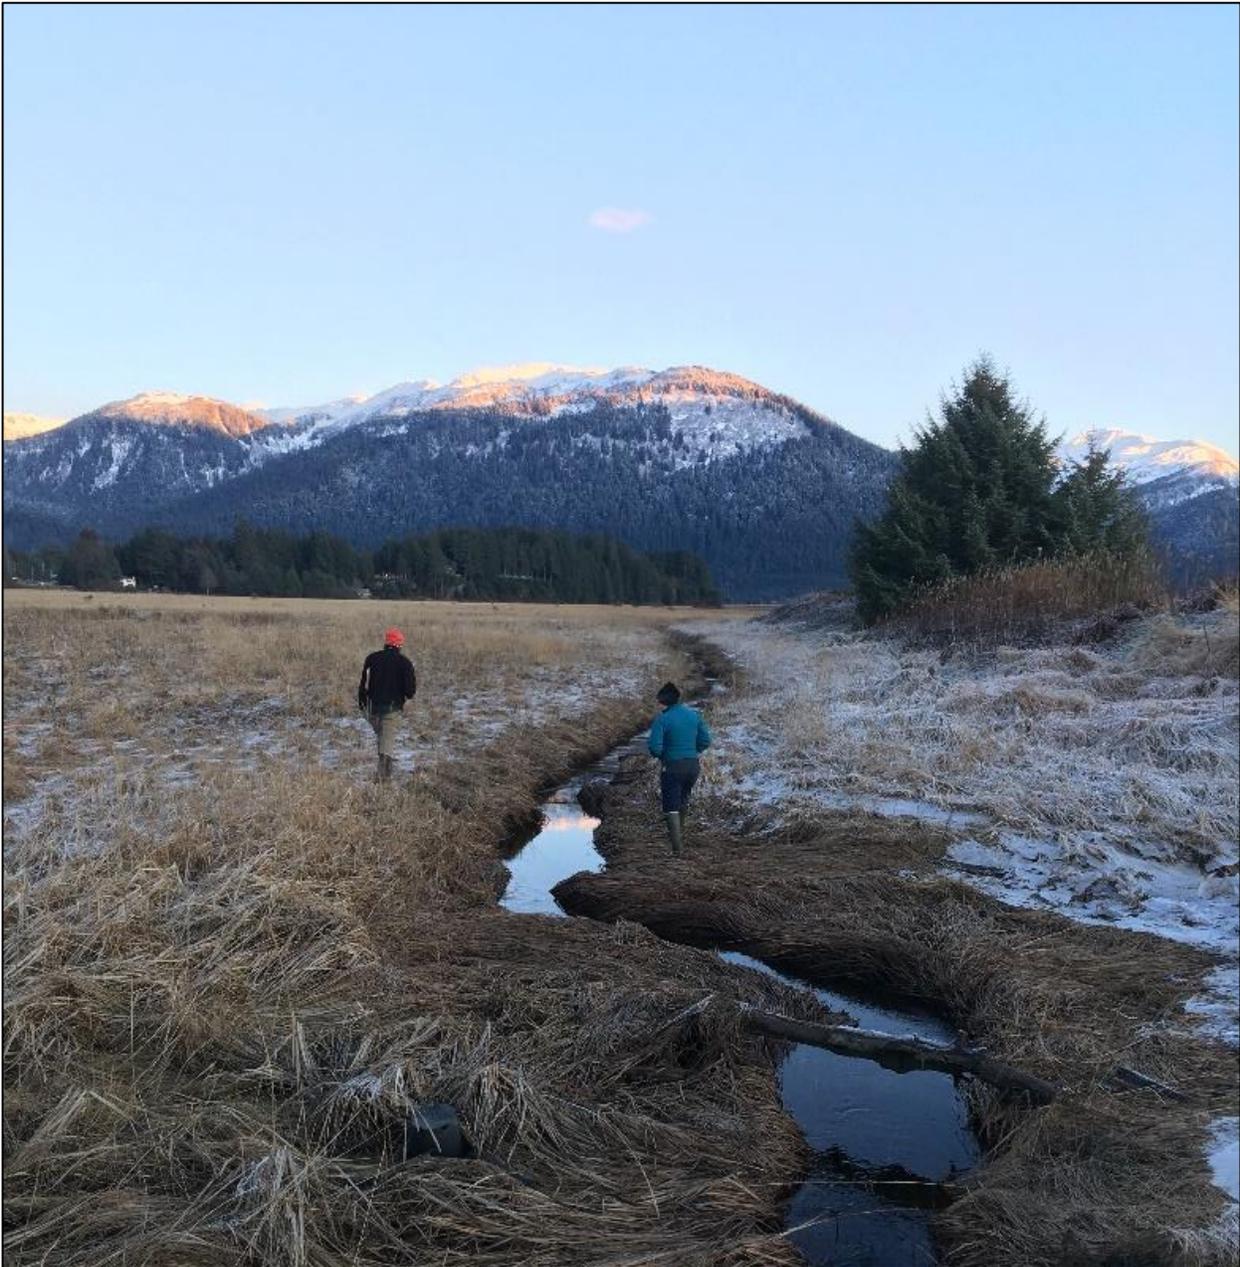
A channelized reach of salmon stream on the northeast side of Honsinger Pond. View looking west on Nov. 26, 2019.

Potential Barriers to Project Success: Sensitive habitat. Equipment used to restore the stream channel could damage adjacent wetland and meadow areas.

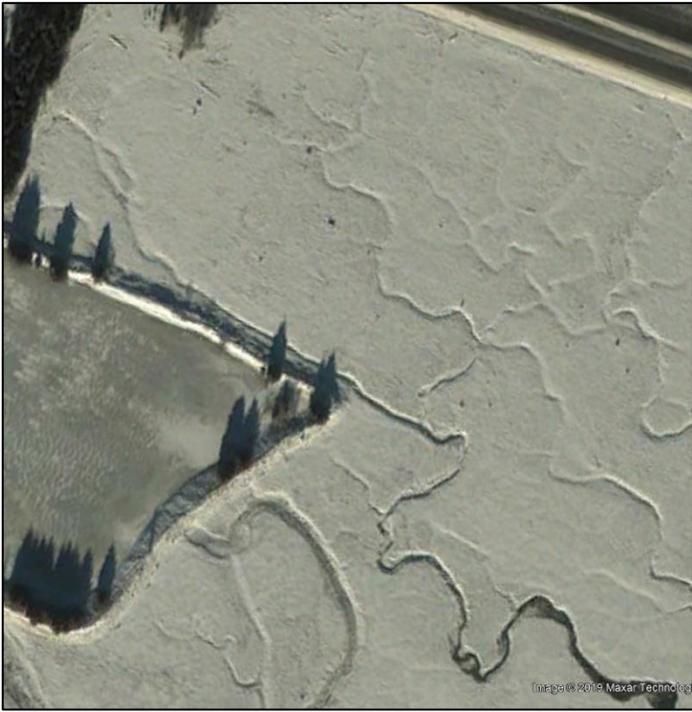
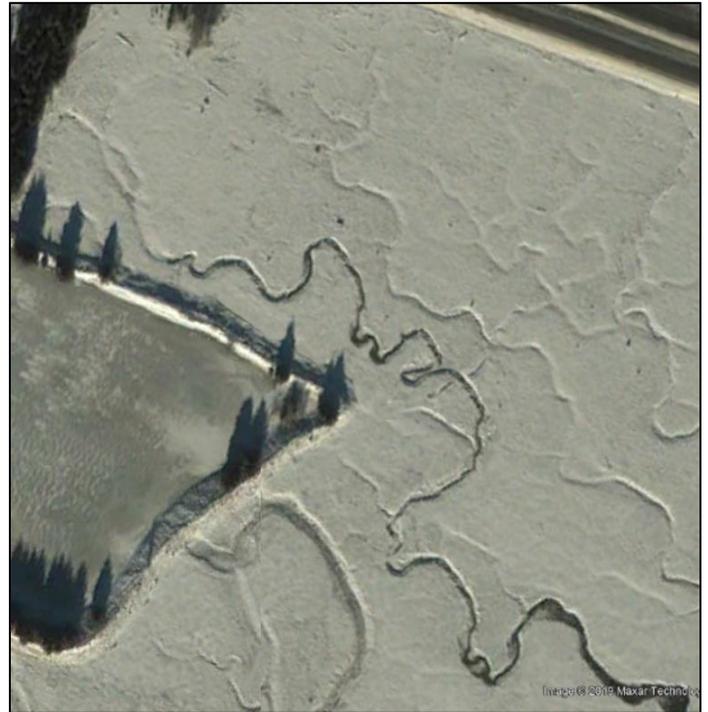
Current planform (left) and proposed planform (right) with more natural meanders and overall greater stream length.

Landowner may not want to risk damage to habitat from heavy machinery used to restore the channel.

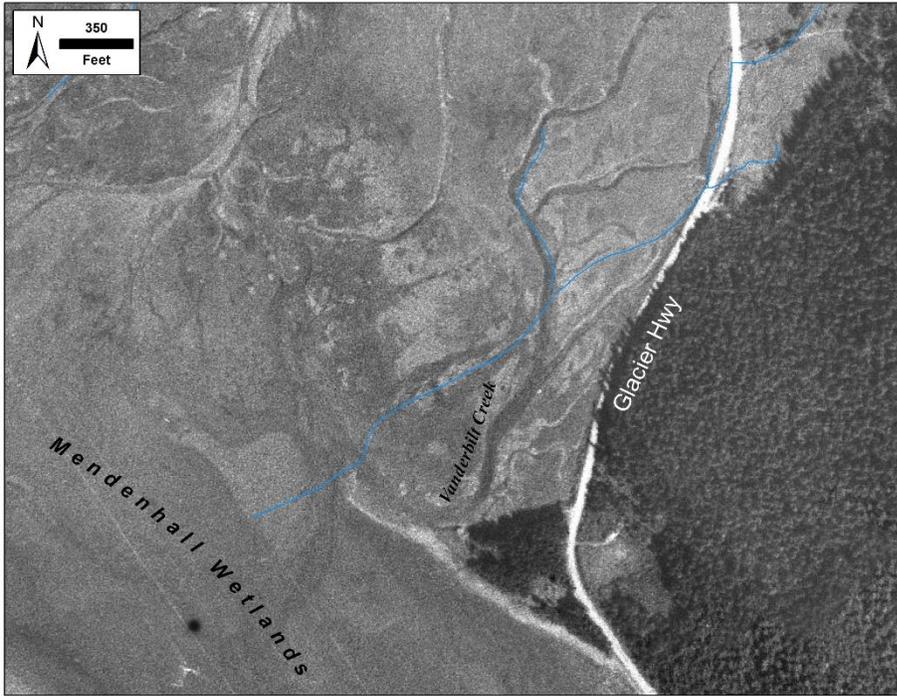
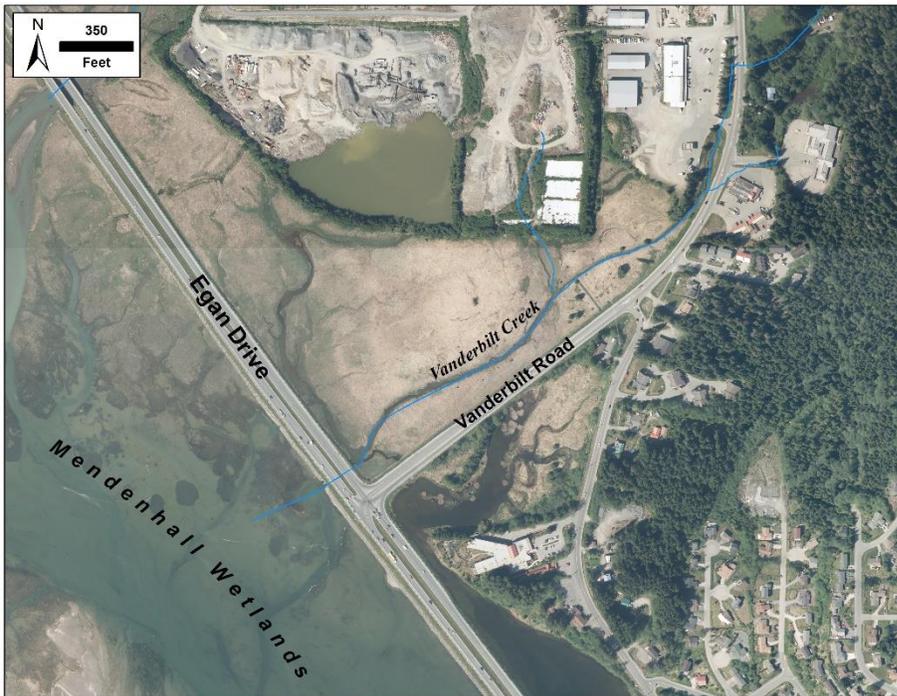
Vanderbilt Creek in 1949. Blue line is current stream channel.

Vanderbilt Creek today. Blue line is superimposed on above 1947 channel.

Background: The lower portion of Vanderbilt Creek was relocated to accommodate development of the Western Auto shopping area, the Juneau Landfill, and Vanderbilt road. The created channel has some slight meanders and a relatively natural looking channel profile. Some of the remnant sloughs of the historic channel fill with water on a high tide. There is a straight line ditch connecting Vanderbilt Creek to Vanderbilt road, presumably to accommodate stormwater runoff from the road. There are also numerous concrete blocks in this tidal meadow that are remnants of a historic radio communication system. They have sizable footings that are not easily removed. The mouth of Vanderbilt Creek naturally flowed into what is now the Pioneer Marsh, but was cut off from this area by road construction. Enhancement of the site would be compatible with ADNR management plans, but any additional enhancement goals, objectives, and/or feasibility would need to be further defined before pursuing any action here.

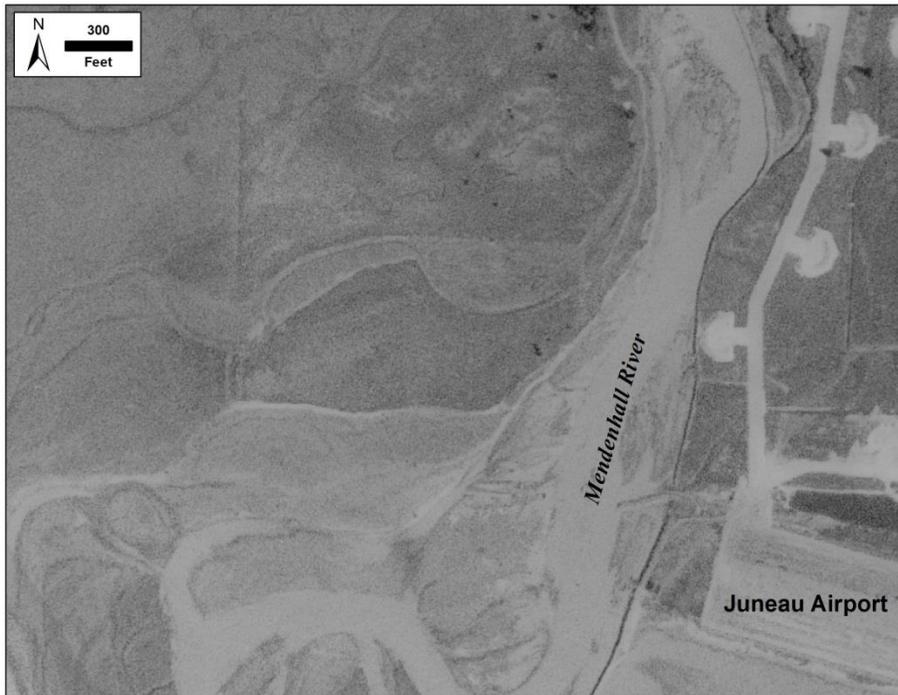
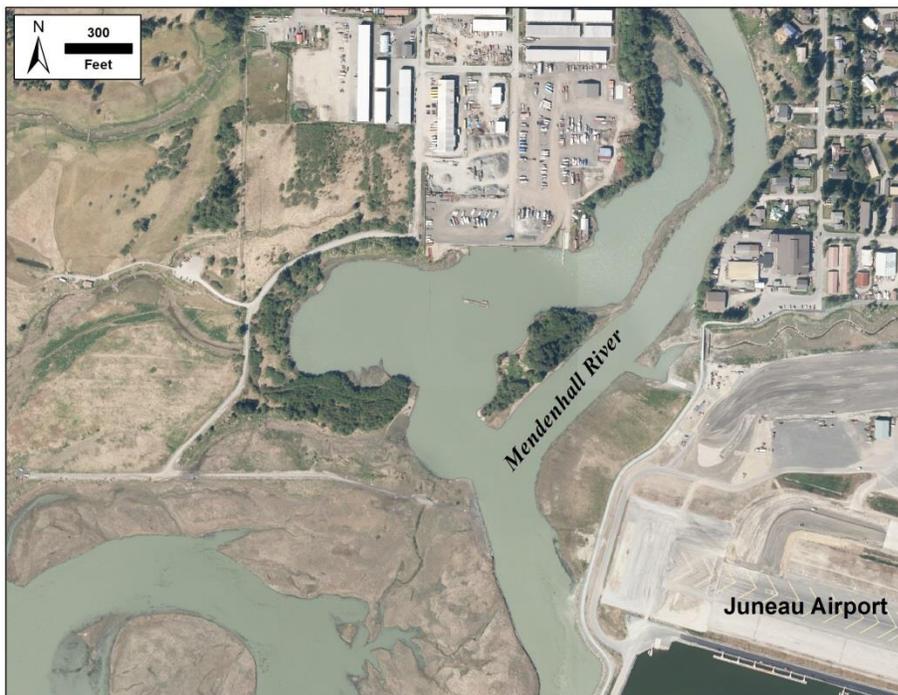
Mendenhall River mouth in 1949.

Mendenhall River mouth today.

Background: The mouth of the Mendenhall River was dredged for gravel and fill material for construction of the airport and other infrastructure. An irregular shaped excavated pool is just northwest of the Juneau International Airport. It is separated by the Mendenhall River by a slight berm with an opening in which boats can pass through. It is used as staging area for hatchery pens and a nearby boat yard. The far NE and W sections of this open water area are not frequently used and could be evaluated for habitat enhancement. Spoils piles from the gravel extraction and former building pads have regrown into thick alder and an airport service road surrounds this filled area. It is unknown what the bottom profile/bathometer of the nearby pool is. Restoration or enhancement goals and objectives for this area have not been defined.

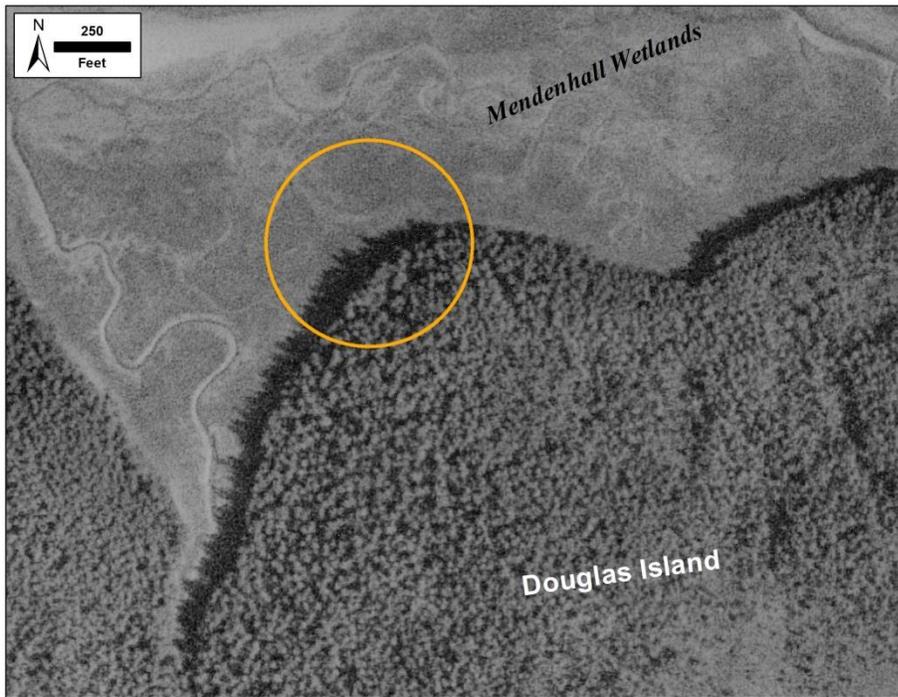
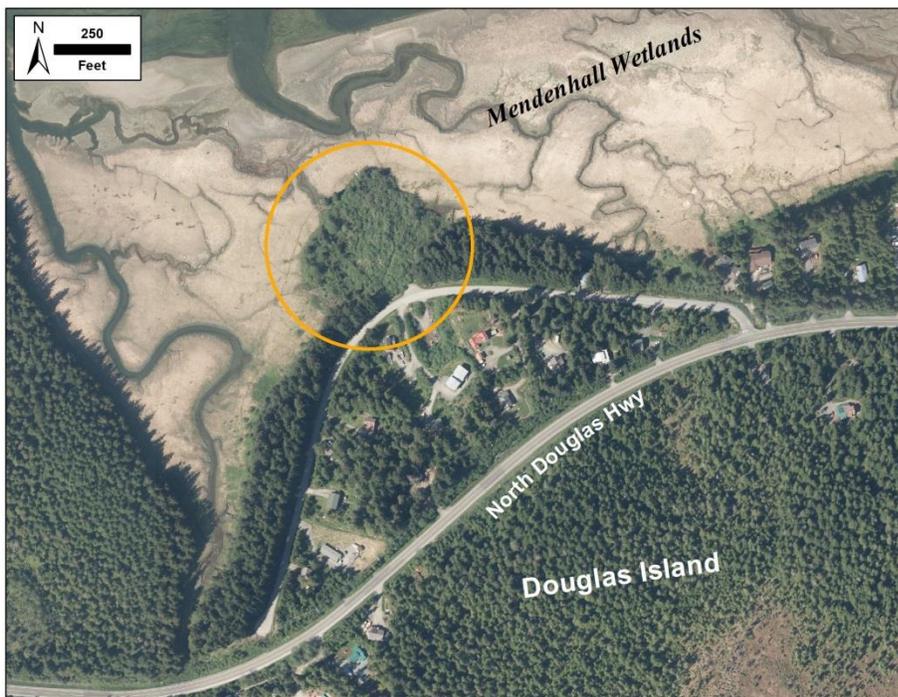
Ninemile Creek Estuary in 1949

Ninemile Creek Estuary today.

Background: Fill associated with a borrow pit was disposed of on intertidal wetlands just east of the Ninemile Creek Estuary on Douglas Island. A healthy growth of alder and shrubs are currently growing on the fill. The Alaska Department of Fish and Game did some small experimental excavations of this fill material over a decade ago. Sites were allowed to revegetate naturally. In the spring of 2019, the excavations, while small, were supporting healthy native wetland plant communities, including Lyngbyei sedge. While these experimental excavations did appear to be successful in restoring wetland habitat, cost and feasibility of backhauling this volume of material is limiting.
