PAT CREEK WATERSHED RECONNAISANCE

SOUTHEAST ALASKA WATERSHED COALITION Connect - Inform - Participate

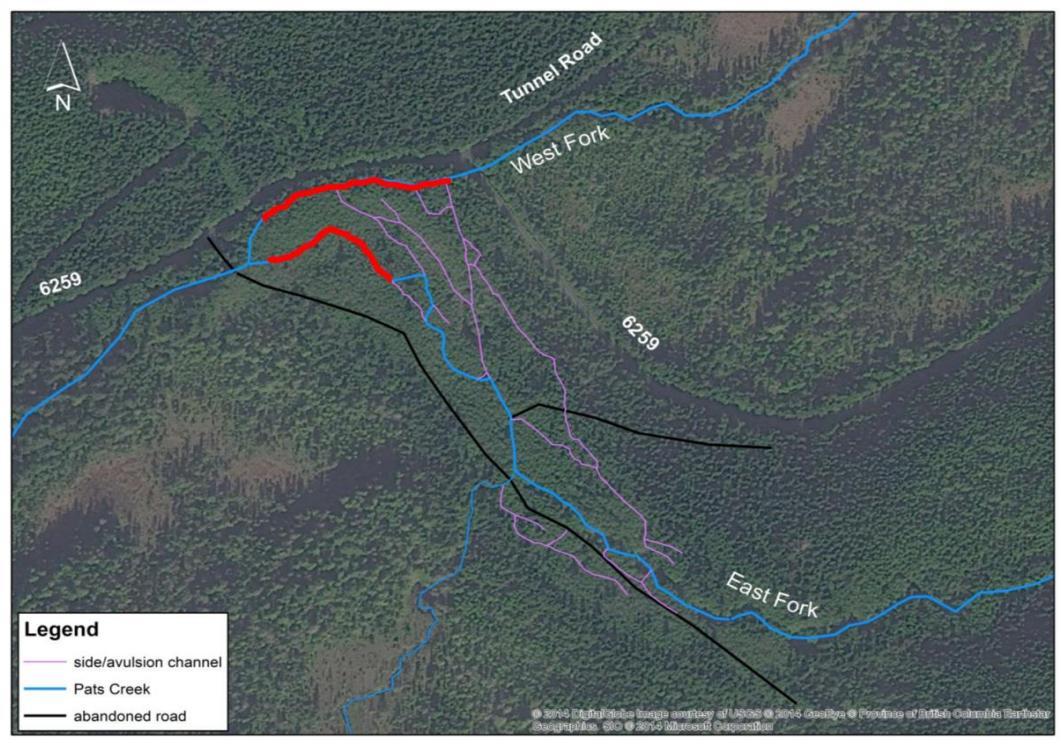
Figure 4. Tier Two habitat survey reaches shown in red on the East and West Forks of Pat Creek.

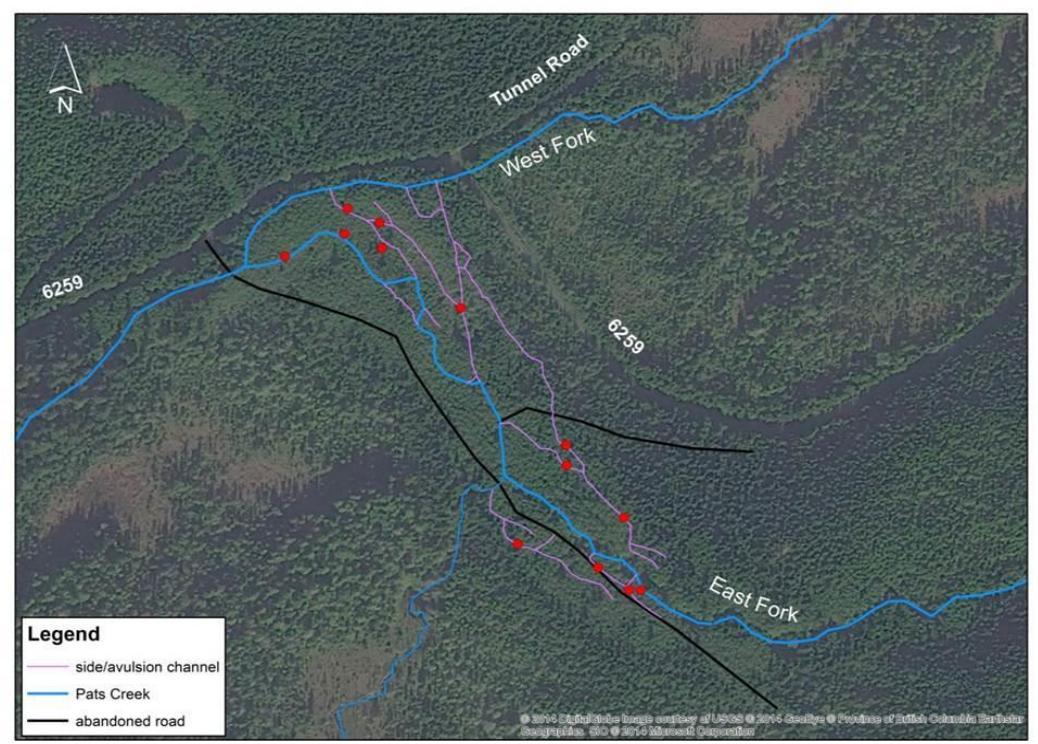
Avulsion channels were largely dry, although some of these channels contained standing water in isolated pools or small amounts of flowing water, the latter from groundwater connections to the active channel. Surface water presence in avulsion channels appeared to be influenced by channel slope and bed topography, bed coarseness, and groundwater connectivity. Juvenile fishes (coho salmon, coastal cutthroat trout) were observed at several locations in these channels (Figure 5).

Figure 5. The lower East Fork of Pat Creek at its confluence with the West Fork. The lowflow channel that was active in August 2014 is indicated by a blue line; purple lines indicate avulsion channels. Red symbols indicate the location of fish observations.

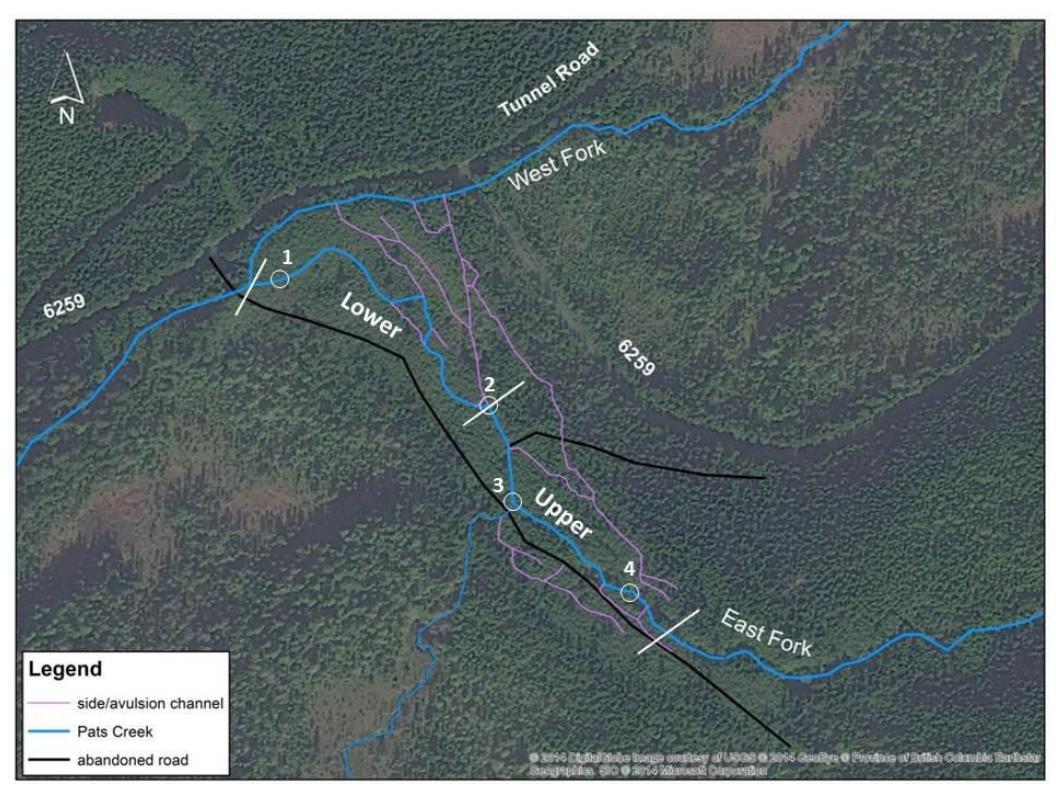
Channel stability and morphology differed dramatically between the upper and lower reaches of the active alluvial channel (Figure 6). Sediment aggradation in the upper half of the alluvial fan was evidenced by large depositional bars of coarse sediment, relatively high width-to-depth ratios, and extreme bank erosion. At several locations within this reach numerous mature red alder had recently fallen or were in the process of falling into the channel (Figure 7). Most of the recently active avulsion channels originate from the upstream half of the fan.

Figure 6. Upper and lower reaches of the East Fork alluvial channel and the location of photo points referenced below.

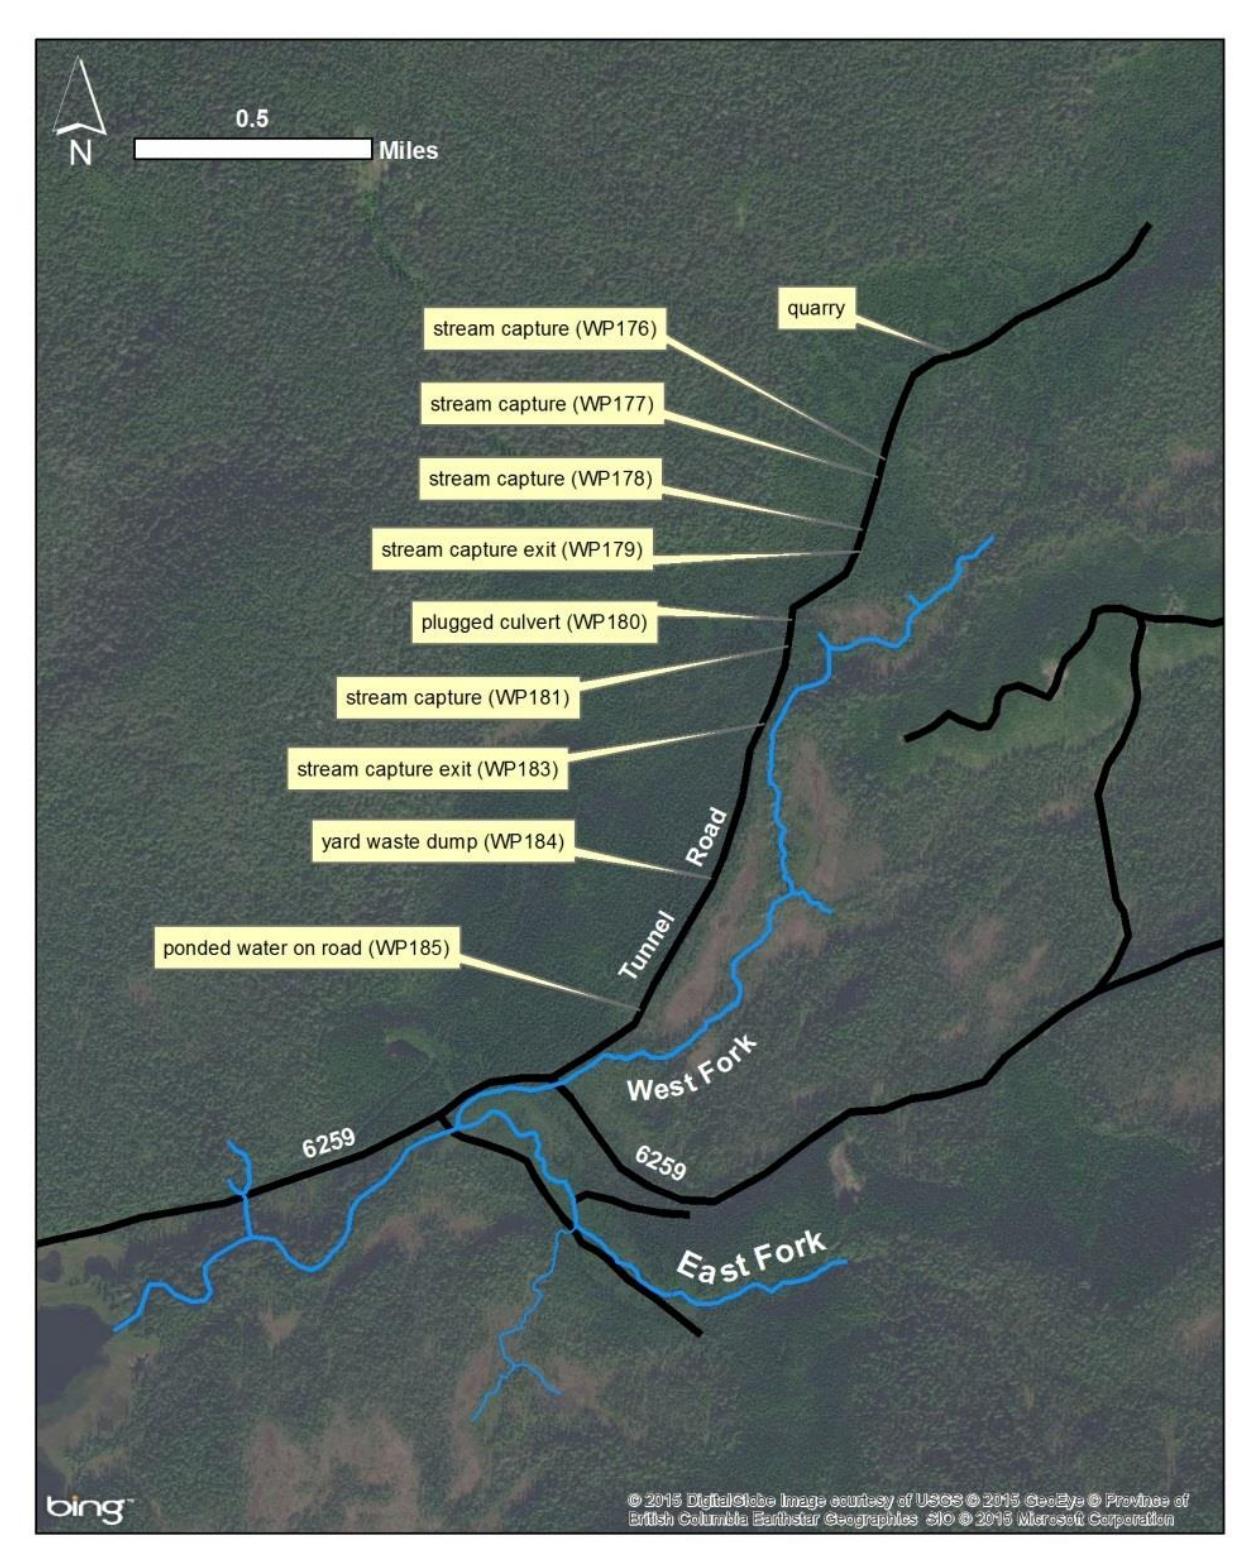
The locally named Tunnel Road is an unmaintained former logging road constructed off of Forest Service road 6259 to provide access to timber that was harvested in the 1960s and 1970s (Figure 12). The road is located on the west side of the West Fork and runs generally parallel to the stream channel for most of its length. The road is used by ATV riders and for illegal dumping of household garbage and yard waste. Our reconnaissance efforts along Tunnel Road identified several opportunities for improving road conditions and aquatic connectivity (Figure 12).

Figure 12. Observation waypoints along Tunnel Road in the West Fork subwatershed of Pat Creek
