## ***Threemile Creek Restoration Opportunities***

### **Klawock Lake Watershed**

*October 2019*

**Klawock Sockeye Salmon Stakeholder Group**

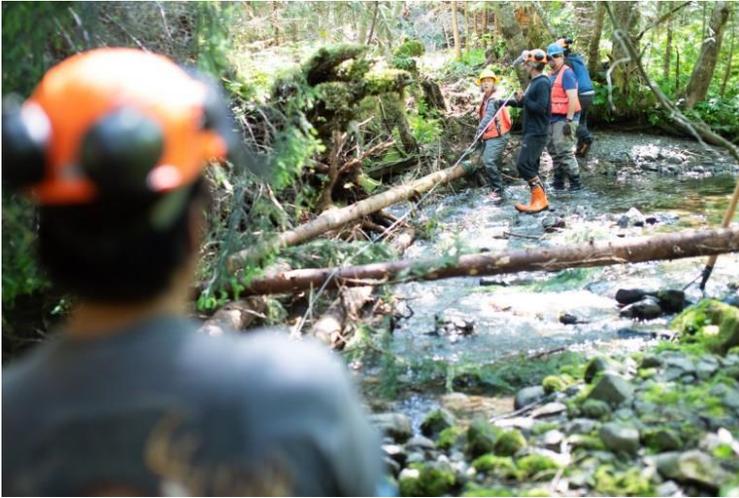
**Figure 9.** A large-wood structure constructed with hand tools in the Spaski Creek watershed on Hoonah Totem land on Chichagof Island. Photo by Ian Johnson.

Instream and riparian restoration are recommended for this stream, both downstream and, if warranted, upstream of the highway. The goal of a restoration project would be to improve fish habitat quality and quantity and enhance plant species and structural diversity in the riparian zone, including promoting conifer growth. Large pieces of wood sourced from riparian spruce trees can be placed in the channel using hand tools (i.e. shovels, picks, winches). The large-wood structures will be located at specific sites to route excess sediment accumulations through the reach, restore natural channel dimensions, and create riffles and pools for fish habitat. Riparian trees could be thinned or pruned to

improve understory light levels, enhance tree growth, and encourage greater plant species diversity. Appendix 2 provides the proposed prescriptions for thinning in the Threemile Creek alluvial Fan. Additional assessment work is necessary to better understand existing conditions so that specific restoration objectives and plans can be developed. A hand-tool instream restoration project in the lower reach of this channel would require a 4-person crew for 6 days. Total cost, including planning and permitting, is estimated at around \$15,000.
